Docket No. 272 – Development and Management Plan Inspection

Segment 4c Underground Line

Date: November 8, 2007

Location: Westport Avenue to the Norwalk Substation in the City of Norwalk

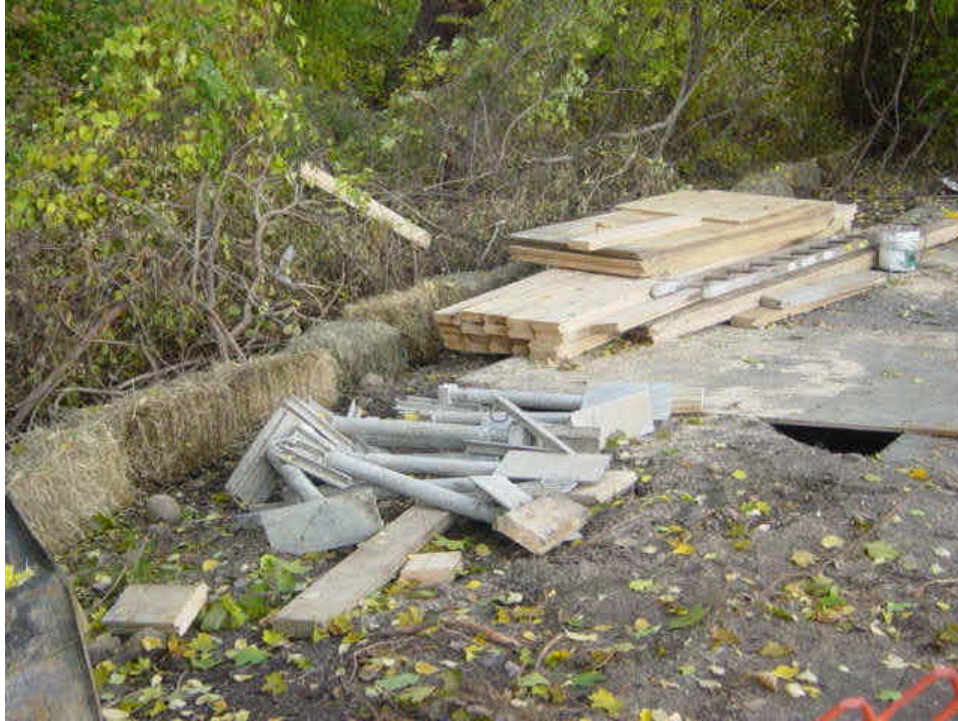
Clearing work has begun near sta. #16-18 along a fairly steep slope. Hay bales have been installed downgradient from the work area along the adjacent slope.

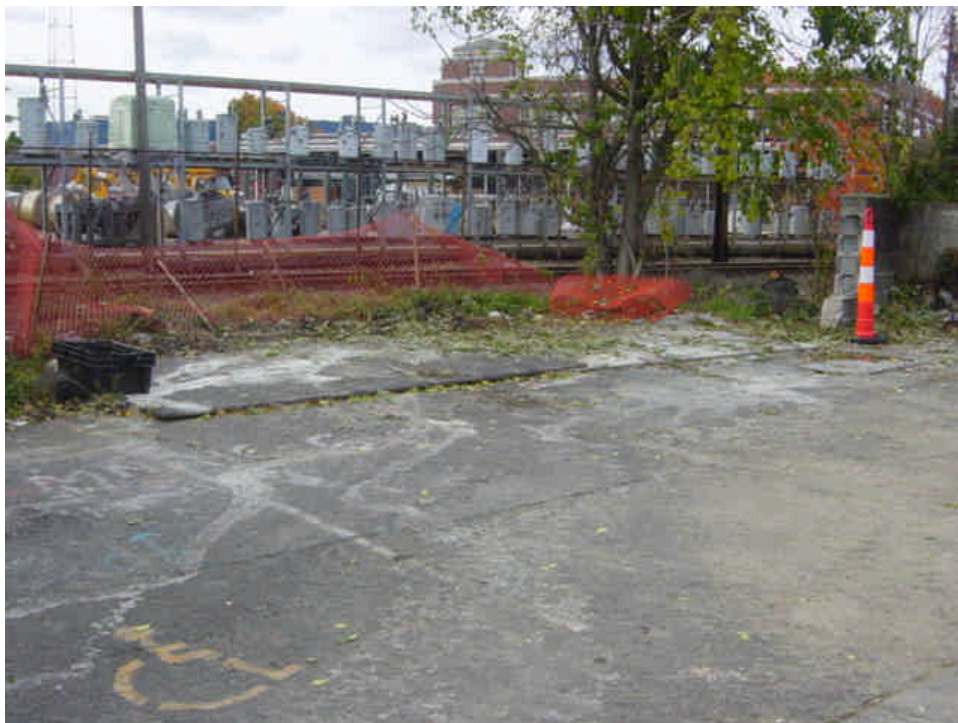
Slurry residue and concrete were cleaned from the paved areas surrounding the work site near sta. # 29. However, the downgradient catch basin still did not have controls in place.
