Docket No. 272 – Development and Management Plan Inspection

The Connecticut Light and Power Company Certificate of Environmental Compatibility and Public Need for the construction of a new 345-kV electric transmission line and associated facilities between Scovill Rock Switching Station in Middletown and Norwalk Substation in Norwalk, Connecticut, including reconstruction of portions of existing 115-kV and 345-kV electric transmission line, the construction of Beseck Switching Station in Wallingford, East Devon Substation in Milford, (and Singer Substation in Bridgeport), modifications at Scovill Rock Switching Station and Norwalk Substation, and the reconfiguration of certain interconnections.

Segment 4c Underground Line

Date: November 15, 2007

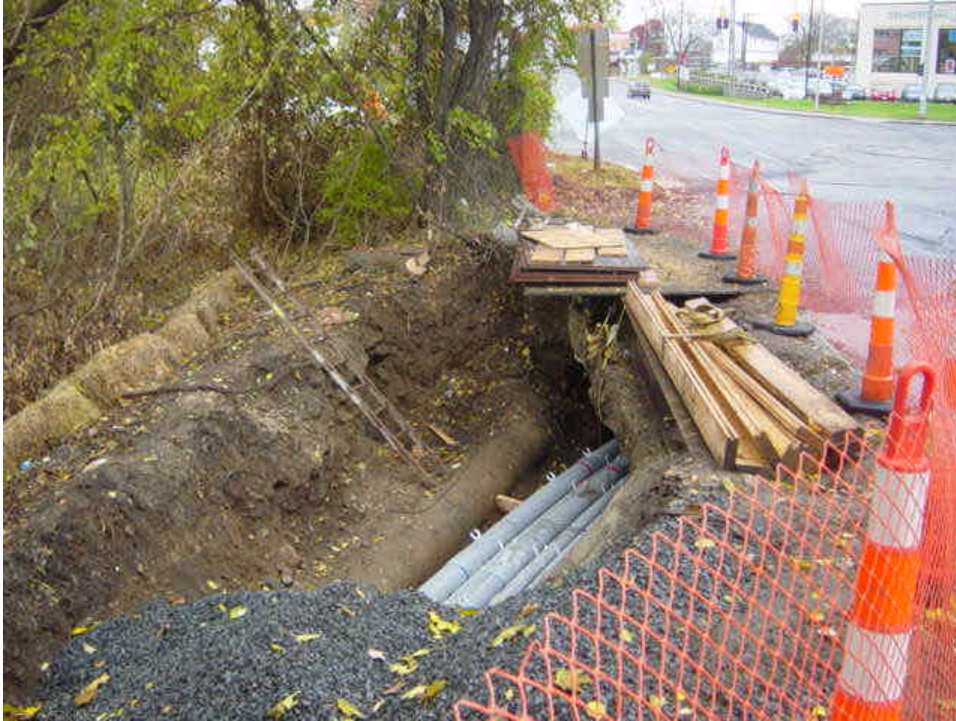
Trench work continues near sta. #16-18 along a fairly steep slope. Haybales remain in place downgradient from the work area along the adjacent slope.

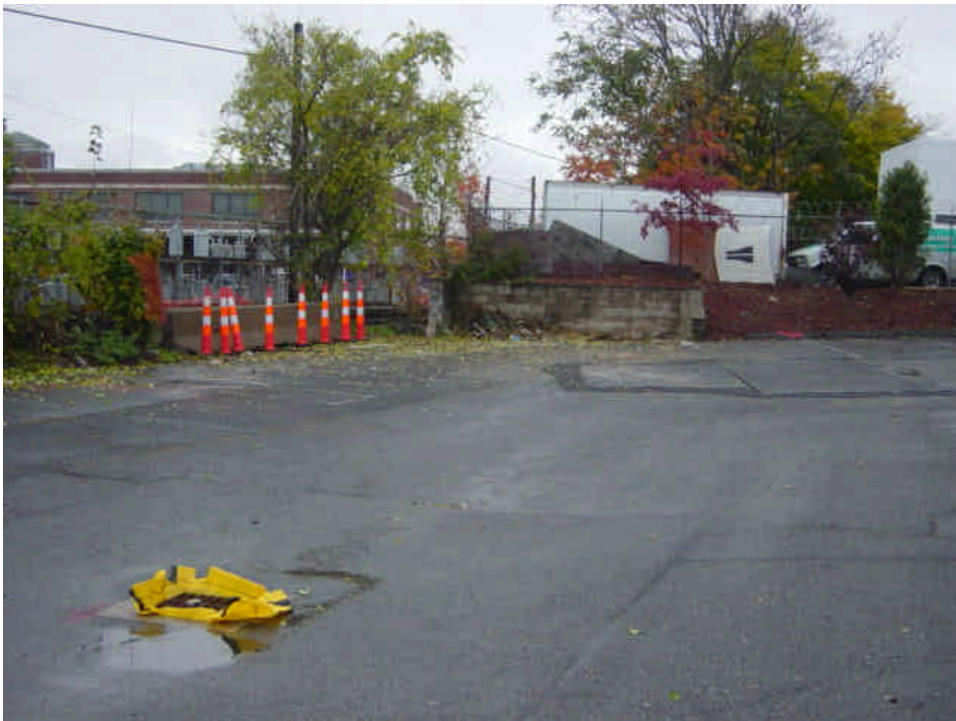
Steel plates are in place over the jack and bore receiving shaft near sta. # 29. The downgradient catch basin has been protected.
