Docket No. 272 – Development and Management Plan Inspection

Beseck Switching Station Inspection

Date: October 1, 2007

Location: Beseck Switching Station

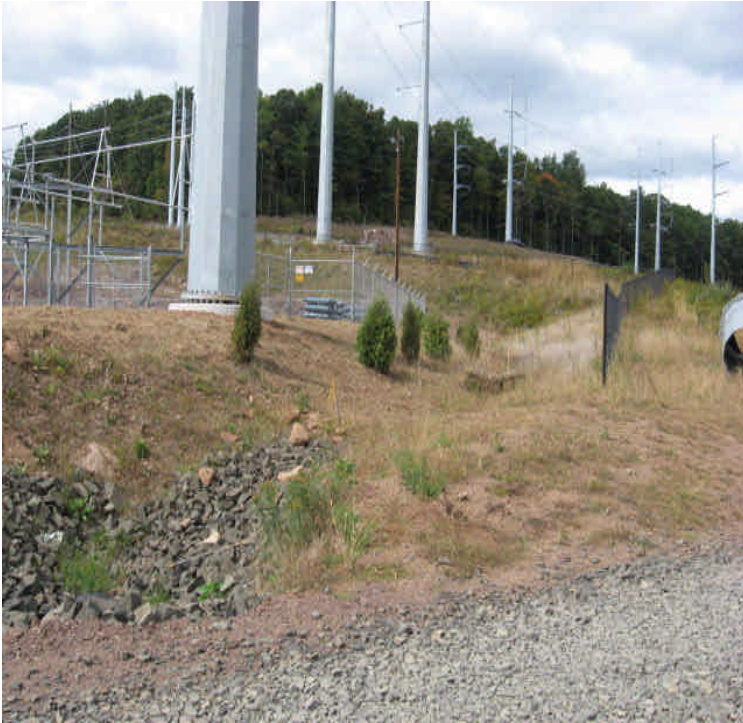
View along the eastern access road. Continue to seed and promote vegetative cover on any bare soil including the recently filled channel.

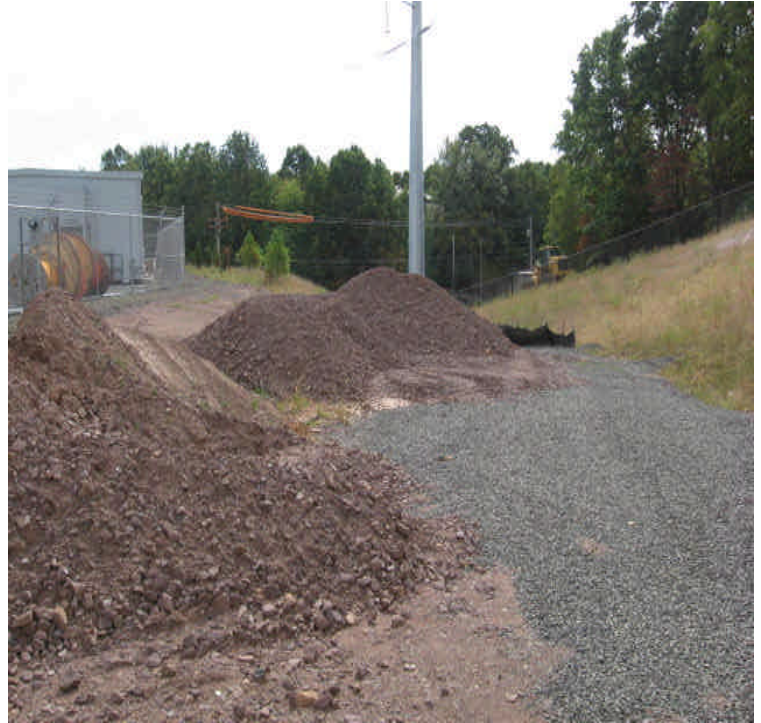
View of the stockpiles and small washouts/eroded channels at the western access drive. Silt fence remains in place across the entrance.

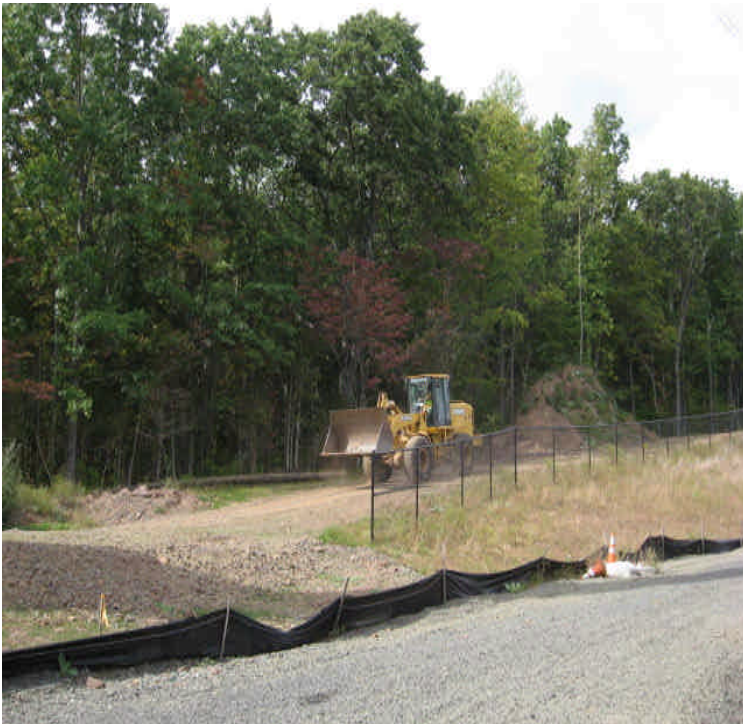
1A contractors were removing the soil stockpile at the old western site entrance, as this is currently an area under their responsibility.

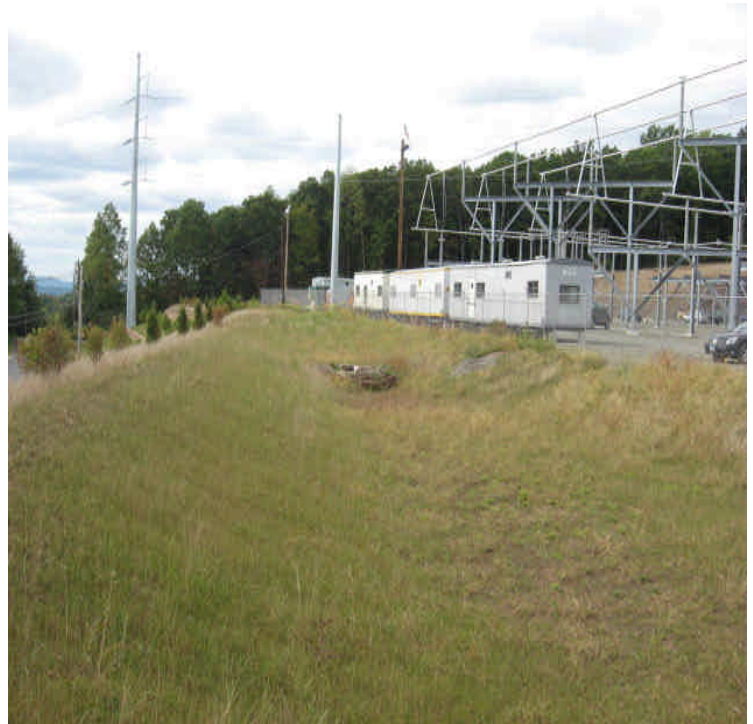
View of the stabilized detention basin onsite.
