Docket No. 272 – Development and Management Plan Inspection

Beseck Switching Station Inspection

Date: October 15, 2007

Location: Beseck Switching Station

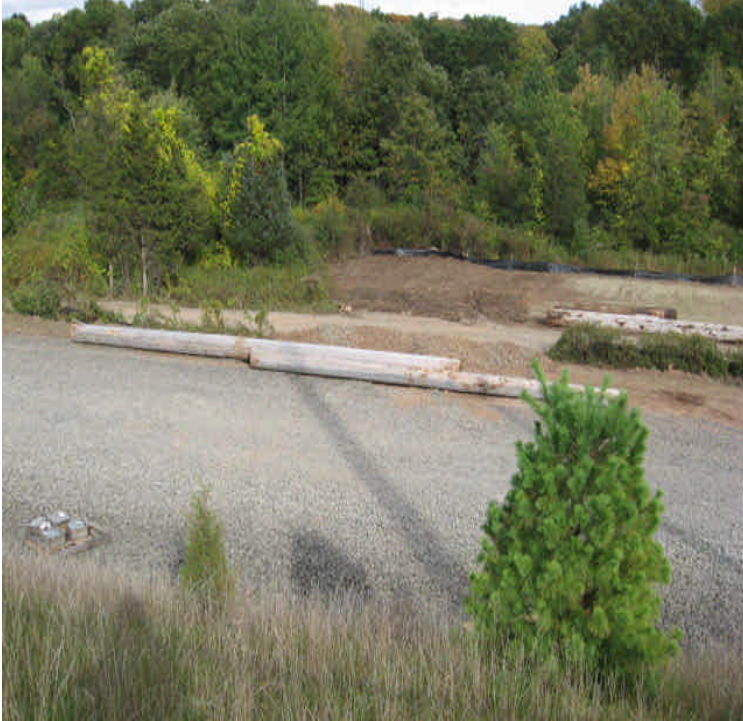
The constructed entrance between BSS and the ROW has been blocked off and graded to prepare for paving the eastern access drive to the station.

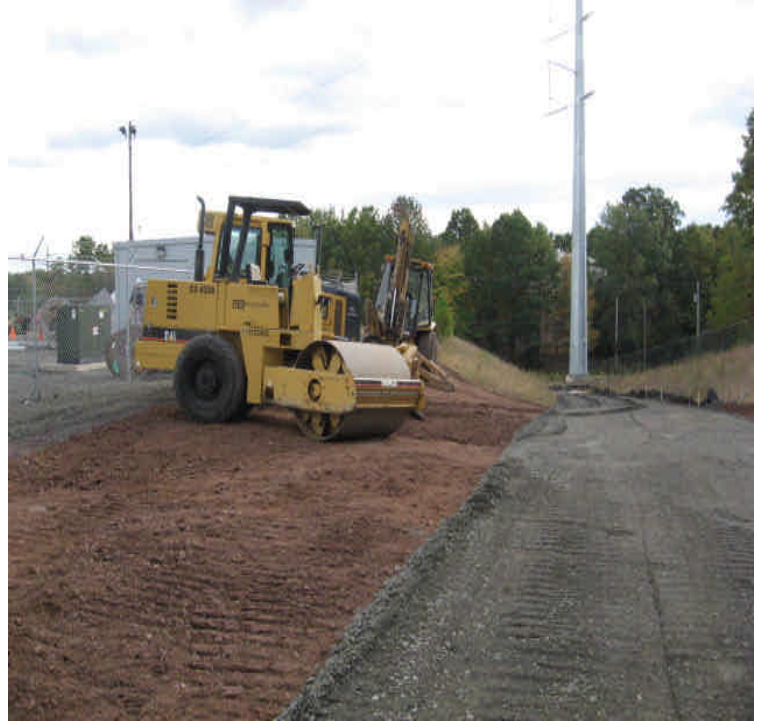
View of the final grading of the western access road in preparation for paving. Soil stockpiles had been used and silt fence controls were removed.

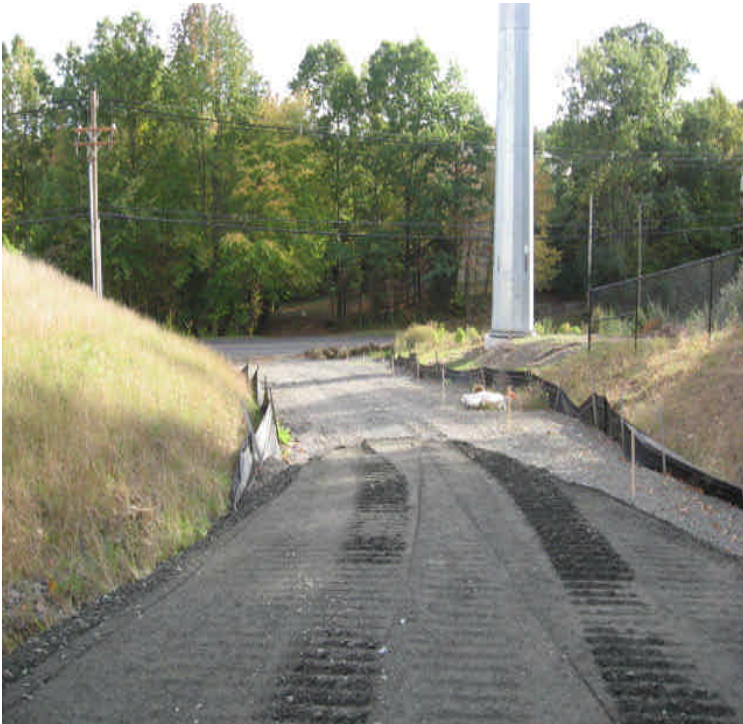
Road base was installed at final grade along the western access road.

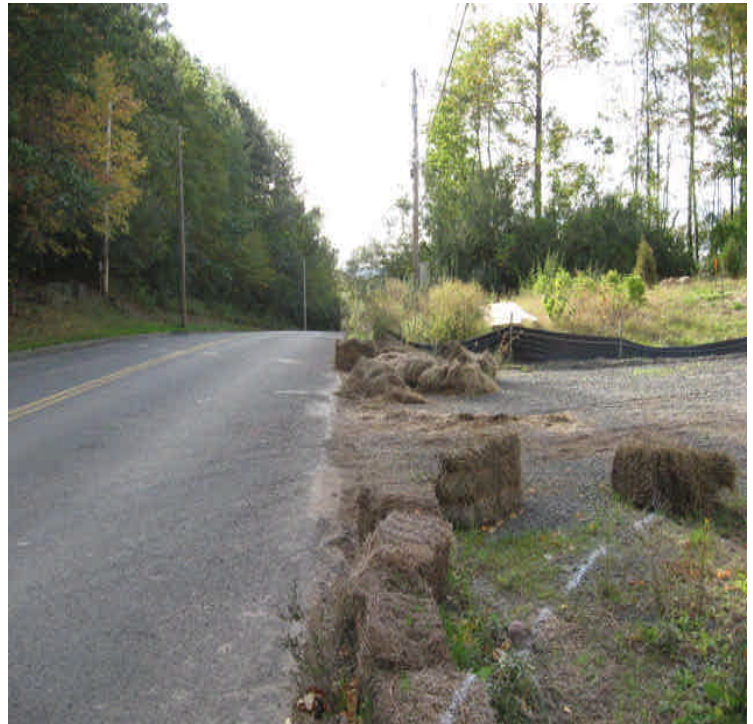
Haybales were removed from the western site entrance.
