Docket No. 272 – Development and Management Plan Inspection

East Devon Substation Inspection

Date: October 5, 2007

Location: East Devon Substation

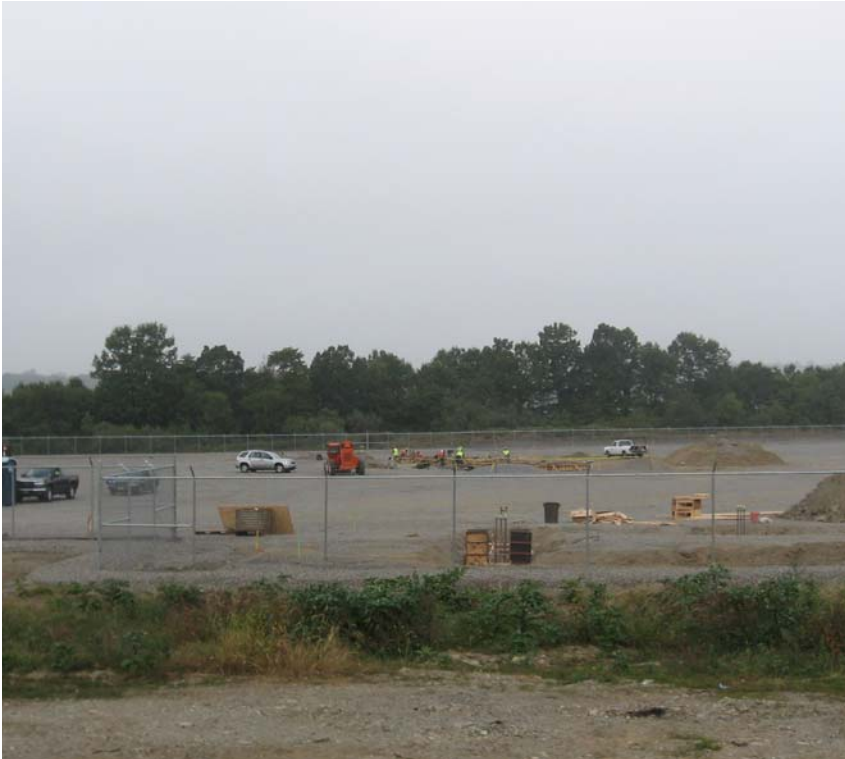
Foundation work continues at the East Devon Substation.

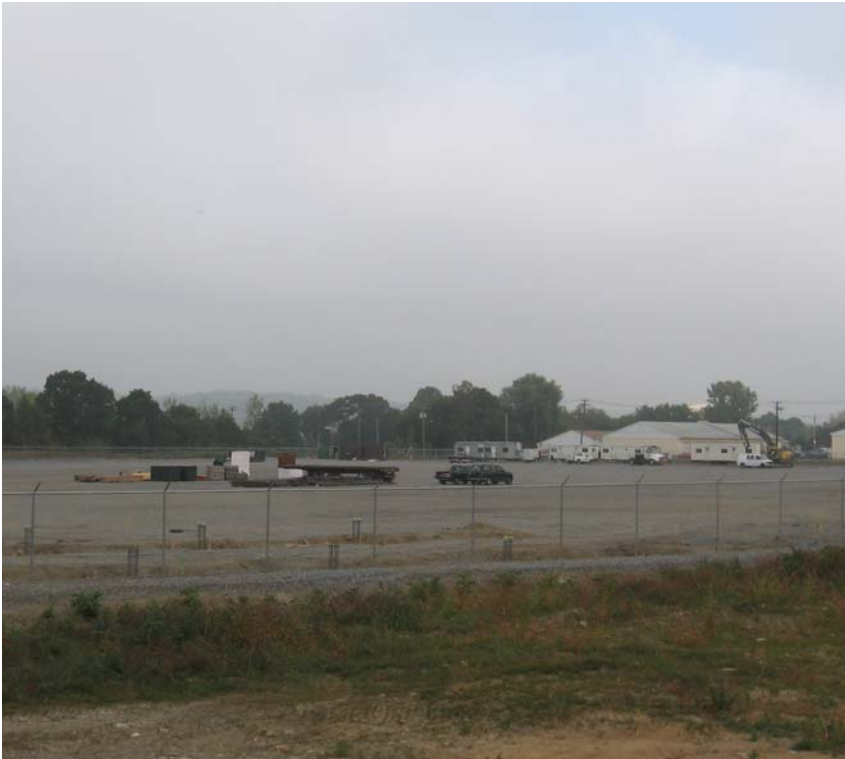
Additional view of the East Devon Substation.
