**Docket No. 272 – Development and Management Plan Inspection**

**East Devon Substation Inspection**

**Date:** October 12, 2007

**Location:** East Devon Substation

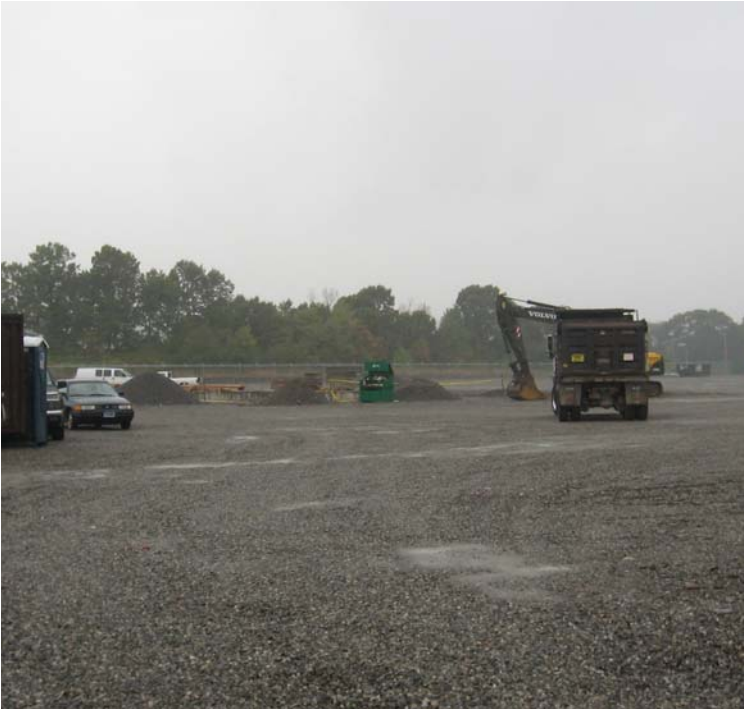
Foundation work continues here this week.

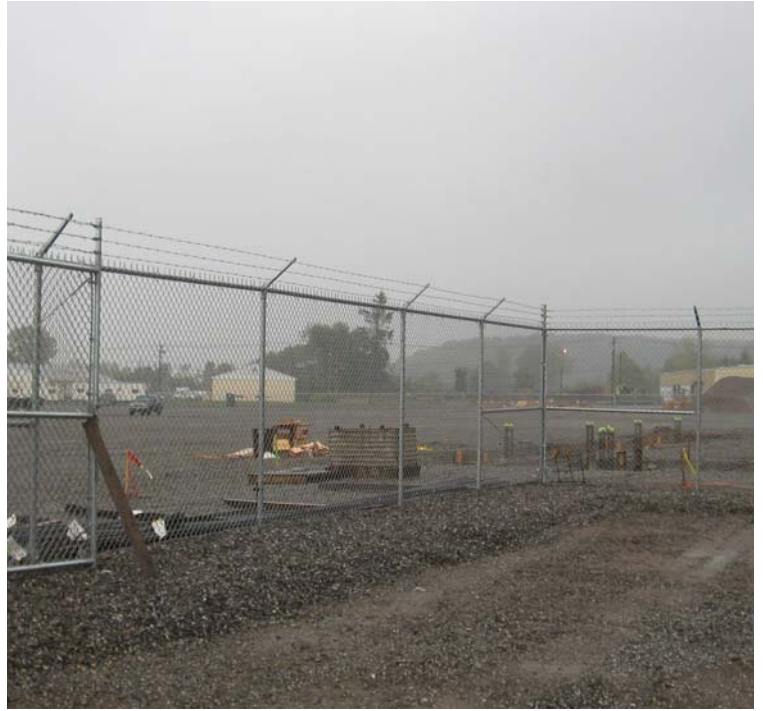
An additional view of the active work at the East Devon Substation.

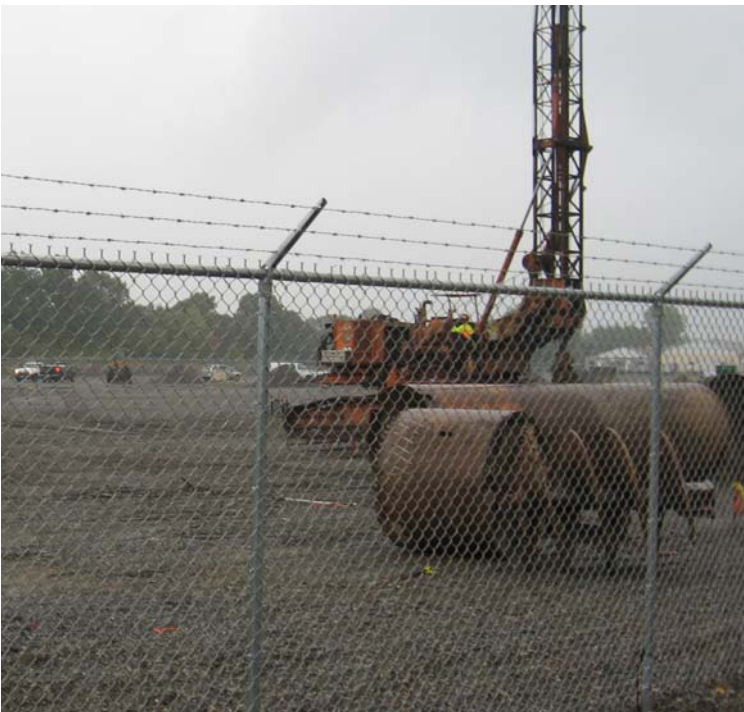
Foundation drilling was observed within the yard this week.

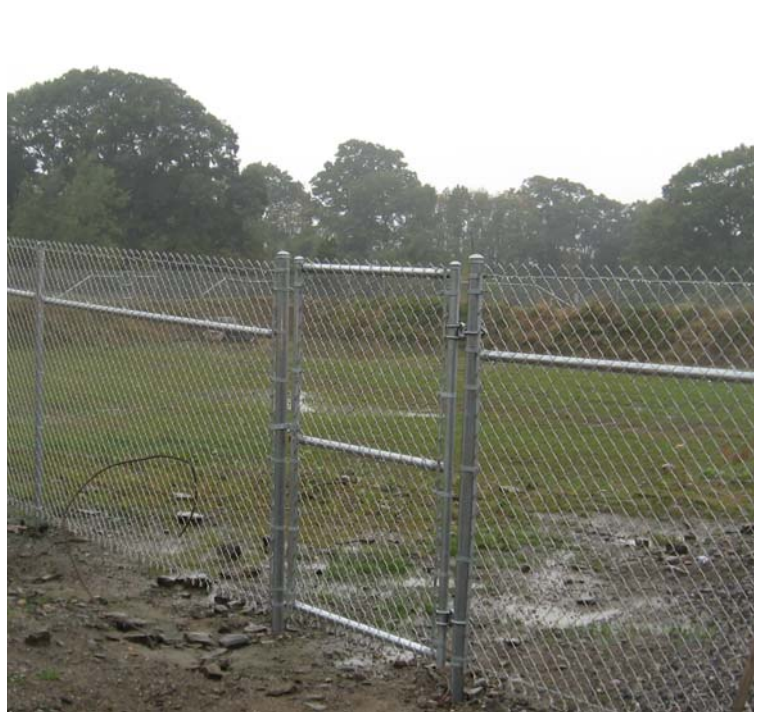
A view of the stormwater detention basin located along the southern site boundary. Increased grass growth was noted here.
