Docket No. 272 – Development and Management Plan Inspection

Segment 1a Inspection

Date: October 9, 2007

Location: Segment 1a – Scovill Rock Switching Station to Chestnut Junction, Oxbow Junction to Beseck Switching Station (excluding Royal Oak Bypass), and Black Pond Junction to Beseck Switching Station

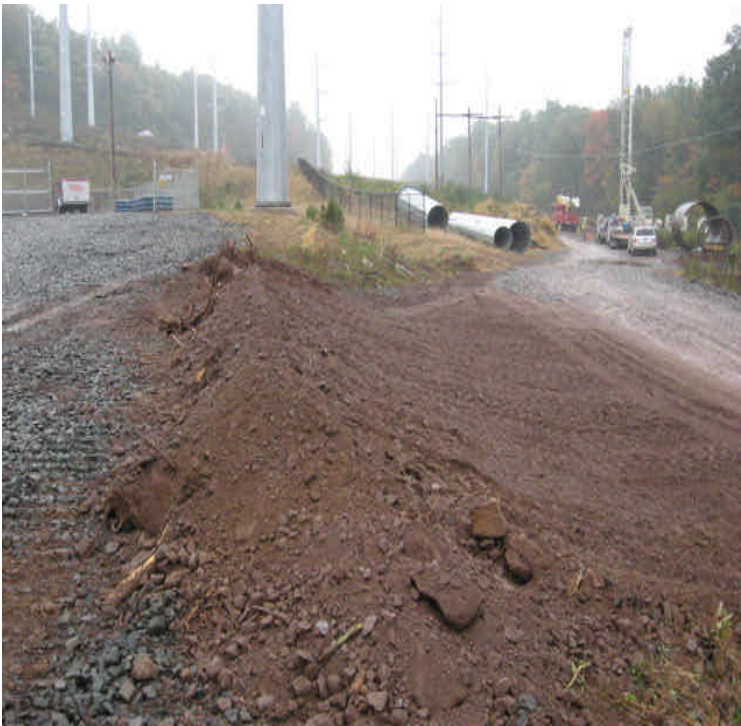
Beseck SS: The original ROW access off Carpenter Ln. was upgraded and is now in use. The constructed access between Beseck and the ROW has now been blocked off. Beseck and 1A contractors should work to stabilize the area with vegetative cover as soon as feasible.

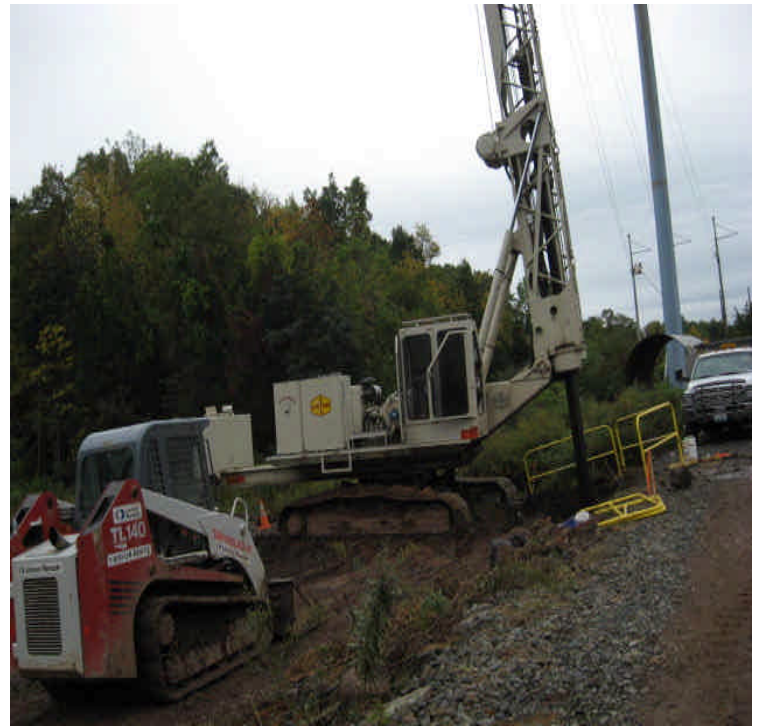
Carpenter Ln (near Beseck): Foundation drilling is occurring up-gradient from wetlands. Sediment/spoil is being removed as it is generated.

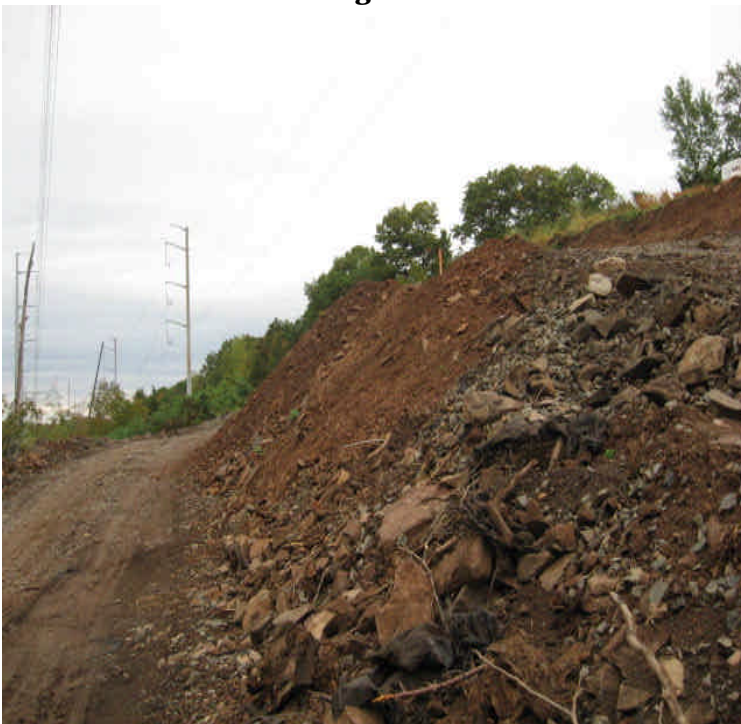
West of E. Meriden SS: Slopes along a new pad site should be seeded and mulched for stabilization. Continue to monitor for run-off; Erosion control blankets may be appropriate due to the steep slope.

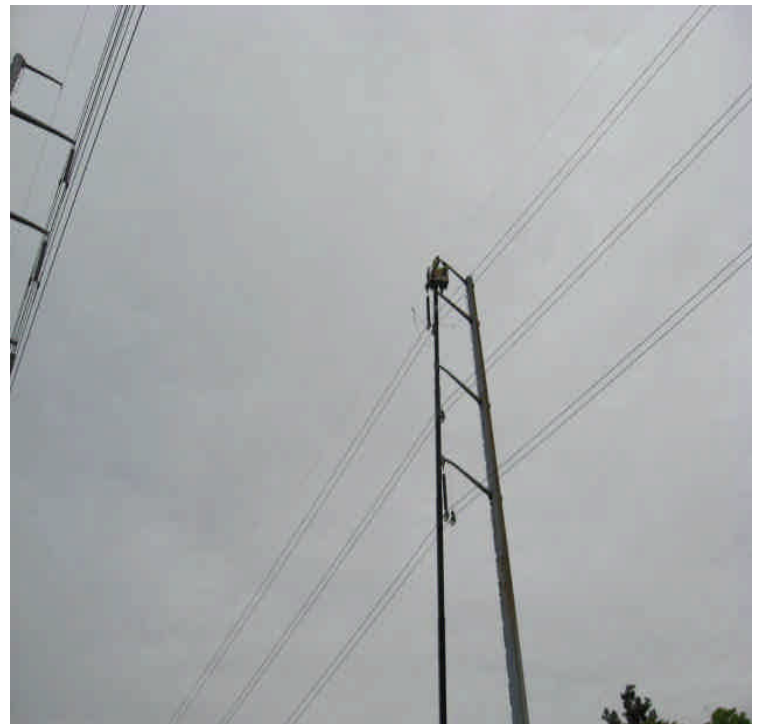
E. Meriden SS: Line work underway. Crews were pulling lines from E. Meriden SS to Beseck SS.

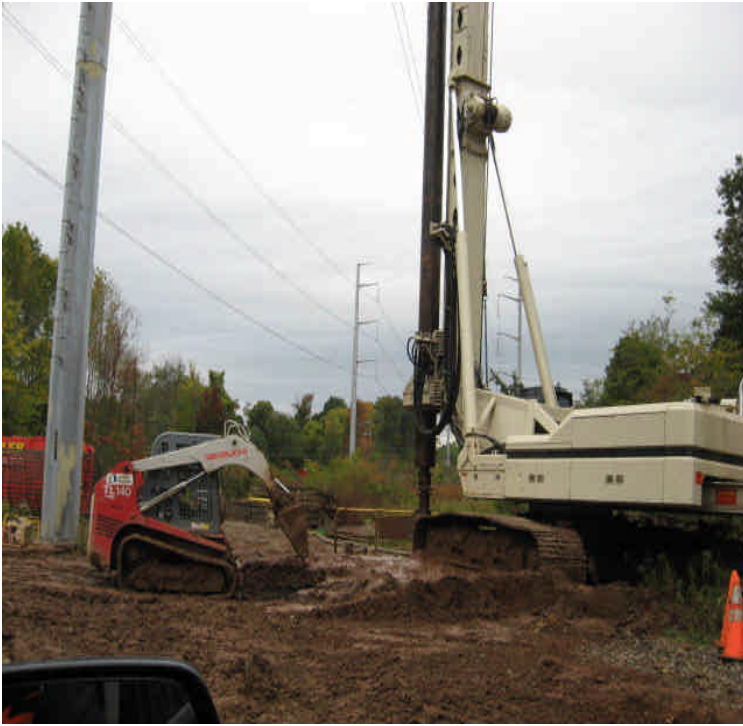
South of High Hill Rd: Drilling within the wetland was underway. Sediment/spoil is being removed as it is generated.

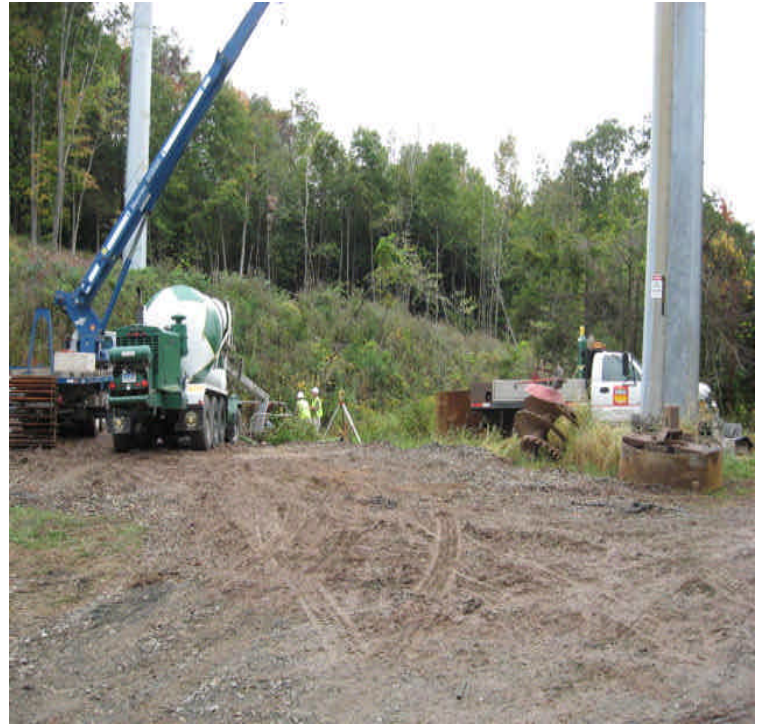
North of High Hill Rd: Crews were pouring concrete at the time of the inspection.

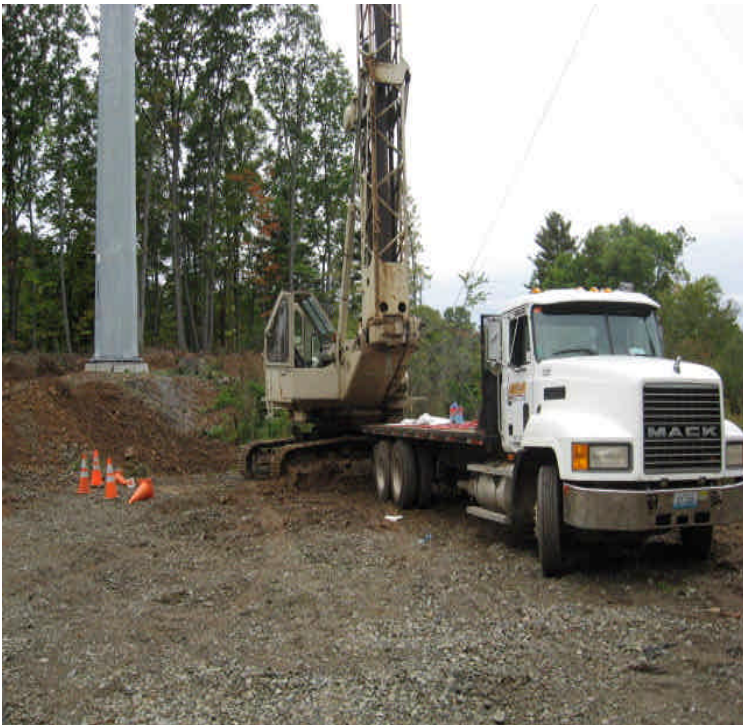
North of High Hill Rd: Broken equipment was noted. Spill controls are in place.

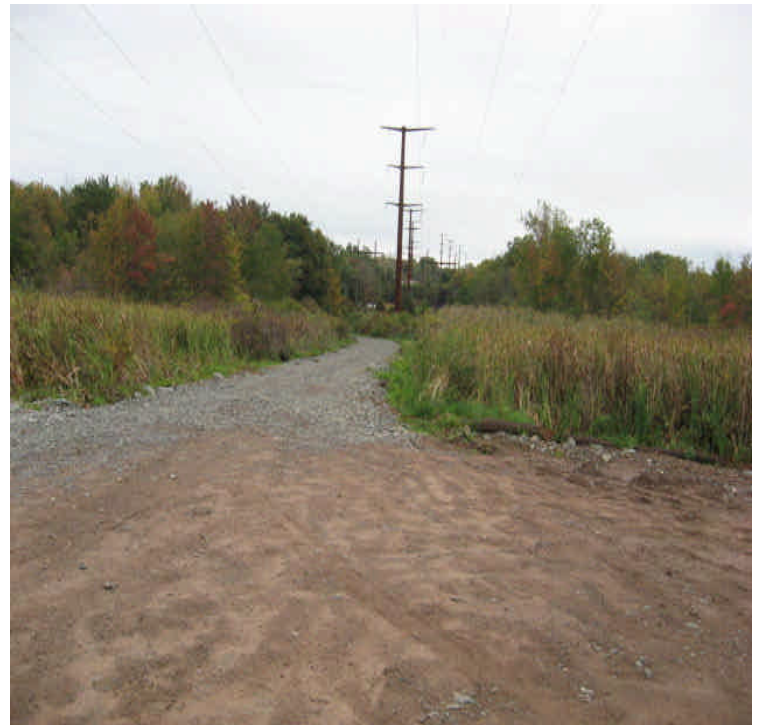
Durham Rd: Sediment migration and accumulation was occurring over the access road and pad within the wetland.
