**Docket No. 272 – Development and Management Plan Inspection**

**Segment 1a Inspection**

**Date:** October 15, 2007

**Location:** Segment 1a – Scovill Rock Switching Station to Chestnut Junction, Oxbow Junction to Beseck Switching Station (excluding Royal Oak Bypass), and Black Pond Junction to Beseck Switching Station

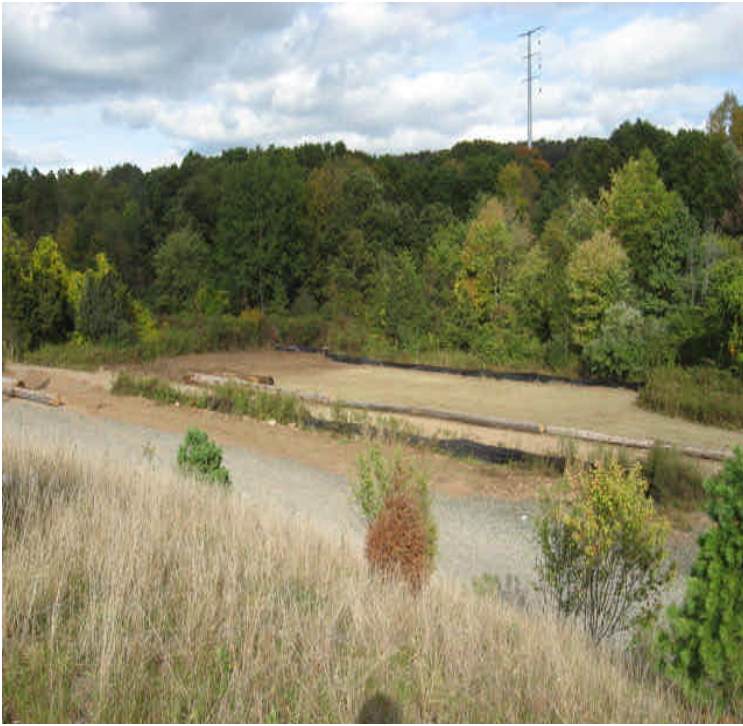
**Beseck SS:** The original ROW access off Carpenter Ln. was upgraded and is now in use. The constructed access between Beseck and the ROW remains blocked off. Adjacent disturbed areas were graded and seeded.

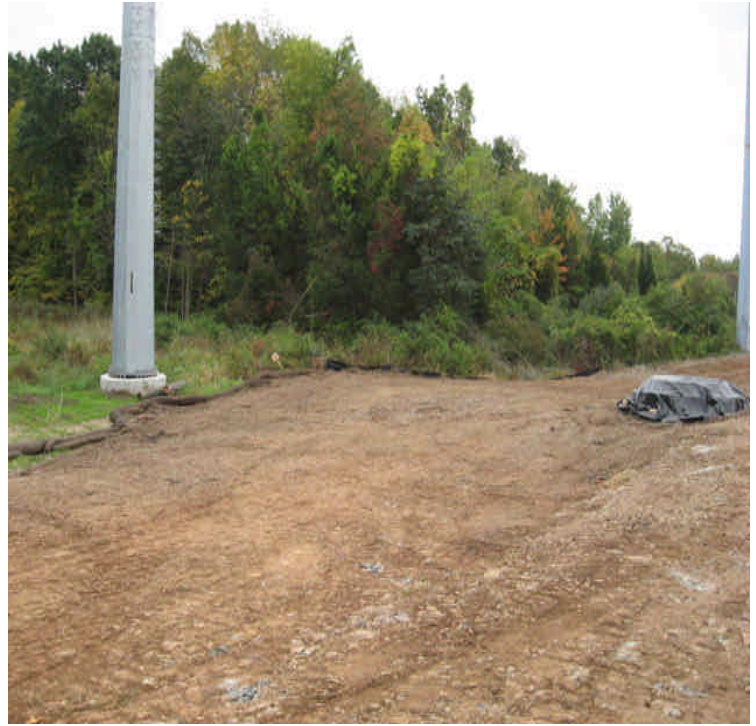
| Areas of Inspection | Observation | Recommended Action | Corrected Action |
|--|---|--|---|
| <p>East of Beseck SS</p> | <p>A pad is in place just upgradient from wetlands here. Drilling and foundation installation is complete. Sediment from the pad site at structure #4534 has migrated into the wetlands. 10/15/07</p> | <p>Remove any stone/soil accumulation and add controls to cover existing gaps in the controls. 10/15/07</p> | <p>Needs attention</p> |

**Carpenter Ln (near Beseck):** Foundation installed upgradient from wetlands. Some sediment accumulation was noted in the wetlands despite controls in place.

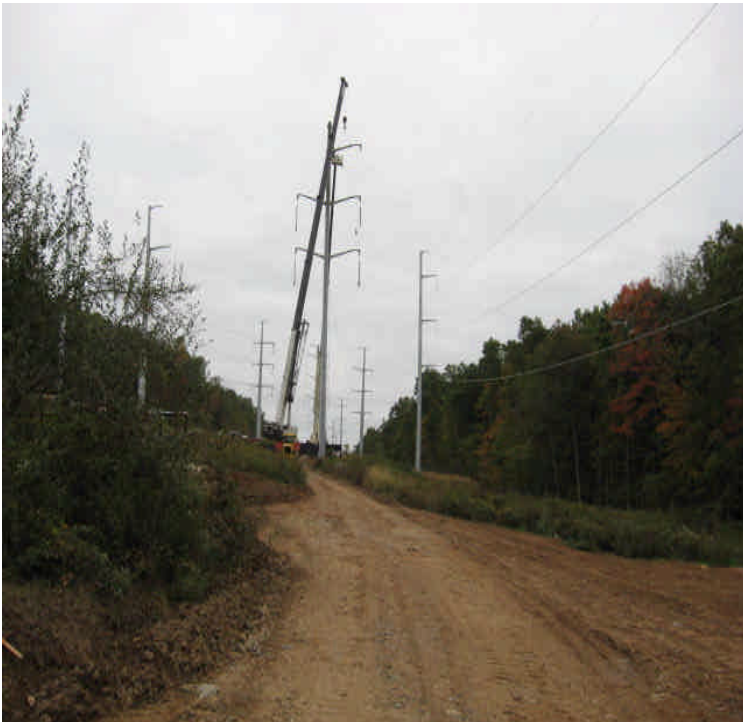
**North of BSS:** Line work was underway.

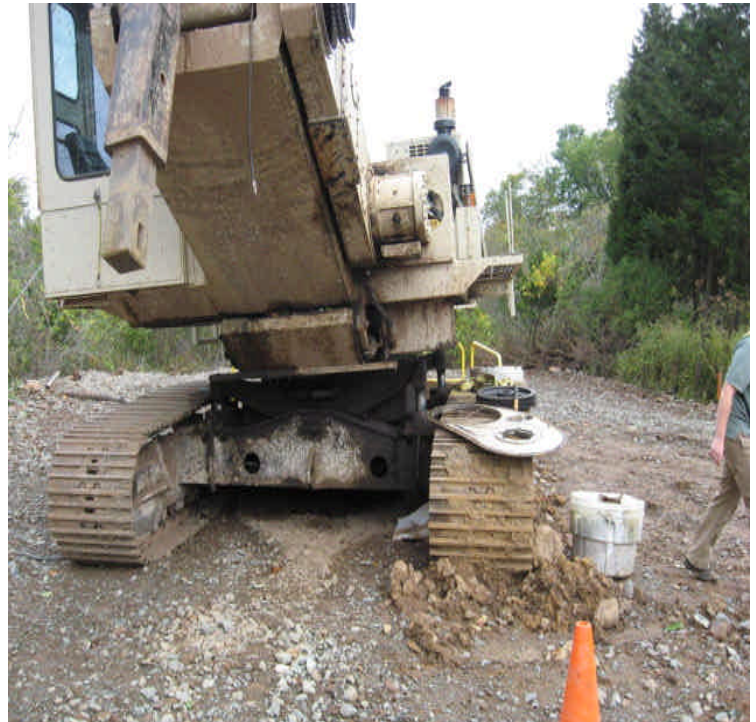
| Areas of Inspection | Observation | Recommended Action | Corrected Action |
|---|---|---|---|
| <b>North of High Hill Rd</b> | <b>A drill rig was broken down at the edge of two wetlands. Spill controls were not replaced and fluid was noted on the ground under the equipment. Contractor installed controls during inspection. 10/15/07</b> | <b>Repair equipment and remove from the edge of wetlands as soon as possible. Keep spill completely contained until it can be repaired and remove any affected soil. 10/9-10/15/07</b> | <b>Needs attention.</b> |

**North of High Hill Rd:** Broken equipment present near the wetland boundary. Repair and remove as soon as possible. Also, remove any affected soil.

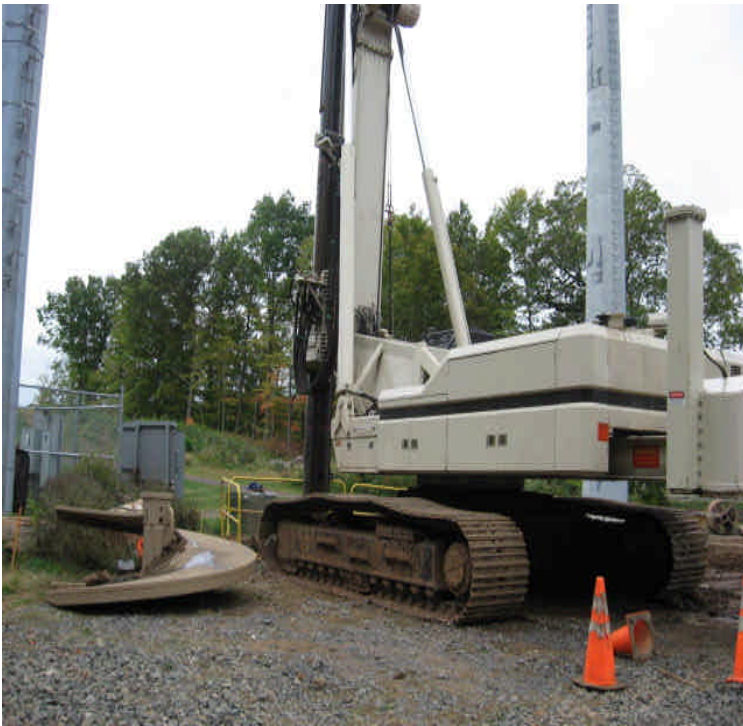
**Behind the PBA: View of foundation drilling. The work area was stable and wetlands are not immediately adjacent.**

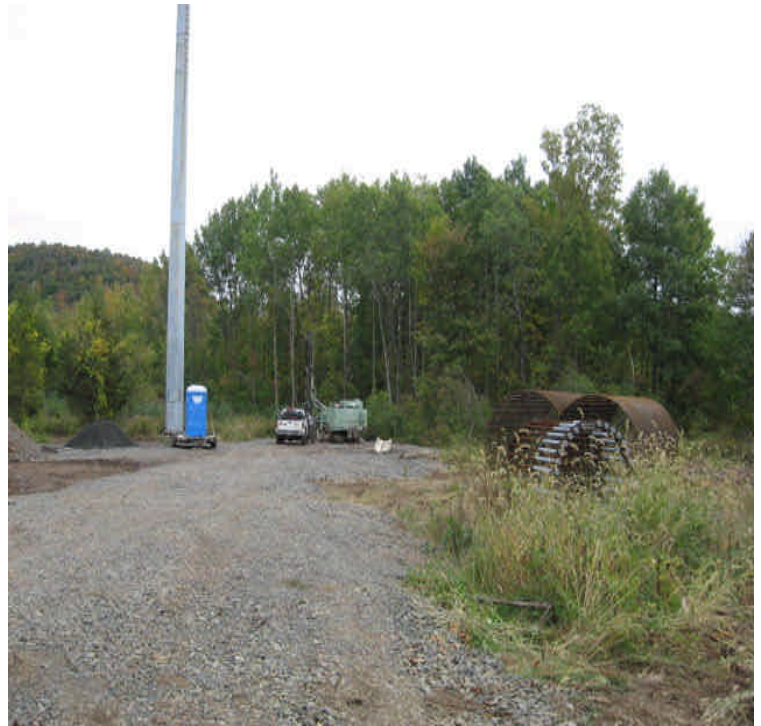
| <b>Areas of Inspection</b> | <b>Observation</b> | <b>Recommended Action</b> | <b>Corrected Action</b> |
|---|---|---|---|
| <b>South of East Main Street</b> | <b>Portable sanitary facility was located adjacent to wetlands behind the condo units. 10/15/07</b> | <b>Avoid storing facilities within 100 feet of wetlands. 10/15/07</b> | <b>Needs attention.</b> |

**South of East Main St: Air drilling for the next foundation. A sanitary facility was located upgradient from a wetland.**

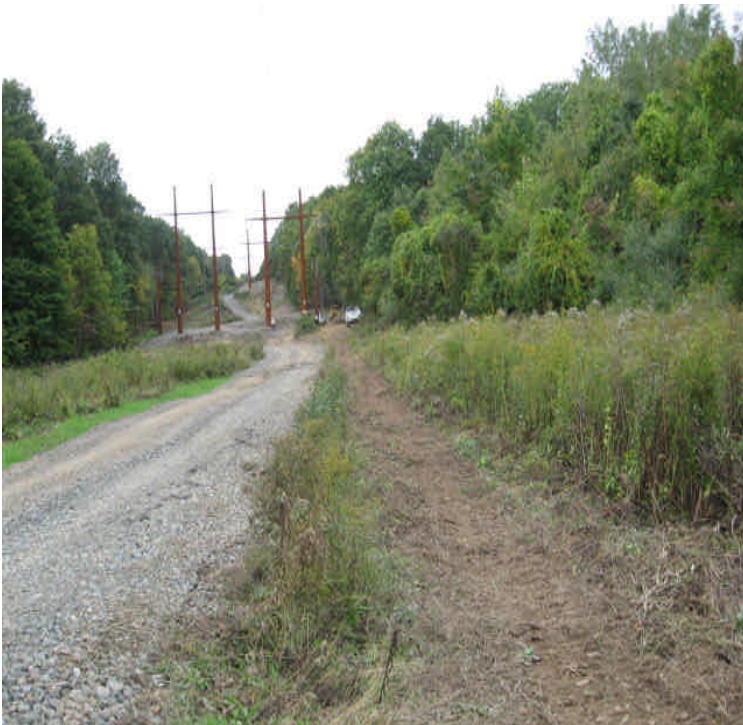
**Black Walnut Dr: Crews were installing grounding wires.**

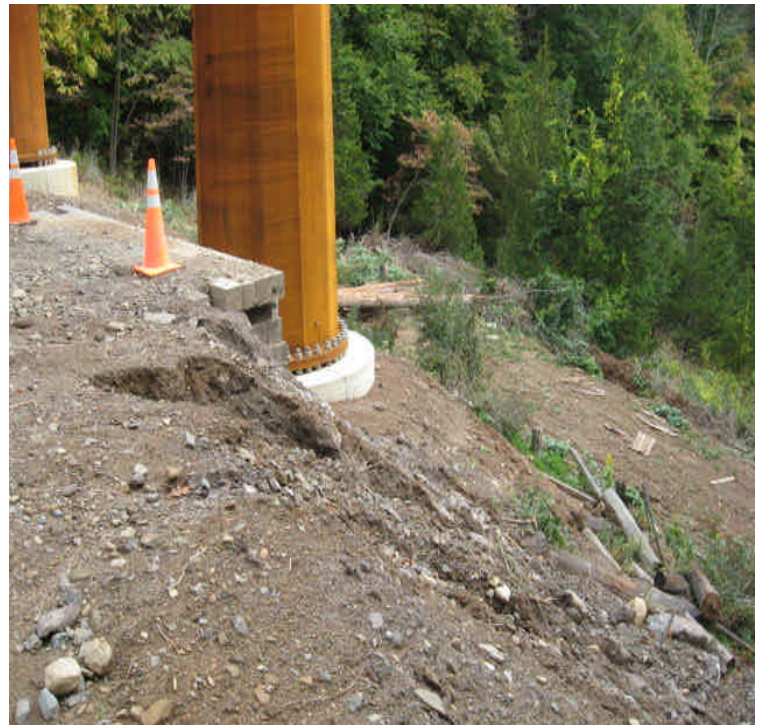
**Black Walnut Drive: An eroded washout was present on the pad slope upgradient from Ball Brook. Repair and stabilize; consider using an erosion control blanket if appropriate.**
