Docket No. 272 – Development and Management Plan Inspection

Segment 1b (Royal Oaks Bypass) Inspection

Date: October 9, 2007

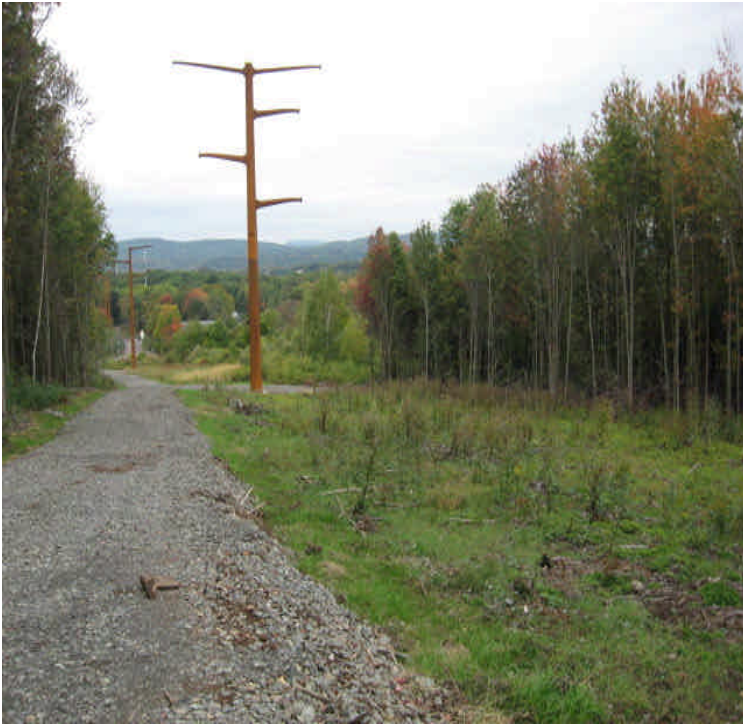
Vegetative cover has established on the seeded portion of the ROW and the area is stable.

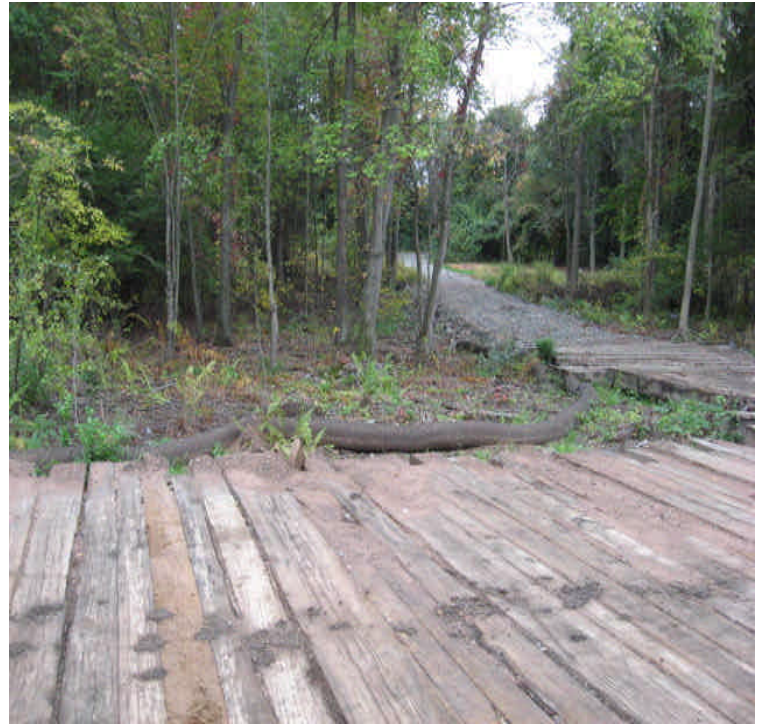
Sediment was removed from mats and wetlands. Controls are in place

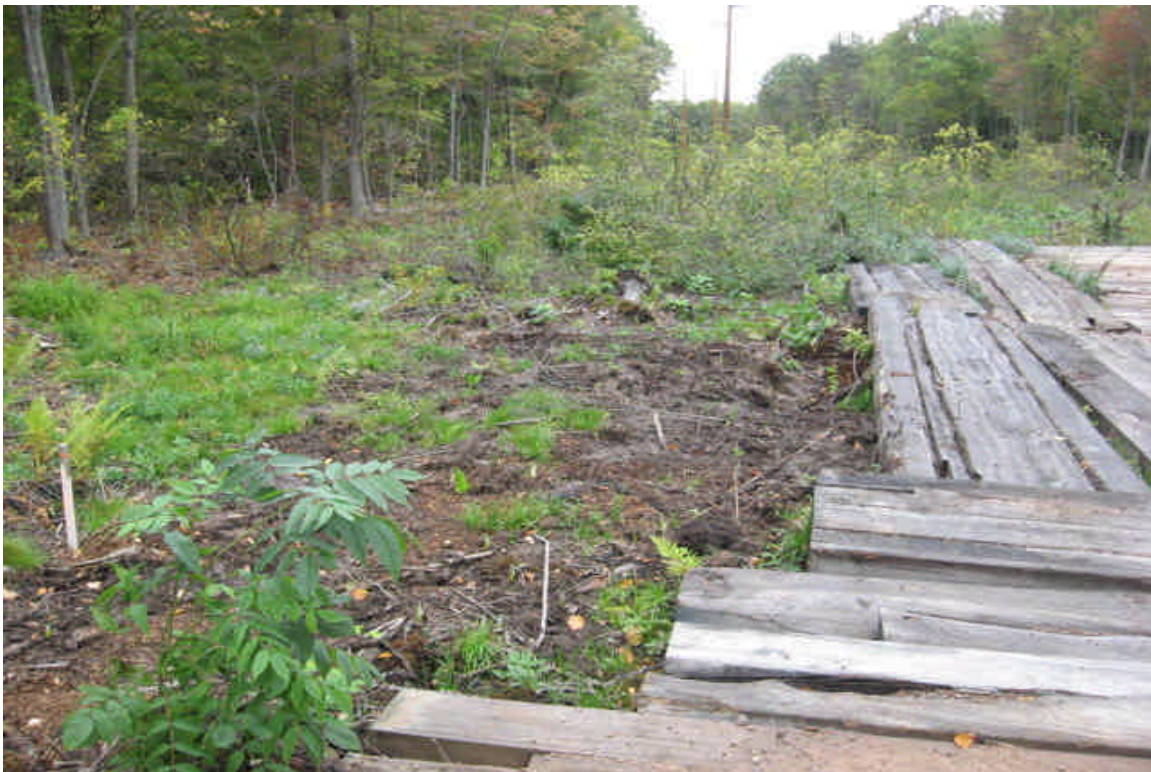
Equipment ruts have been filled in and soils have been regraded. Monitor for stabilization.
