Docket No. 272 – Development and Management Plan Inspection

Segment 1b (Royal Oaks Bypass) Inspection

Date: October 22, 2007

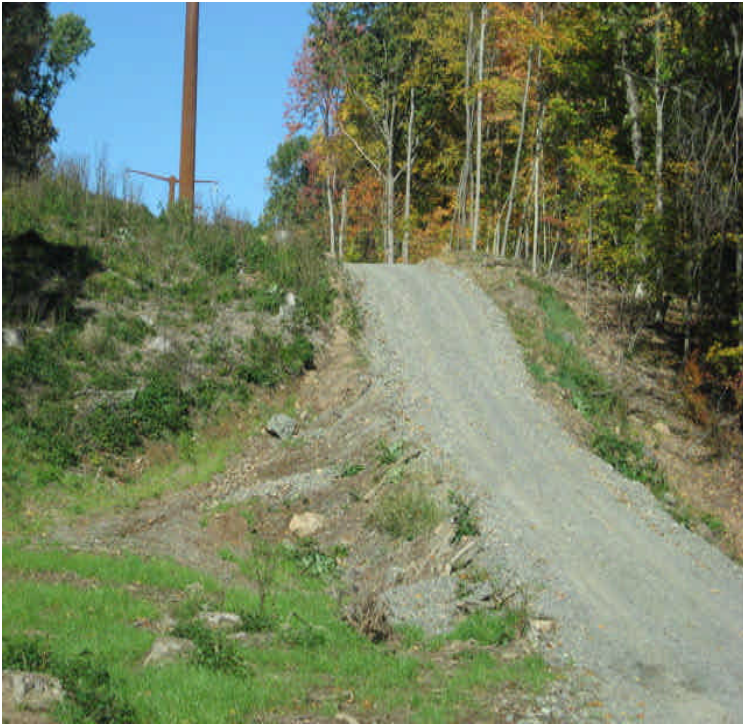
Minor erosion noted along the access road at the steep slope off Black Walnut Drive.

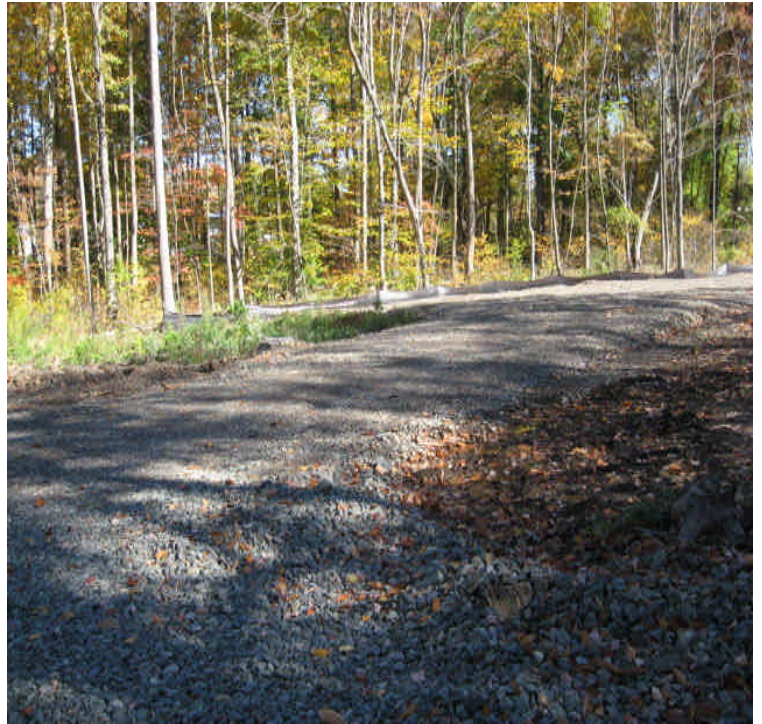
View of a pull site installed upgradient from wetlands near the contractor receiving yard. Controls were installed.

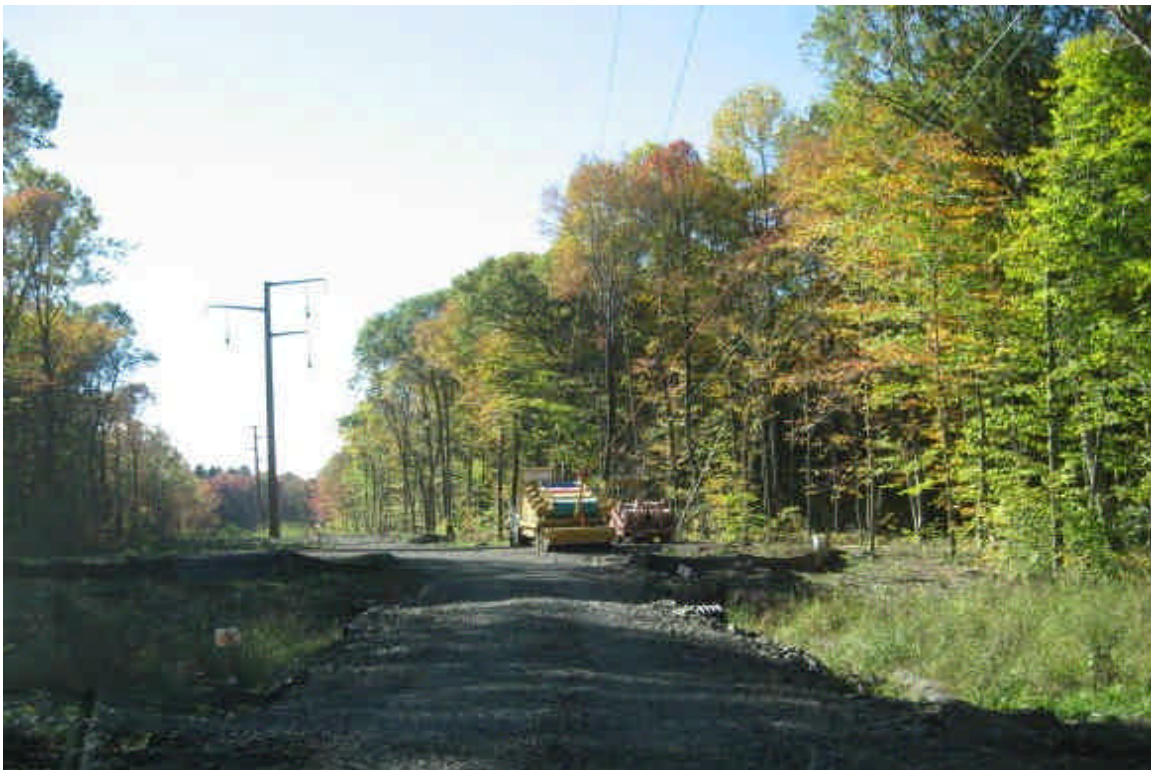
A view of the line pulling equipment and new pull sites installed upgradient from wetlands near the contractor receiving yard.
