Docket No. 272 – Development and Management Plan Inspection

Segment 2a Inspection

Date: October 2, 2007

Location: Segment 2a – Beseck Switching Station to Cheshire/Hamden Town Line

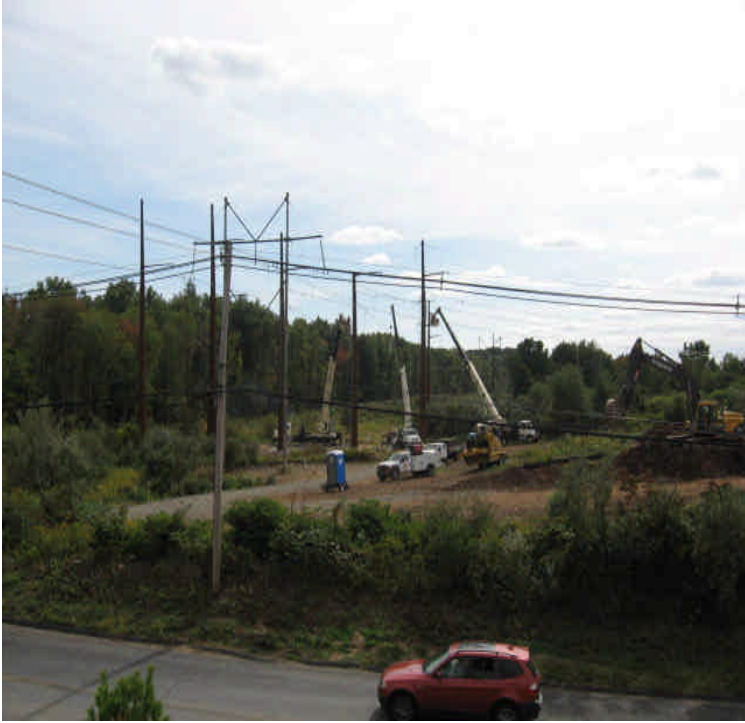
Carpenter Ln: Line work is underway.

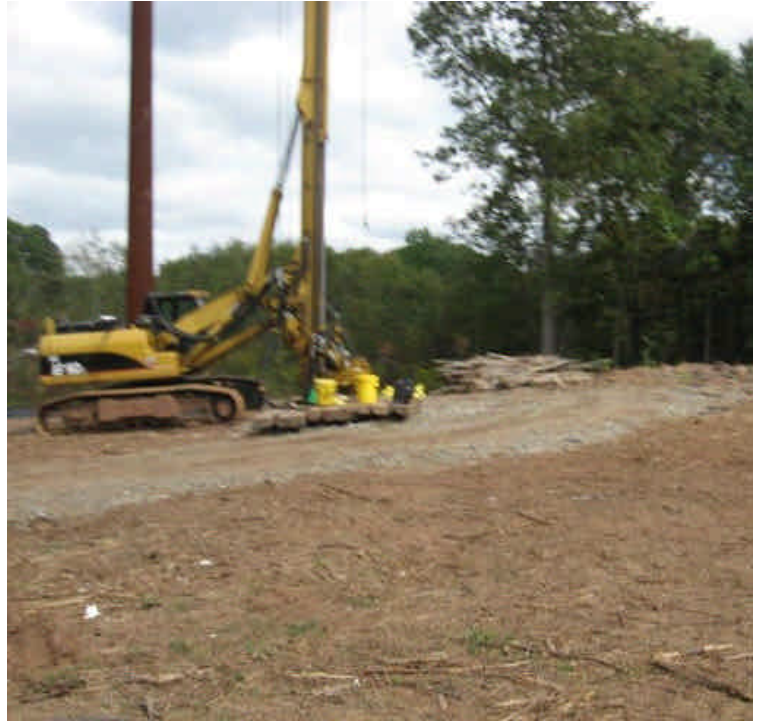
Durham Rd.	Leaking equipment was parked with appropriate spill containment controls in place. 9/25-10/2/07	Spill controls should be maintained and refreshed as needed until equipment is repaired. Avoid using equipment in wetlands/sensitive areas and remove any affected soils as soon as possible. 9/25-10/2/07	Leaking equipment needs maintenance. Controls are in place.
Additional Observations	None 10/2/07	None

Durham Rd: View of leaking equipment with controls in place. Repair the equipment as soon as feasible.

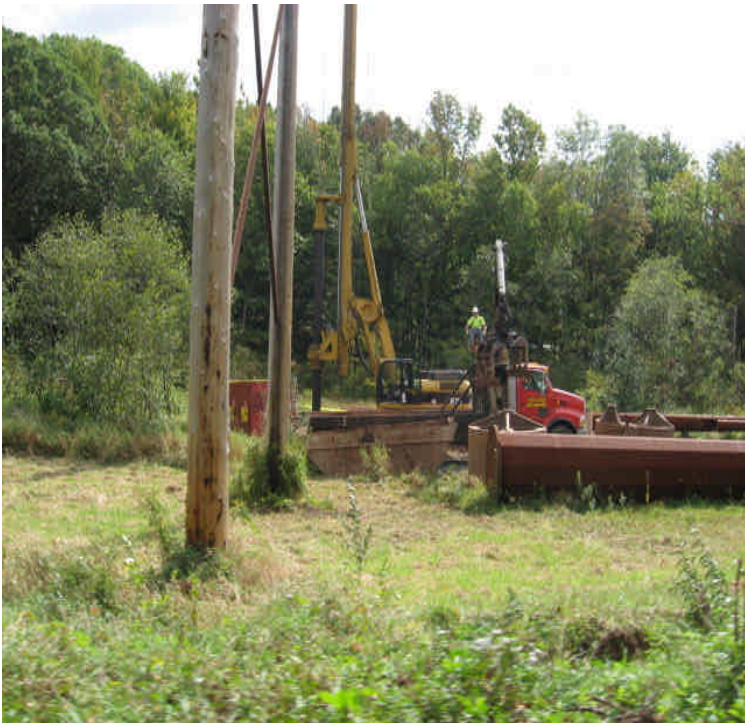
Liney Hall Ln: Crews were working within a wetland, drilling a foundation.

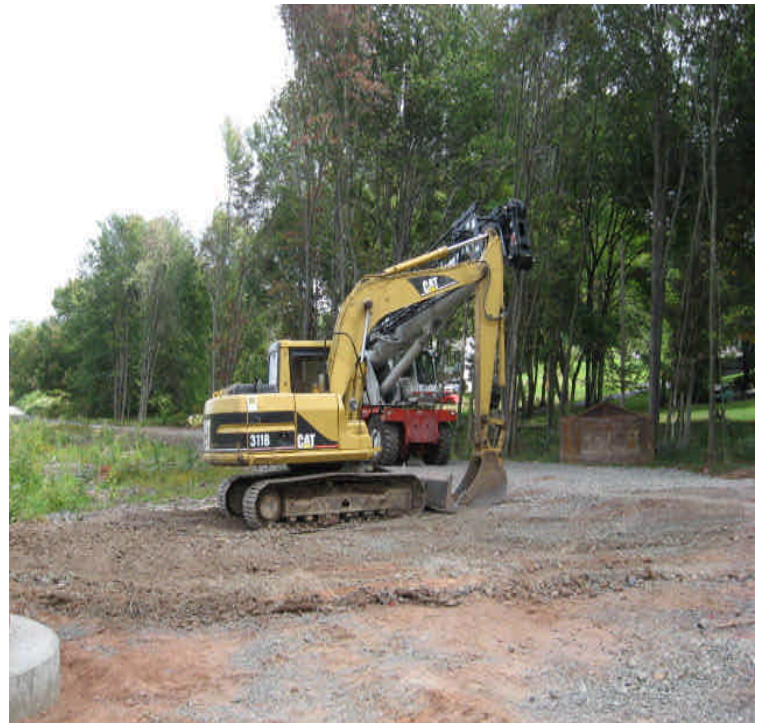
Powers Rd: Restoration efforts adjacent to wetlands are complete for now.

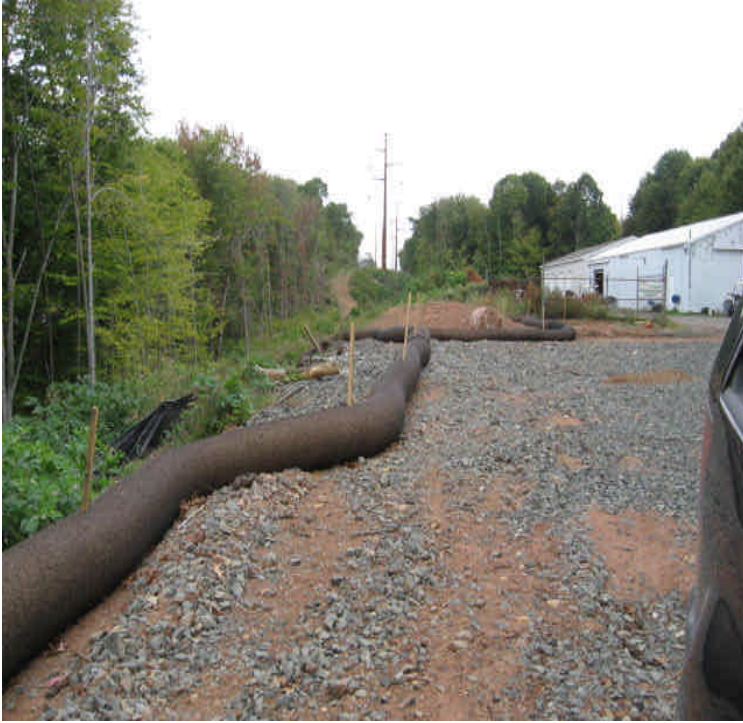
Harrison Rd: Fiber sock installed along the pad site and stockpile.

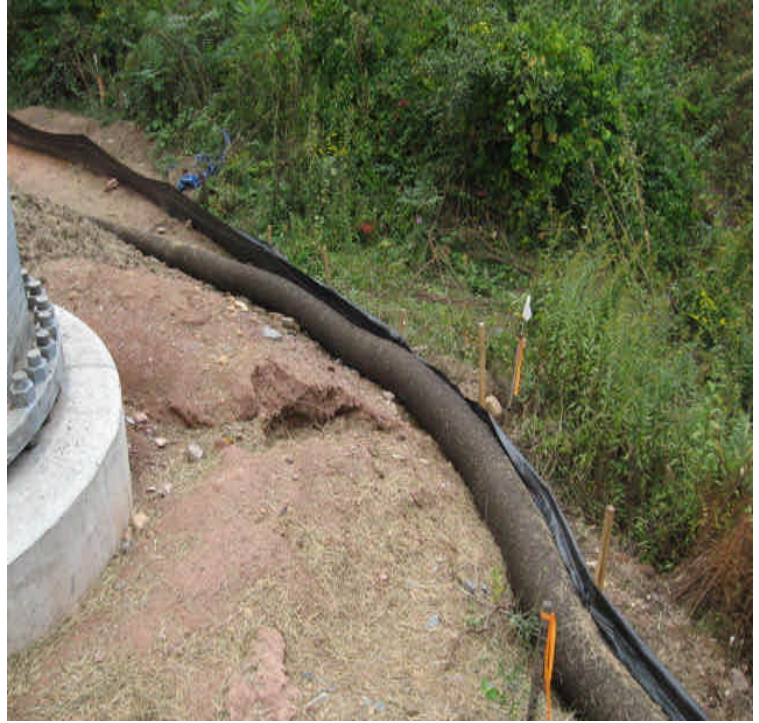
Docker Dr: A silt sock was installed upgradient from the wetlands at the new foundation where controls were overwhelmed last week. The disturbed area was mulched. Regrade and stabilize the small, eroded channel as needed.

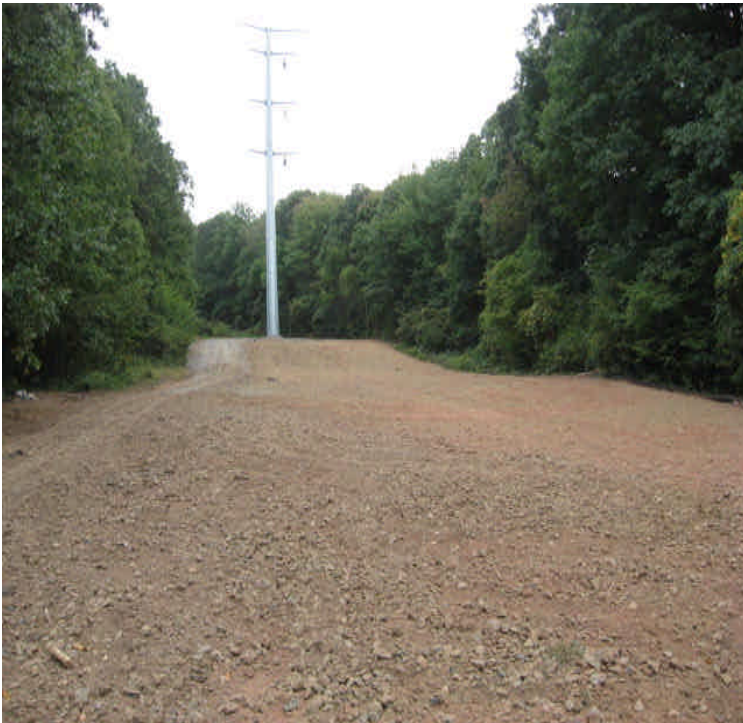
Docker Dr: Exposed soils have been graded, mulched, and seeded.

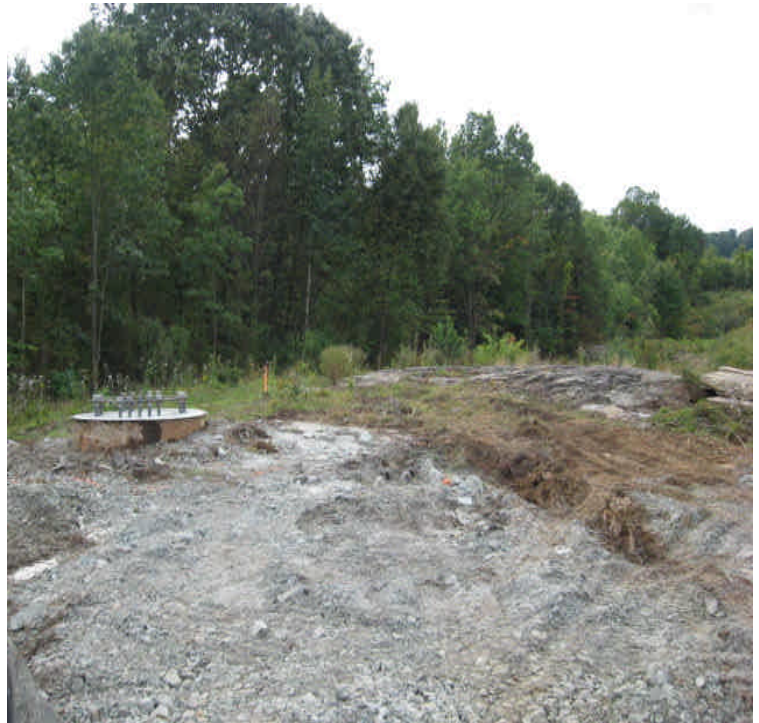
S. Turnpike + Merritt Parkway Area	A foundation was installed leaving a disturbed area at the top of slope off S. Turnpike. Additional controls may be needed especially due to the steep slope. 10/2/07	Add controls as a precaution and monitor the area closely for erosion. 10/2/07	Needs evaluation
Mansion Rd. Apple Orchard	A small channel was installed to divert a spring but is causing turbid water to pool at the edge of the access road at two locations. 6/19-10/2/07	A culvert appears to be necessary to prevent turbid water from ponding and reaching wetlands. 6/19-10/2/07	Needs evaluation
Mansion Rd. to Tuttle Ave.	Drilling was occurring upgradient from wetlands. Ensure the area is contained with controls. 10/2/07	Add controls as necessary. 10/2/07	Needs confirmation that the area is contained.
	Significant erosion/ sedimentation was observed during a heavy rainstorm (9/11). Turbid water was flowing into wetlands from the culvert and off site. Washouts along the access road and slopes were noted. 10/2/07	Add controls as soon as possible to prevent erosion along the slopes and access road. Controls need to be reinforced at the culvert and exposed areas contributing to the run-off need stabilization to the extent feasible. 9/11-10/2/07	Needs attention

South Turnpike: Disturbed area remains at the top of slope. The foundation was installed.

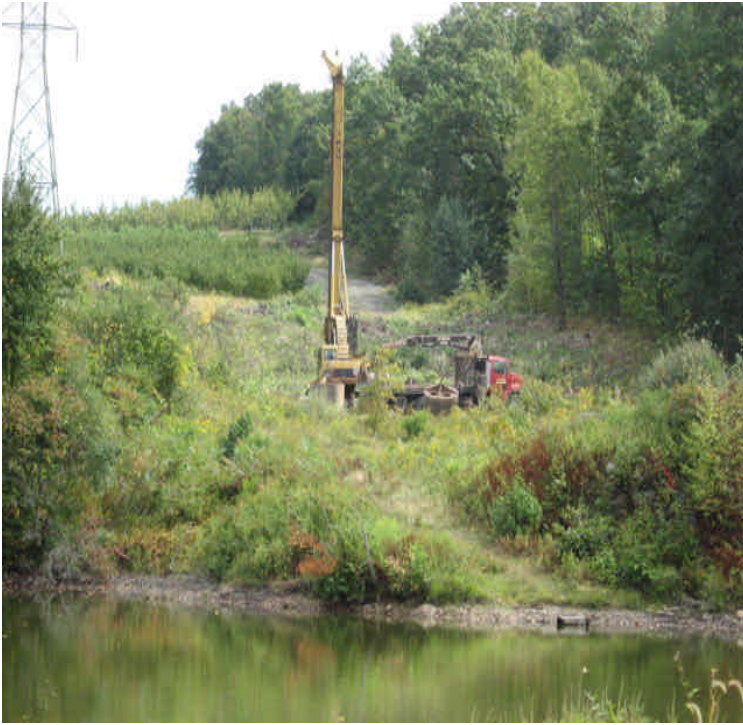
Orchard: Foundation drilling was occurring within the apple orchard, upgradient from the wetlands.

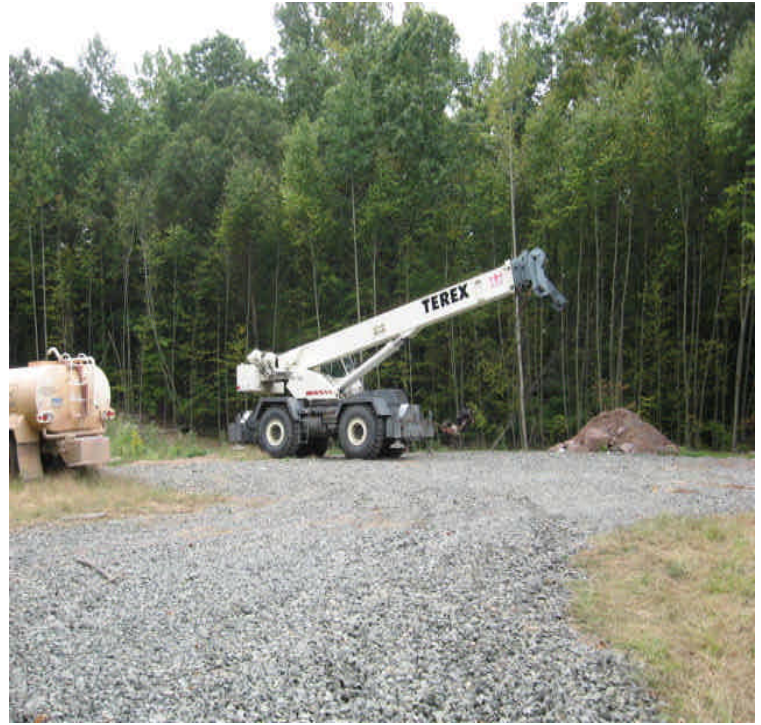
Tuttle Ave: Pole installation equipment was being stored here.

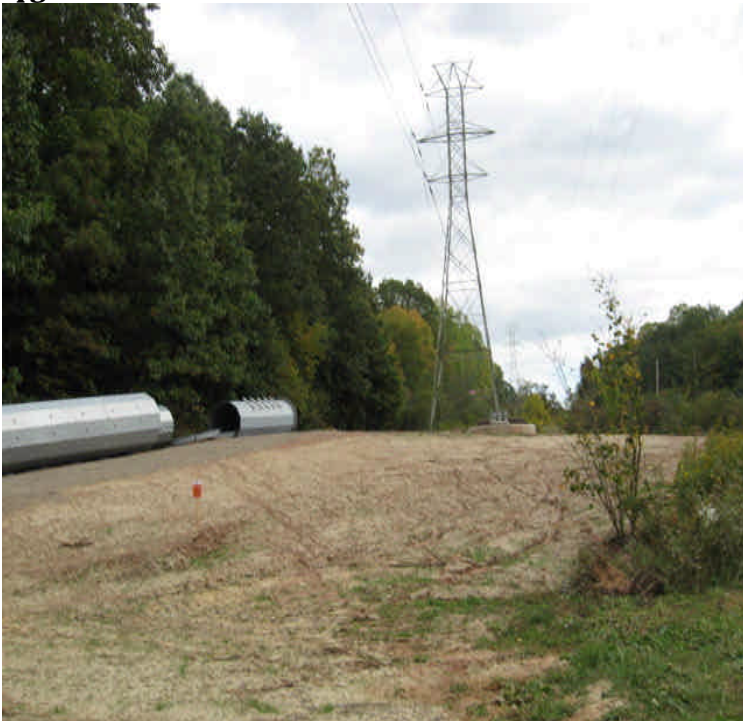
Areas of Inspection	Observation	Recommended Action	Corrected Action
<p>Old Farms Rd. (115kV Underground work)</p>	<p>Soil in the adjacent shoulder has been graded and hydroseeded. Some ruts were noted. 10/2/07</p>	<p>Continue to monitor for stabilization. Repair ruts if necessary. 10/2/07</p>	<p>Soil has been hydroseeded.</p>
<p>Inland Wetland and Watercourse encroachment and mitigation</p> <p>Carpenter Ln. to Rte 68</p> <p>Durham Rd. Liney Hall Ln.</p> <p>Williams Rd to East Center St.</p> <p>Powers Rd. & Woodhouse Ave.</p>	<p>Jurisdictional wetlands can be accessed now that ACOE permit is in hand. 10/2/07</p> <p>Sections of ROW are located within the McKenzie Watershed Protection District of the Town of Wallingford from existing pole #8798 to Beseck SS. 10/2/07</p> <p>Timber mat staging areas and several foundations are in place within wetlands off Carpenter Ln. Sediment was noted within controls, accumulating at the wetland edge. 5/8-10/2/07</p> <p>Timber mats are in place at the wetland crossings in these sections and well installed bridges are in place for two larger stream channels. Controls were installed. Drilling underway within wetlands. 10/2/07</p> <p>The continued disturbance/fill of the exposed soil adjacent to wetlands in this section was determined to be related to the landowner activities. 10/2/07</p> <p>Some sedimentation was noted in the wetlands, pushed over the degraded controls where timber mats were removed. Exposed soils were seeded but stone was not removed from the</p>	<p>Approved work in wetlands will follow the permit guidelines. 10/2/07</p> <p>This area should be closely monitored. Monitor equipment for leaks whenever working in these sensitive areas. Refuel and store equipment outside of the district. 10/2/07</p> <p>Add controls as needed in this area. Remove sediment from wetlands before removing controls. Monitor for run-off 5/8-10/2/07</p> <p>Continue to monitor and add controls at needed. Monitor the bridge surface for sediment tracking. Continue to keep up with spoil as it is generate. 10/2/07</p> <p>See erosion control section for more details. 10/2/07</p> <p>Remove the remaining sediment/stone from the wetlands to the extent feasible. 10/2/07</p>	<p>NA</p> <p>Needs to be monitored</p> <p>Needs evaluation</p> <p>NA at this time</p> <p>Most issues are related to the landowner but attempt to improve if feasible</p> <p>Exposed soils were seeded but additional attention is needed</p>

Old Farms Rd: View of the hydroseeded area with some equipment ruts.

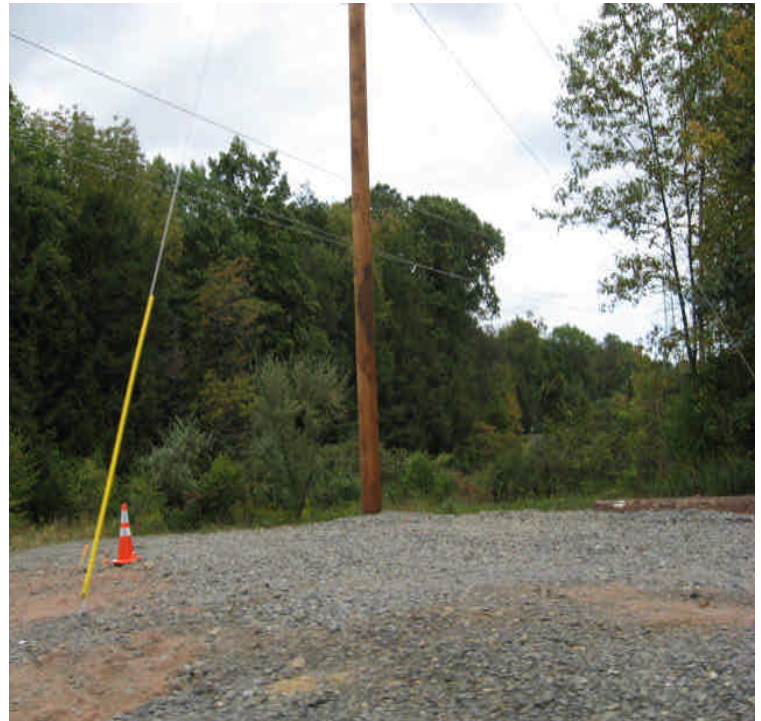
Old Farms Rd: New poles were installed along the ROW.
