**Docket No. 272 – Development and Management Plan Inspection**

**Segment 2a Inspection**

**Date:** October 10, 2007

**Location:** Segment 2a – Beseck Switching Station to Cheshire/Hamden Town Line

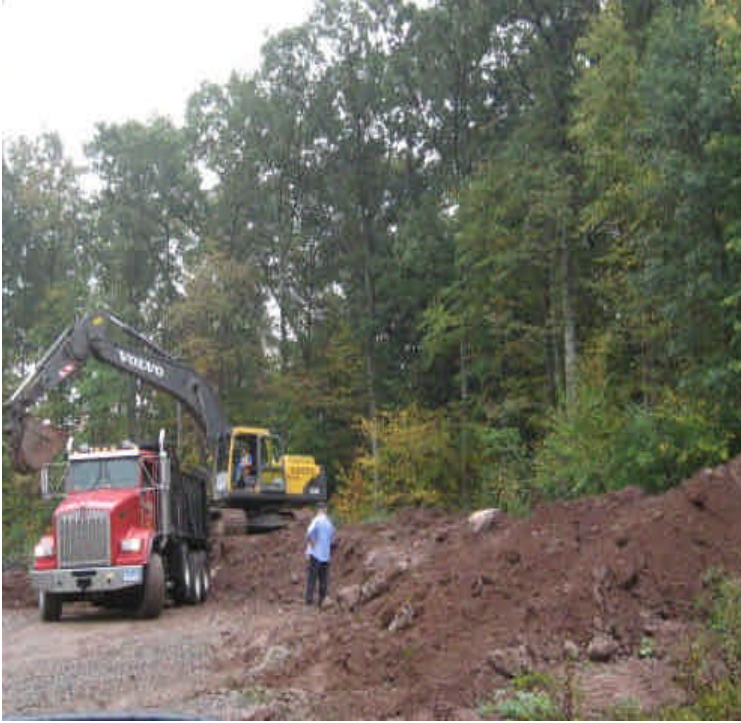
**High Hill Rd: Foundation drilling and removal of resulting spoils is underway.**

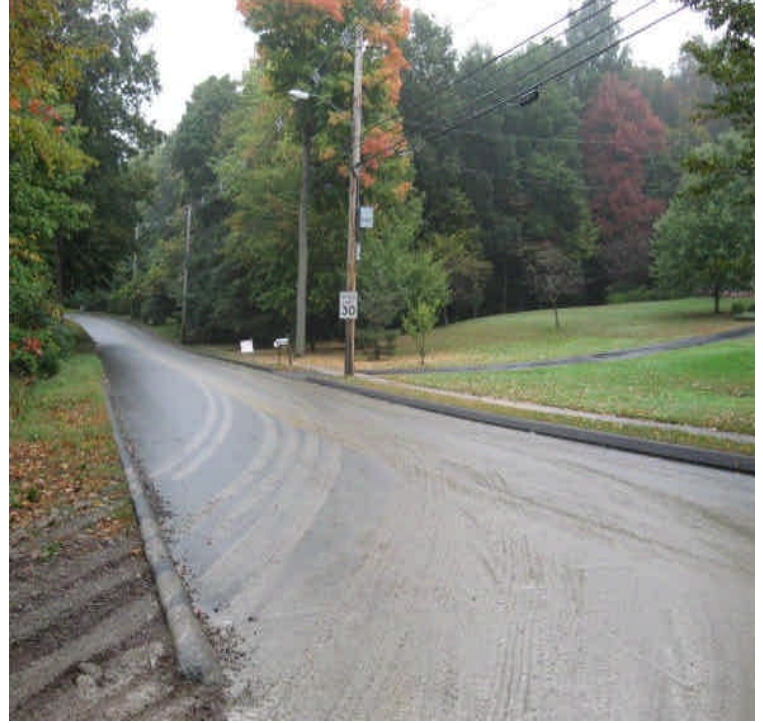
<b>Sediment tracking was noted along High Hill Rd. 10/10/07</b>	<b>Sweep roadway and add CB controls as needed. 10/10/07</b>	<b>Needs attention.</b>
<b>Durham Rd. Liney Hall Ln.</b>	<b>Access road construction is complete south off Durham Rd. An equipment bridge crossing is in place over the Muddy River tributary and a second bridge is in place off</b>	<b>Continue to monitor and add controls as needed. 10/10/07</b>	<b>NA</b>

**High Hill Rd: Some sediment tracking was noted on the roadway.**

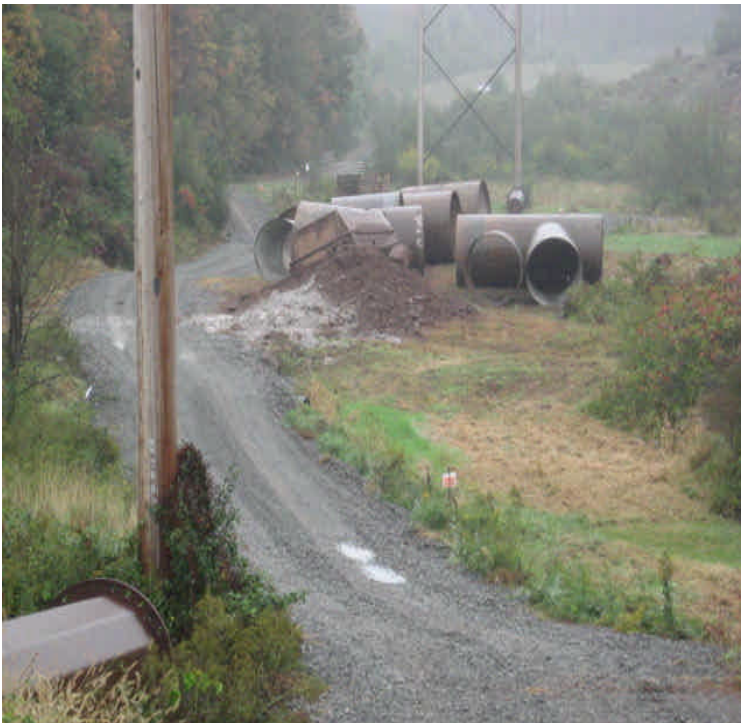
Liney Hall Ln. A soil stockpile and partially concrete washout were located upgradient from a small wetland with no controls in place. 10/10/07	Add controls and remove the material as soon as possible. Provide adequate capacity and designated areas for concrete washouts. 10/10/07	Needs attention.
Additional Observations	None 10/10/07	None

**Liney Hall Ln: Soil stockpile and an uncontained concrete washout were noted upgradient from wetlands. It appears that there was an attempt to designate a washout area but it did not have adequate capacity.**

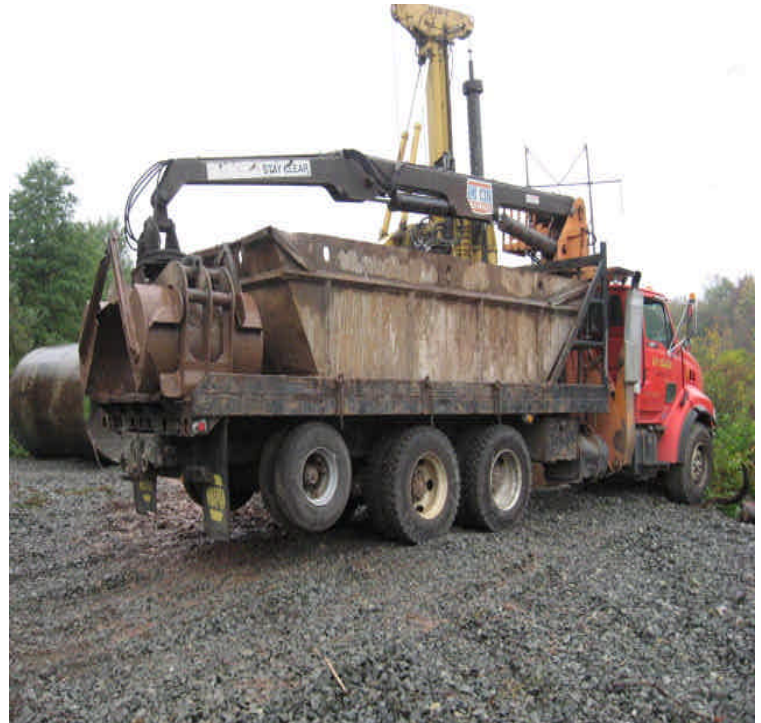
**Tamarack Swamp Rd.: Foundation drilling and removal of the resulting spoil/sediment was underway.**

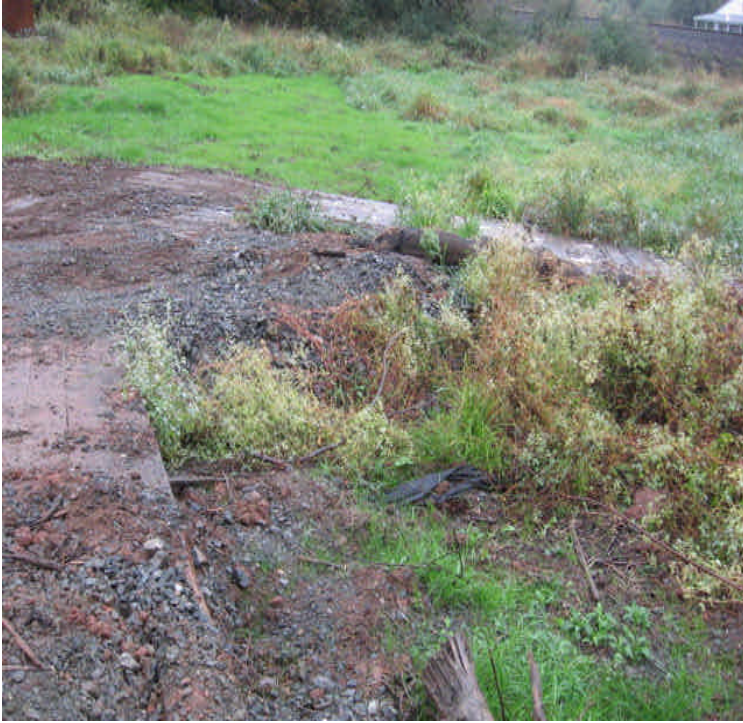
<p>Powers Rd. &amp; Woodhouse Ave.</p>	<p>In the process of removing timber mats, sediment was pushed over some controls (8/28). Soils exposed by timber mat removal were seeded, but not all stone was removed prior to seeding. 9/25-10/10/07</p>	<p>Remove the stone from the wetlands to the extent feasible and stabilize the exposed soil with a wetland seed mix. Continue to monitor for stabilization. 9/25-10/10/07</p>	<p>Soils were seeded but further attention is needed here</p>
	<p>A large stockpile/exposed soil area remains off Woodhouse Ave. Large fiber rolls remain down-gradient to contain it. 10/10/07</p>	<p>Remove/stabilize stockpile when feasible and monitor controls. 10/10/07</p>	<p>NA at this time</p>
<p>Woodhouse Ave. Harrison Rd.</p>	<p>Controls, including several large fiber rolls remain along the slope and at the sediment trap. The large gully on the slope should be addressed. 9/25-10/10/07</p>	<p>Continue to monitor and adjust controls as needed. Attempt to repair/stabilize the gully. 9/25-10/10/07</p>	<p>Gully needs evaluation/attention.</p>

**Powers Rd: Timber mats and stone/sediment were present within the wetland. Carefully remove sediment and add controls.**

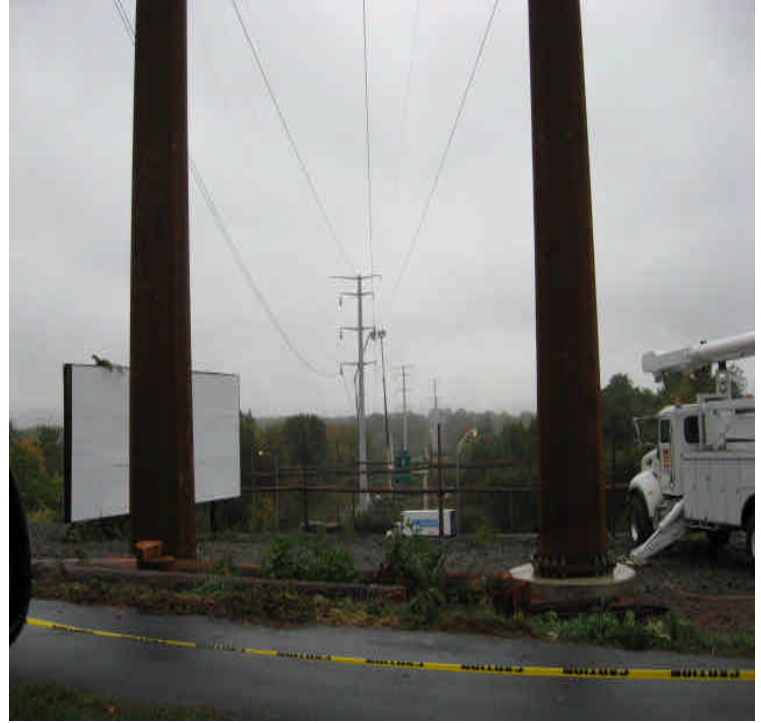
**I- 91: Crews were pulling lines across Route 91 to Docker Dr.**

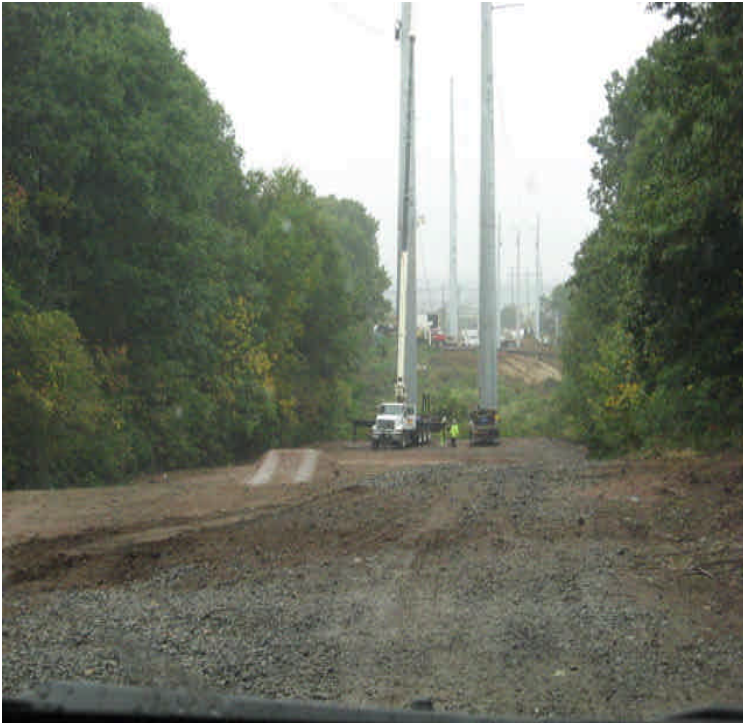
**Docker Dr: Exposed soils remain graded, mulched, and seeded. Crews were performing line work.**

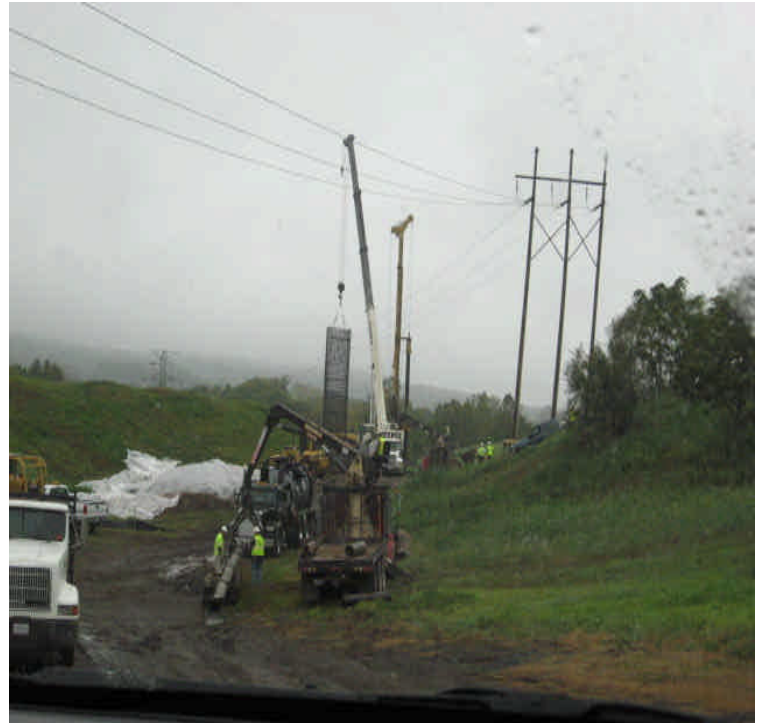
**Pent Rd: Foundation installation was underway.**
