Docket No. 272 – Development and Management Plan Inspection

Segment 2a Inspection

Date: October 15, 2007

Location: Segment 2a – Beseck Switching Station to Cheshire/Hamden Town Line

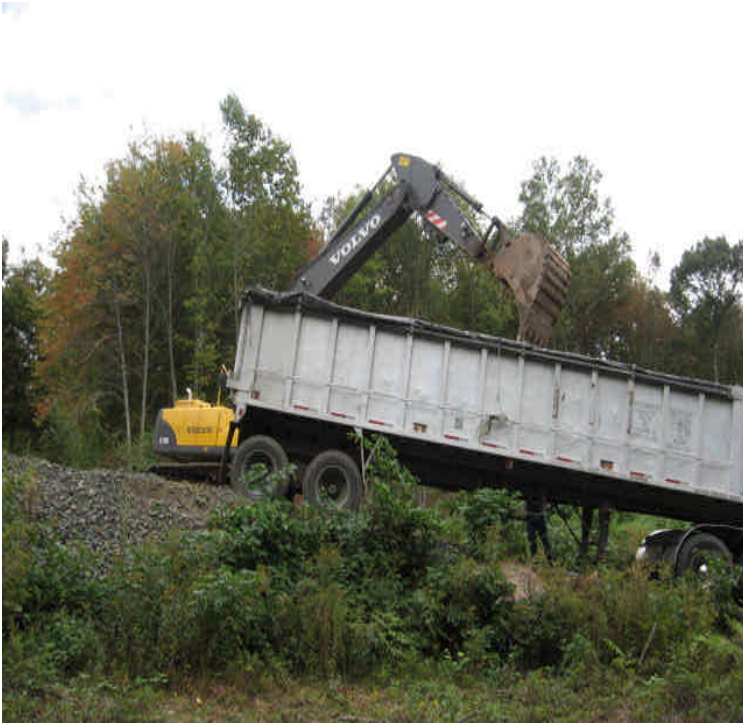
High Hill Rd: Crews were removing soil stockpiles.

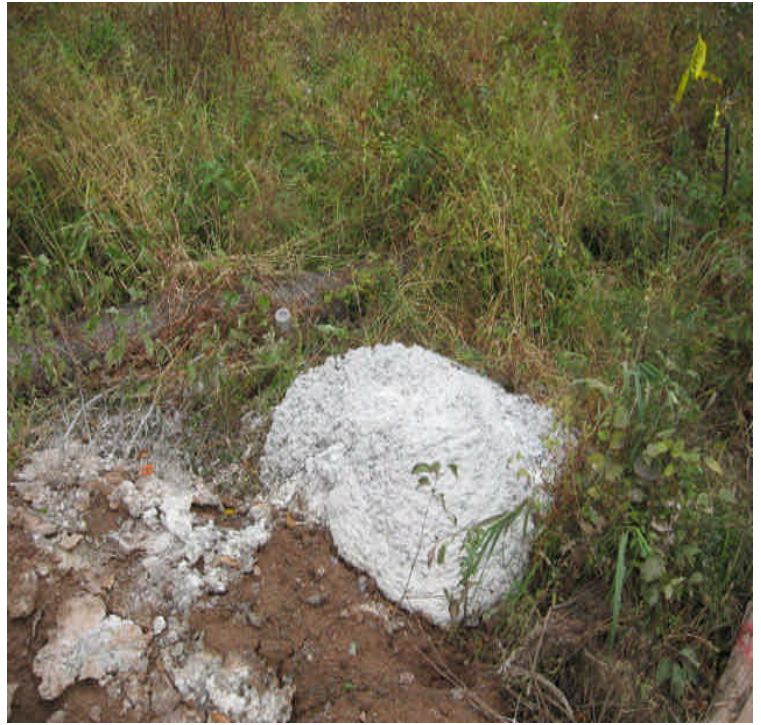
Liney Hall Ln: An excess concrete washout was noted within at the Wetland boundary.

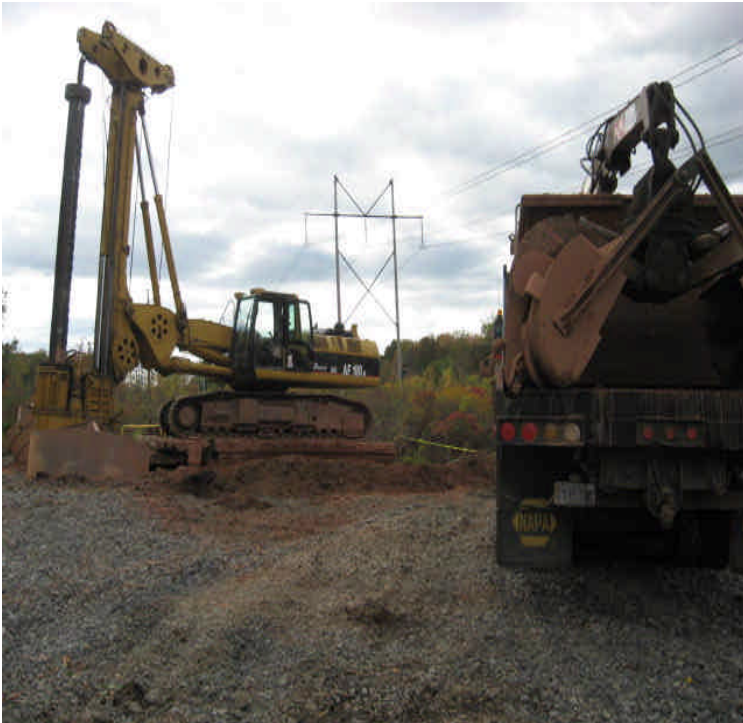
Tamarack Swamp Rd: Foundation drilling in the wetlands continues.

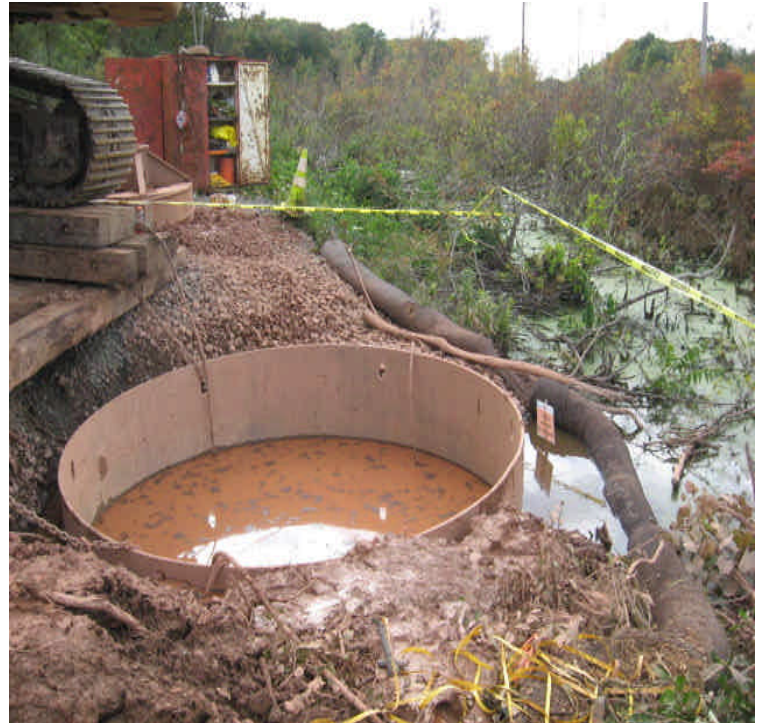
Tamarack Swamp Rd.: Foundation drilling and stockpiling the resulting sediment/spoil continues. Continue to monitor very closely and carefully contain the work due to the adjacent area of standing water.

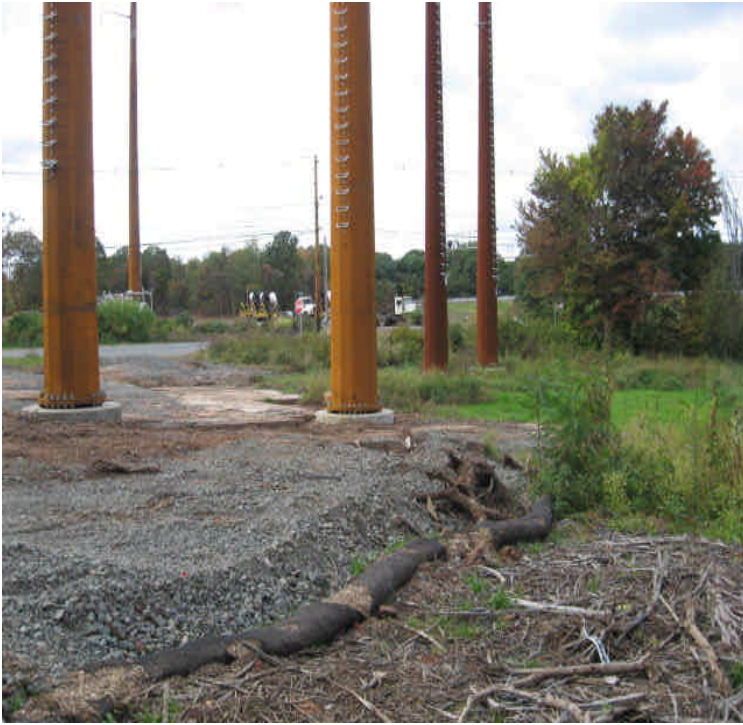
Powers Rd. & Woodhouse Ave.	In the process of removing timber mats, sediment was pushed over some controls (8/28). Soils exposed by timber mat removal were seeded, but not all stone was removed prior to seeding. 9/25-10/15/07	Remove the stone from the wetlands to the extent feasible and stabilize the exposed soil with a wetland seed mix. 9/25-10/15/07 Crews will be returning here for line work, potentially disturbing the area again before final stabilization but temporary restoration to the extent feasible is recommended for the time being 10/15/07	Further attention is needed here
	A large stockpile/exposed soil area remains off Woodhouse Ave. Large fiber rolls remain down-gradient to contain it. 10/15/07	Remove/stabilize stockpile when feasible and monitor controls. 10/15/07	NA at this time
	Controls, including several large fiber rolls remain along the slope and at the sediment trap. The large gully on the slope should be addressed. 9/25-10/15/07	Continue to monitor and adjust controls as needed. Attempt to repair/stabilize the gully. 9/25-10/15/07	Gully needs evaluation/attention.

Powers Rd: Timber mats and stone/sediment were present within the wetland. Carefully remove sediment and reinforce controls.

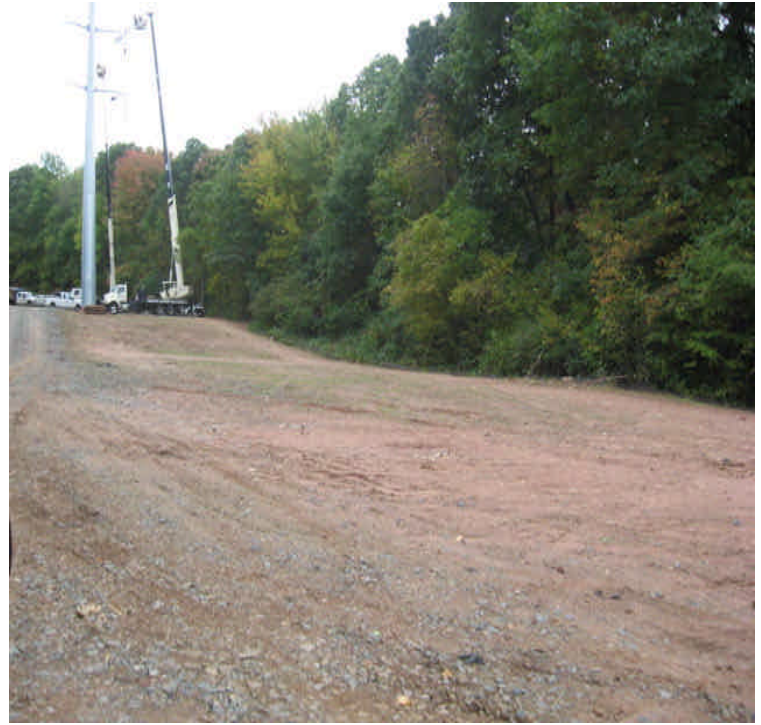
Docker Dr: Exposed soils remain graded, mulched, and seeded. Crews were performing line work.

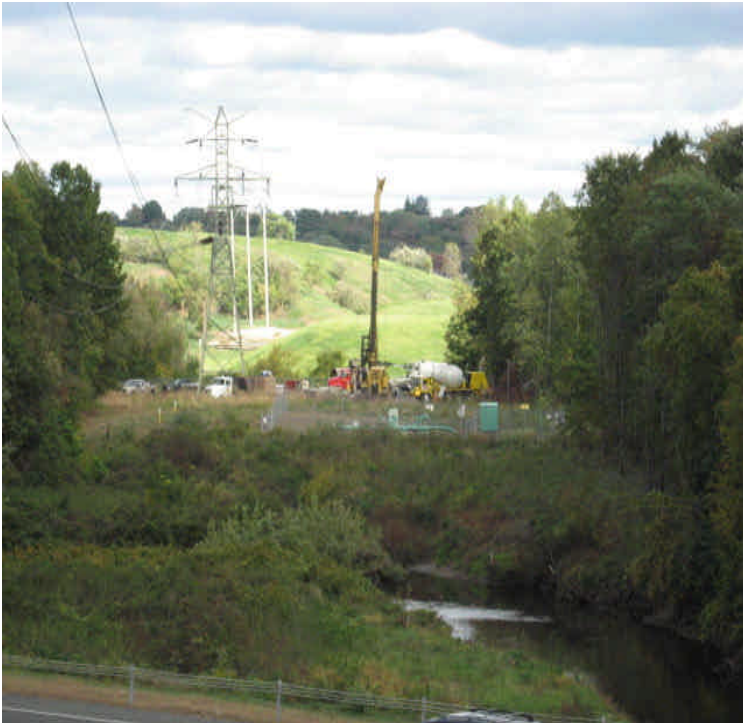
Pent Rd: View of foundation drilling underway at structure #24225, located between Wallingford landfill and the Quinnipiac River. This view also shows the extent of re-vegetation following the necessary clearing at the river.

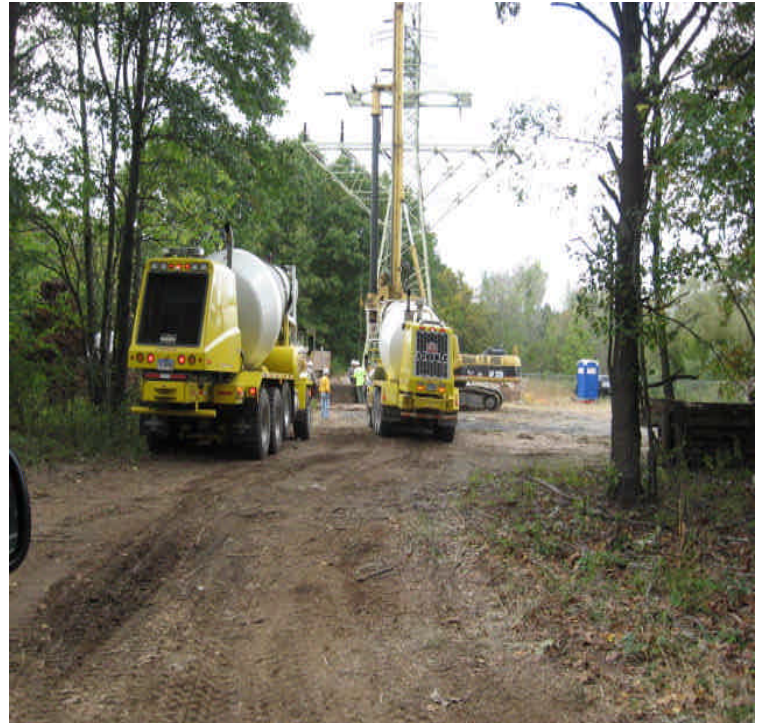
Pent Rd: Foundation drilling continues.
