**Docket No. 272 – Development and Management Plan Inspection**

**Segment 2a Inspection**

**Date:** October 23, 2007

**Location:** Segment 2a – Beseck Switching Station to Cheshire/Hamden Town Line

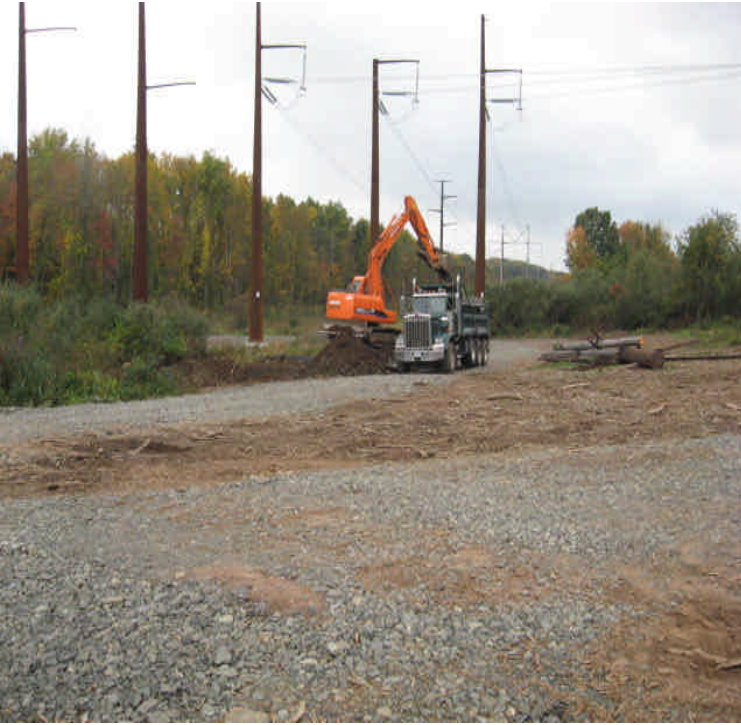
**Carpenter Ln:** Crews were removing soil stockpiles.

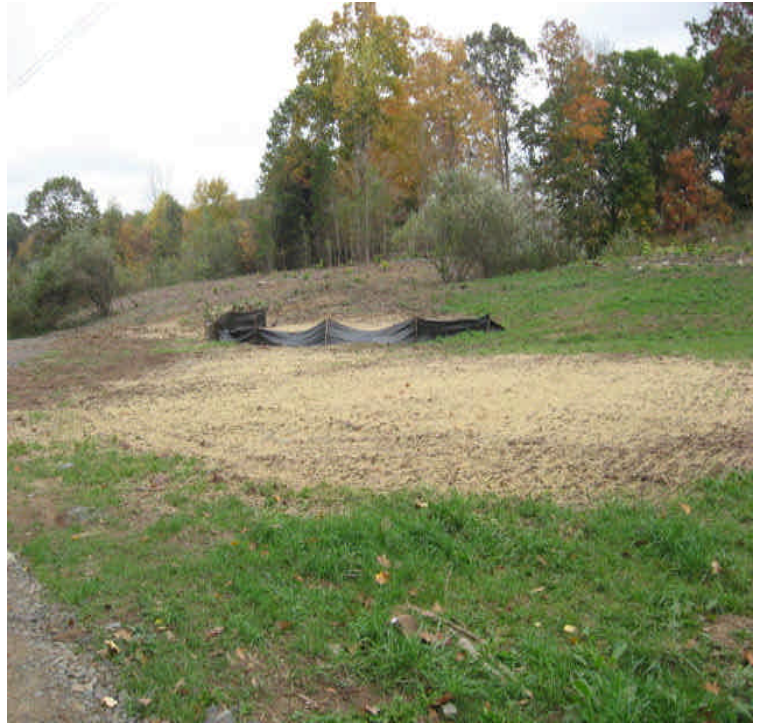
**Durham Rd:** Exposed soils were graded and seeded.

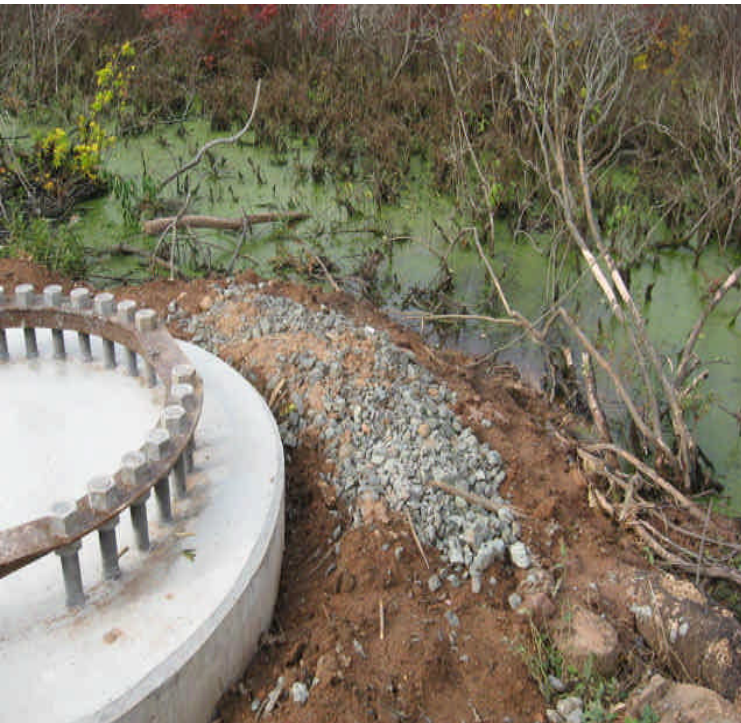
**Tamarack Swamp Rd:** Foundation was installed, but sediment was piled/pushed beyond the controls. Carefully pull sediment back and then reinforce controls. Avoid adding another layer of controls prior to removing the sediment.

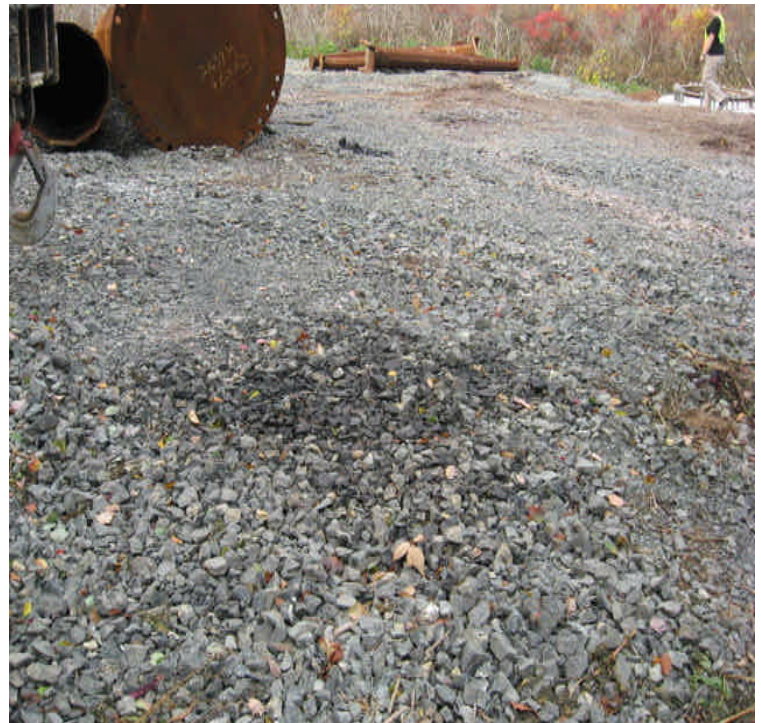
**Tamarack Swamp Rd.:** One of three stains/drip spots associated with leaking equipment and noted adjacent to the wetlands.

Areas of Inspection	Observation	Recommended Action	Corrected Action
	<p><b>drilling and stored equipment during the construction process. 10/23/07</b></p>	<p><b>prevent repeated problems. Always contain and control stockpiles as soon as possible. 10/23/07</b></p>	
<p><b>Durham Rd.</b></p>	<p><b>Leaking equipment was removed from the site. 10/23/07</b></p>	<p><b>None. 10/23/07</b></p>	<p><b>Equipment was removed.</b></p>
<p><b>Liney Hall Ln.</b></p>	<p><b>Two excess concrete piles/ washouts were located within the wetlands. One was present on the timber mats and the 2<sup>nd</sup> was adjacent to the new foundation. 10/15-10/23/07</b></p>	<p><b>Remove concrete from the wetlands. Concrete should never be washed out in or within 100 feet of wetlands. This includes concrete testing. 10/15-10/23/07</b></p>	<p><b>Needs attention.</b></p>
<p><b>Tamarack Swamp Rd.</b></p>	<p><b>Three small hydraulic fluid/oil stains associated with two pieces of equipment were noted on the stone pad adjacent to wetlands. 10/23/07</b></p>	<p><b>Remove affected stone/soils and add spill controls under the equipment. Repair equipment as soon as possible and keep equipment out of wetlands until repairs are made. 10/23/07</b></p>	<p><b>Needs attention.</b></p>

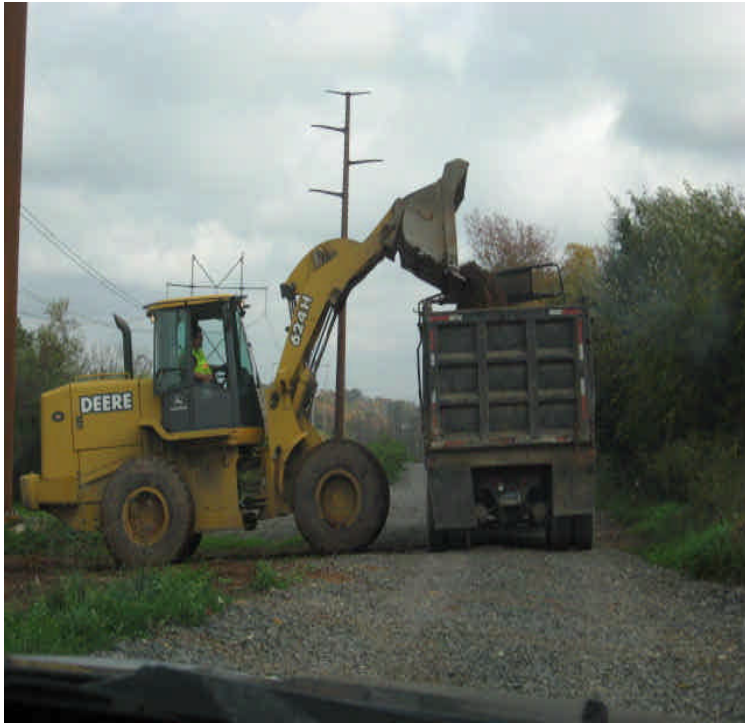
**Powers Rd:** Crews were reclaiming a pad site in the uplands.

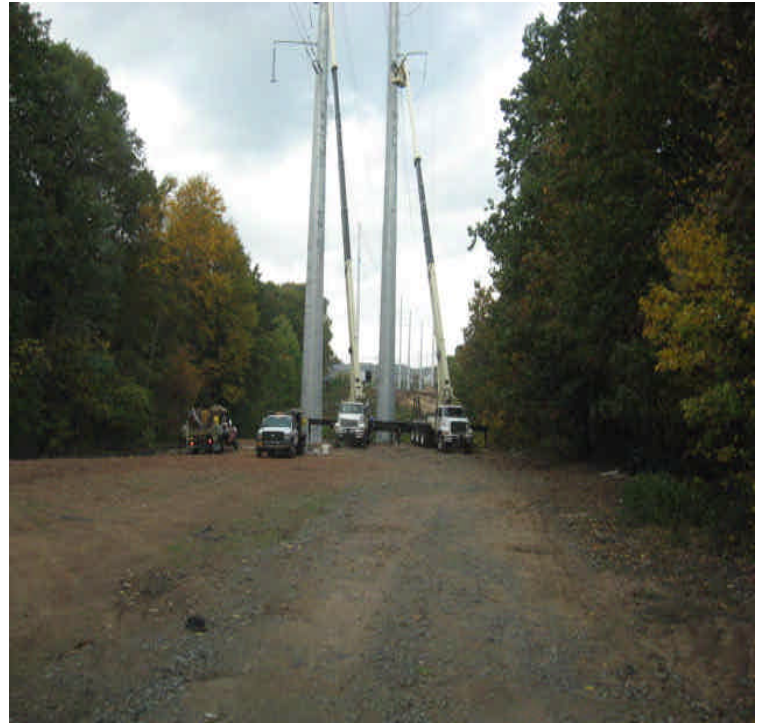
**Docker Dr:** Some exposed soils remain graded, mulched, and seeded. Crews were performing line work.

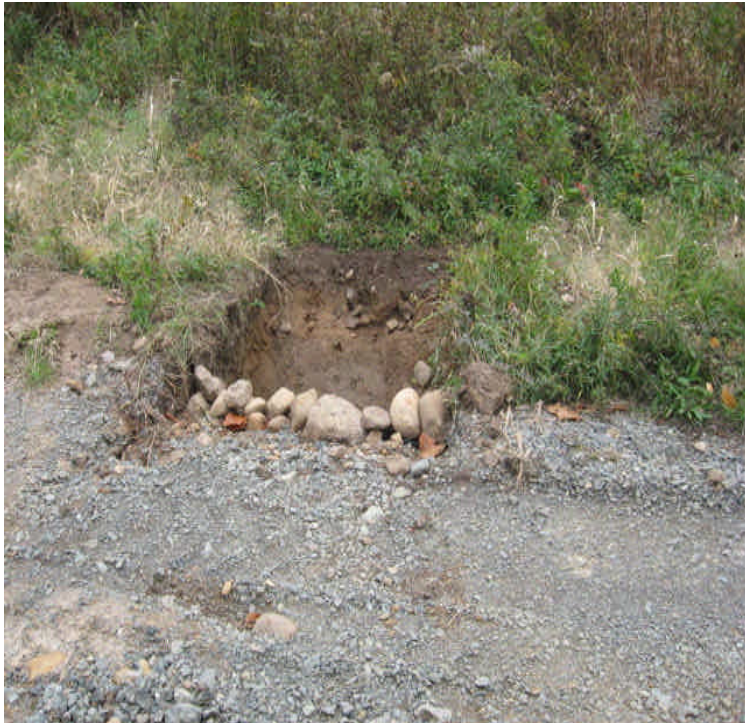
**Mansion Rd Apple Orchard:** Culvert was installed to reduce ponding on the access road.

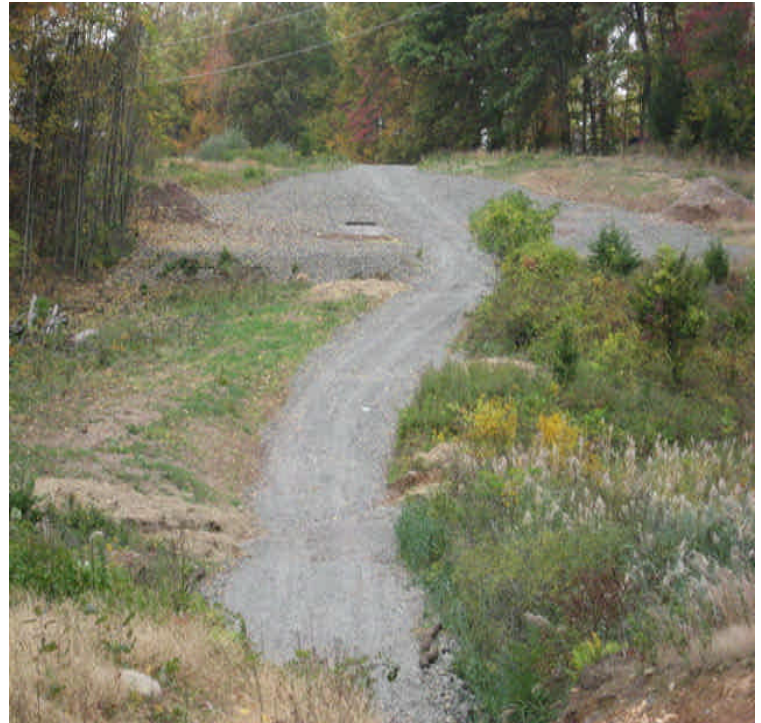
**Tuttle Dr:** Water bars were installed along the access road to divert stormwater into detention areas.
