## Docket No. 272 - Development and Management Plan Inspection

## Segment 2b Inspection

Date: October 5, 2007

**Location:** Segment 2b – Cheshire/Hamden Town Line to East Devon Substation

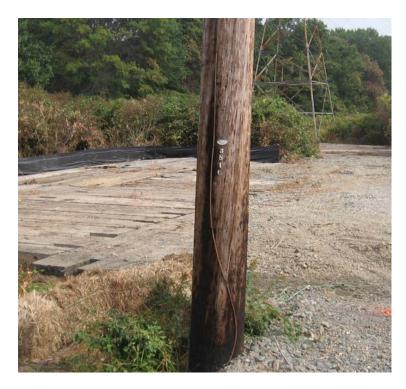
West River St. (Milford): Pad Reclamation and access road upgrades are complete in this area.

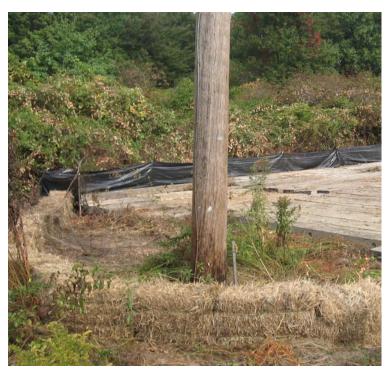
West River St: Pad reclamation is complete and proper controls are in place.

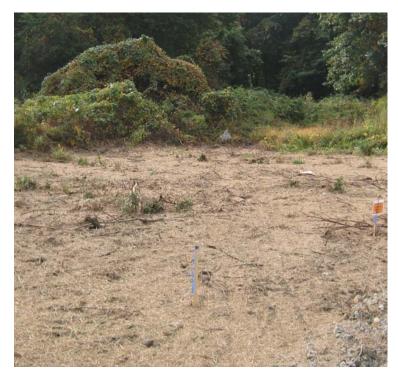
West River St: The timber mat crane pad has been removed and exposed soils have been graded, mulched and seeded at structure # 3838.
