Docket No. 272 – Development and Management Plan Inspection

Segment 2b Inspection

Date: October 12, 2007

Location: Segment 2b – Cheshire/Hamden Town Line to East Devon Substation

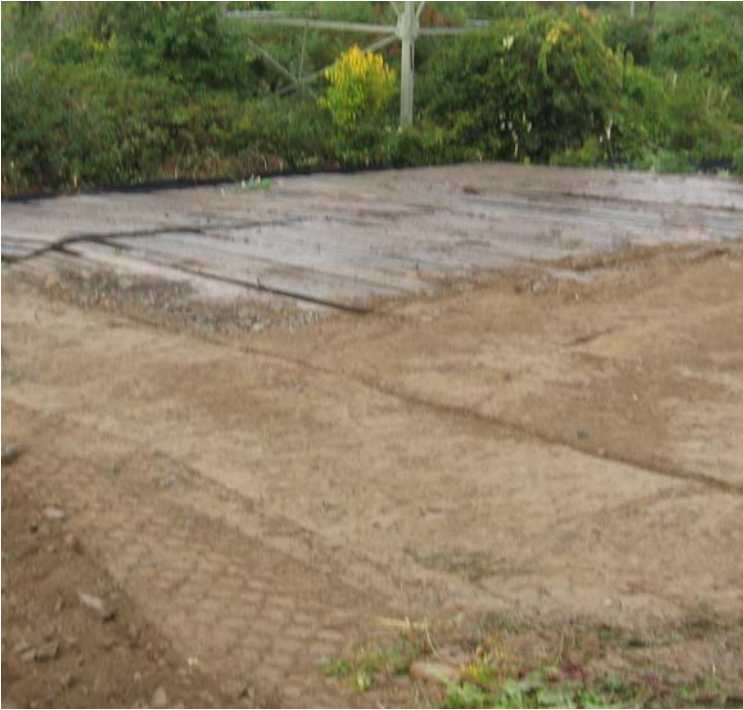
Naugatuck Ave (Milford): A timber mat crane pad was installed within the wetland at proposed structure #3804.

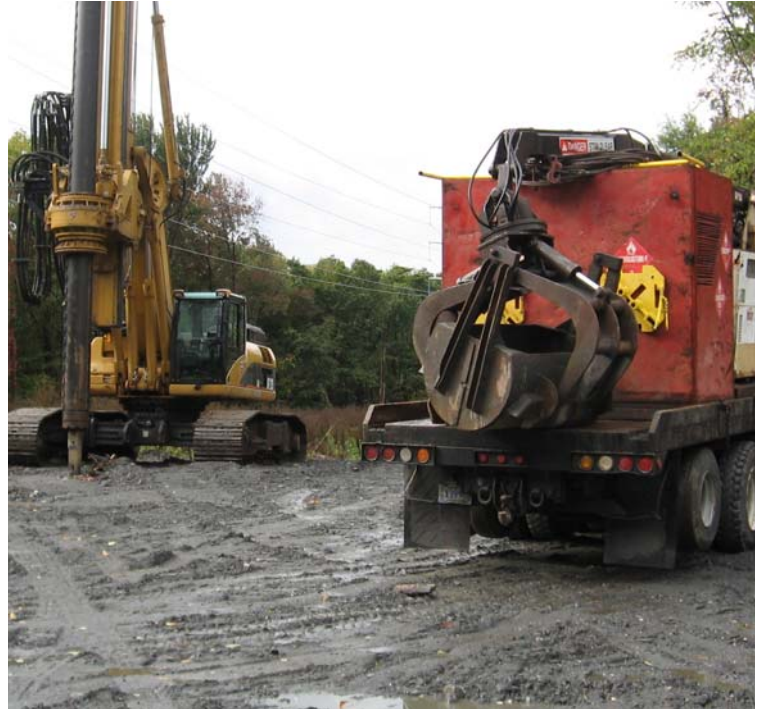
Pease Rd (Woodbridge): Drilling for the 345kV line has begun in this section.

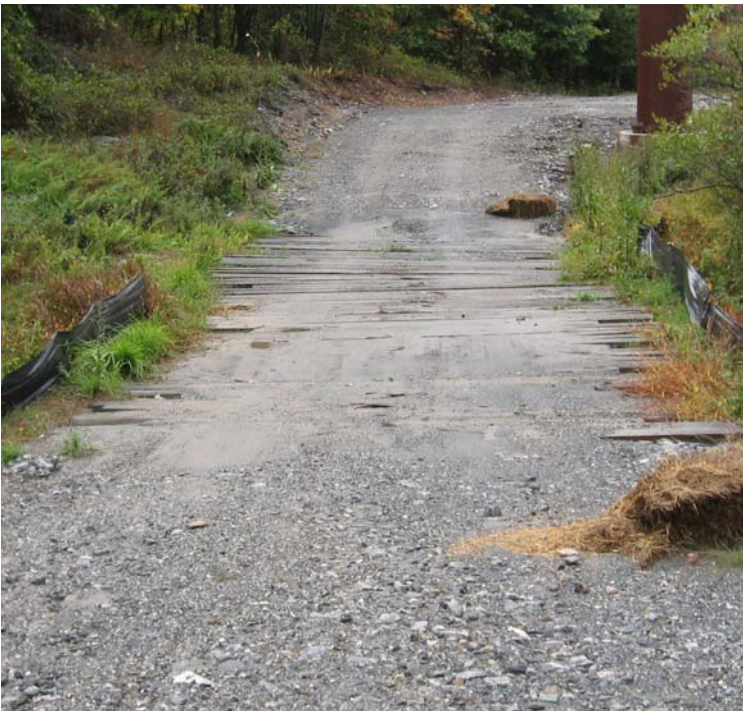
Litchfield Turnpike (Bethany): Excess sediment has accumulated on the timber mat crossings along the access road in this section. Sediment has seeped through the mats and into the wetlands at several crossings.

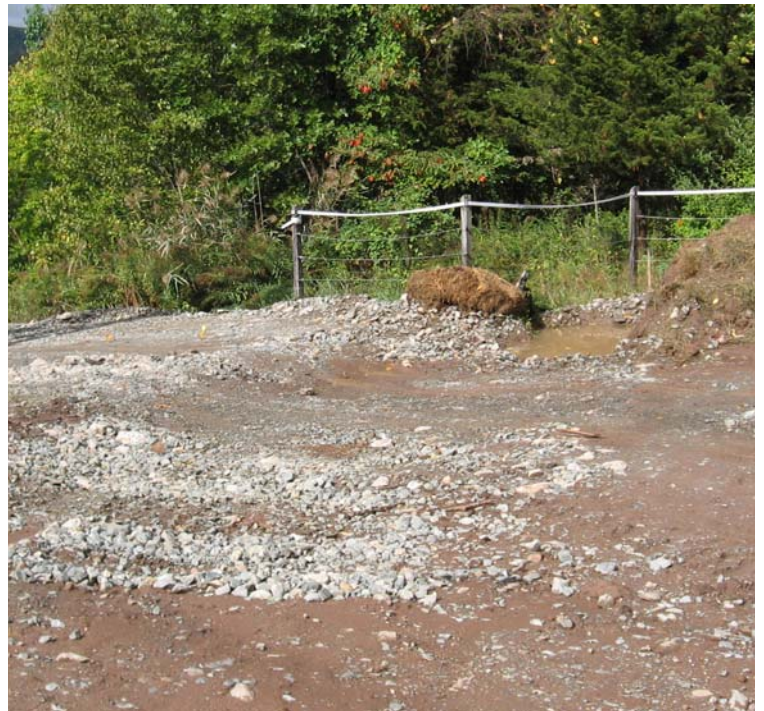
Old Lane Rd (Hamden): Storm water has been redirected from the access road to a haybale/silt fence check dam near structure #4013.

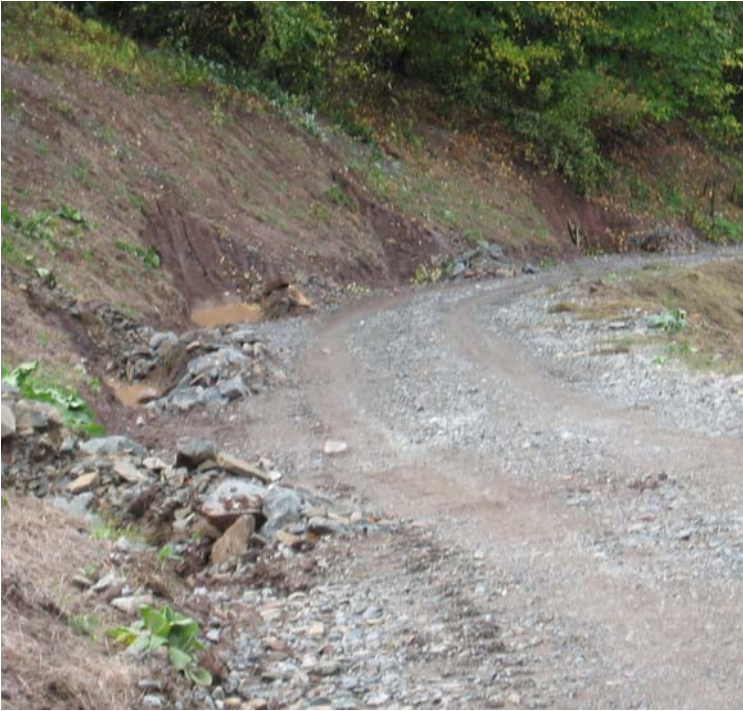
Old Lane Rd: Several modified stone check dams have been installed along the access road here.

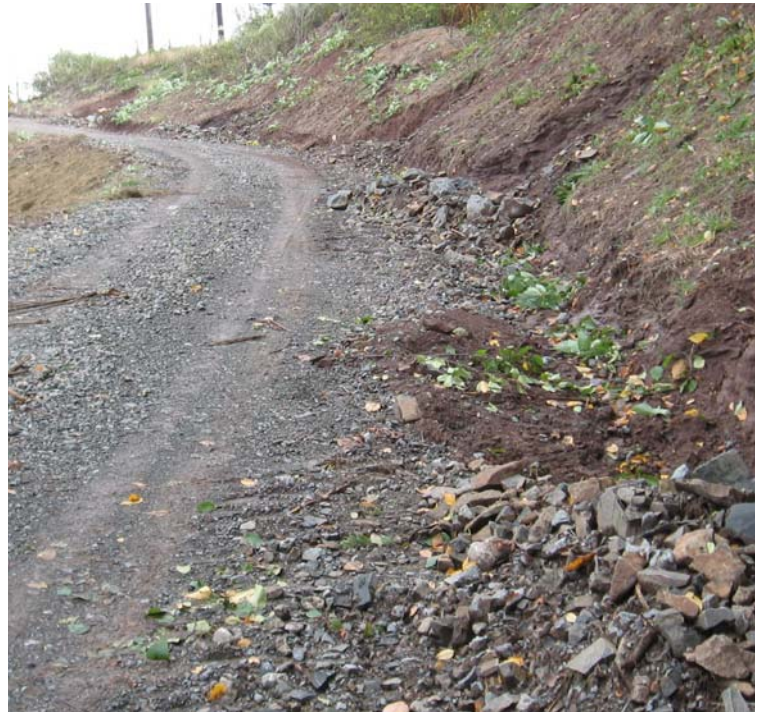
Old Lane Rd: Additional view of the stone check dams.

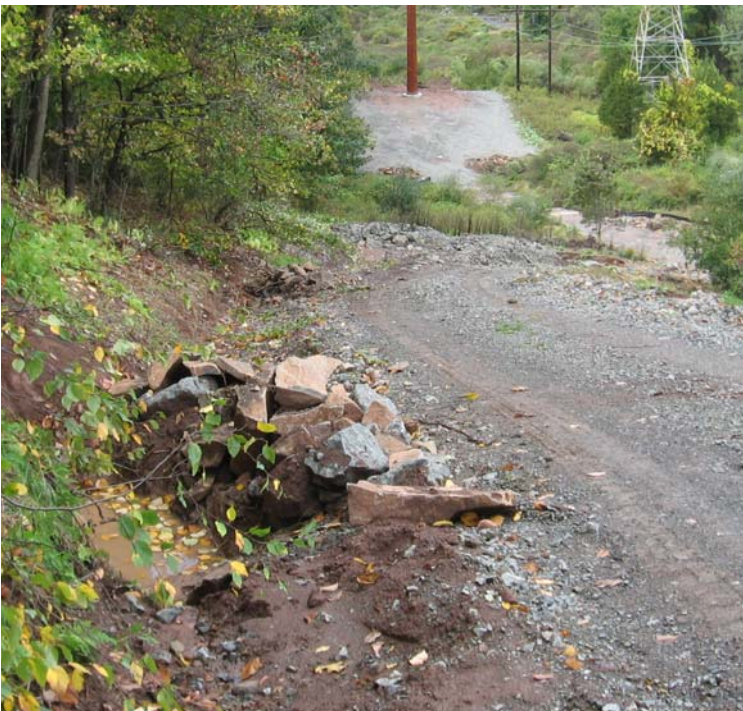
Old Lane Rd: View of the access road looking toward the stone sediment trap.

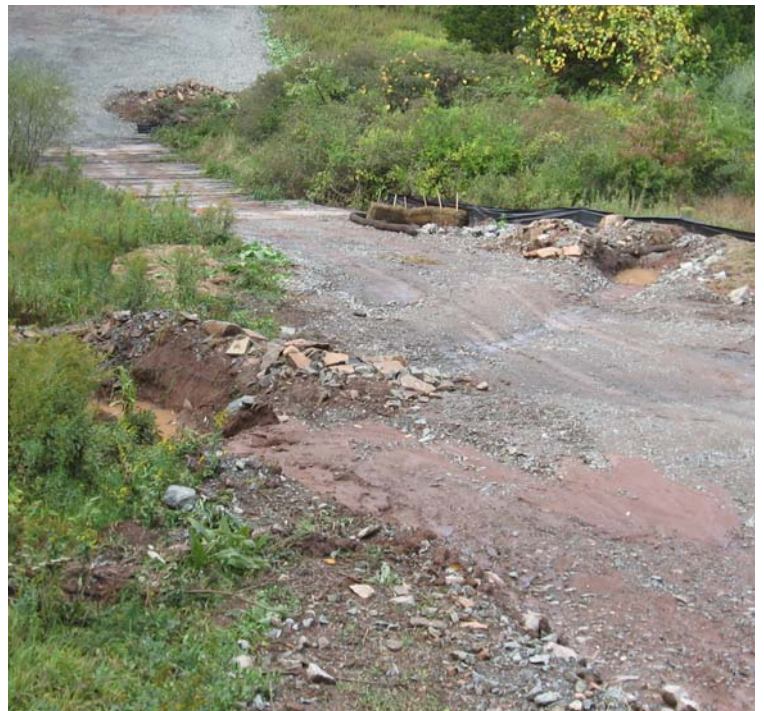
Old Lane Rd: Additional controls have been installed upgradient of wetland #94.
