**Docket No. 272 – Development and Management Plan Inspection**

**Segment 2b Inspection**

**Date:** October 19, 2007

**Location:** Segment 2b – Cheshire/Hamden Town Line to East Devon Substation

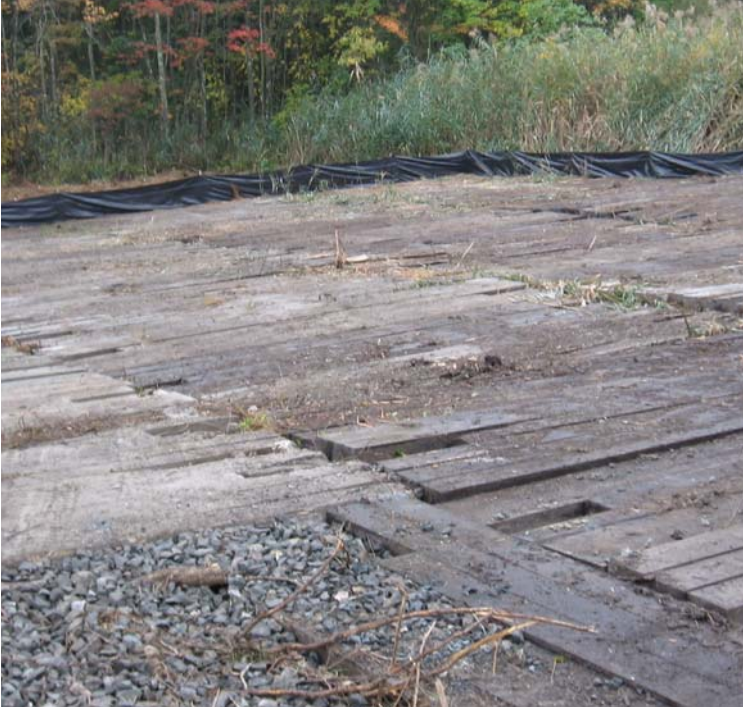
West River St (Milford): Pad Reclamation is complete at proposed structure #24023. Controls are in place.

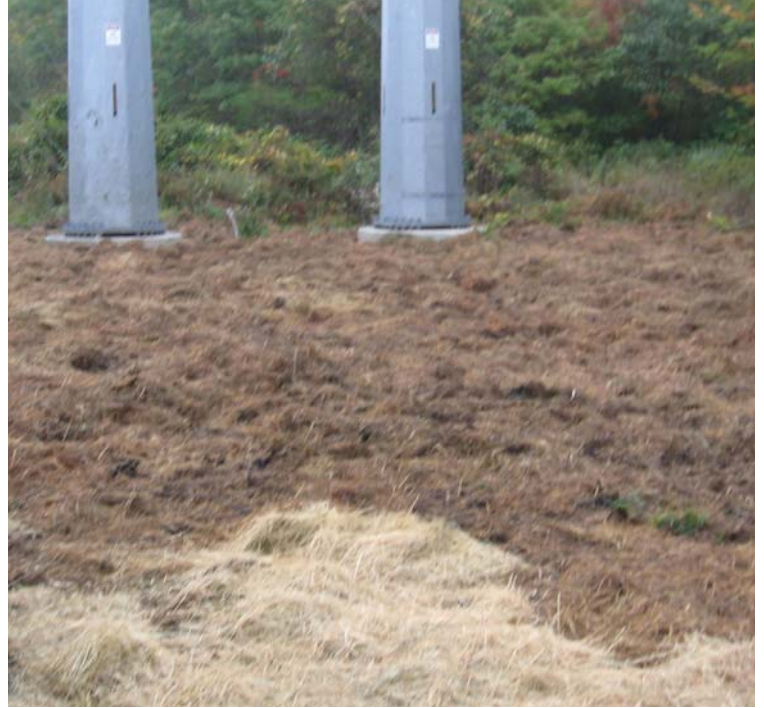
West River St: Restoration efforts are complete at structure #3836.

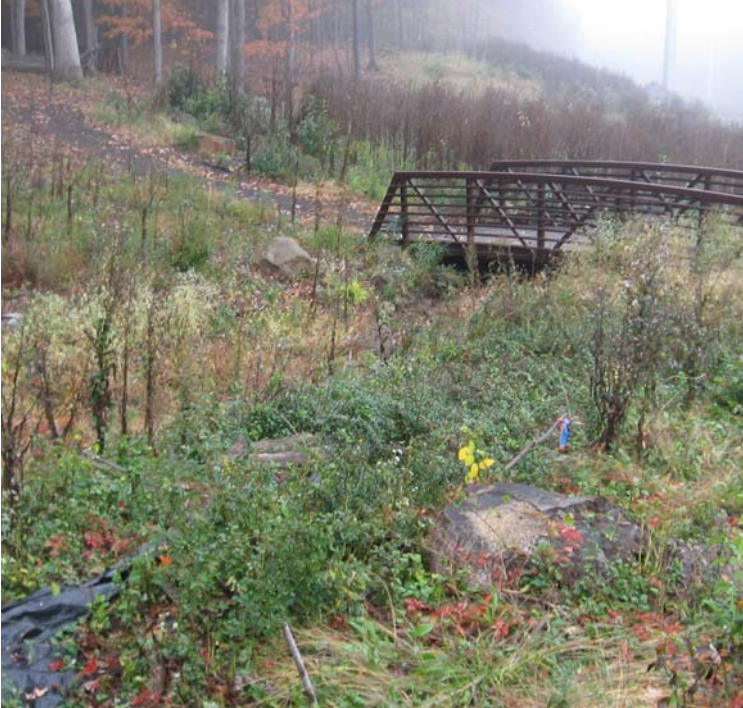
JCC (Woodbridge): Silt fence is in need of repair along the wetland boundary here.

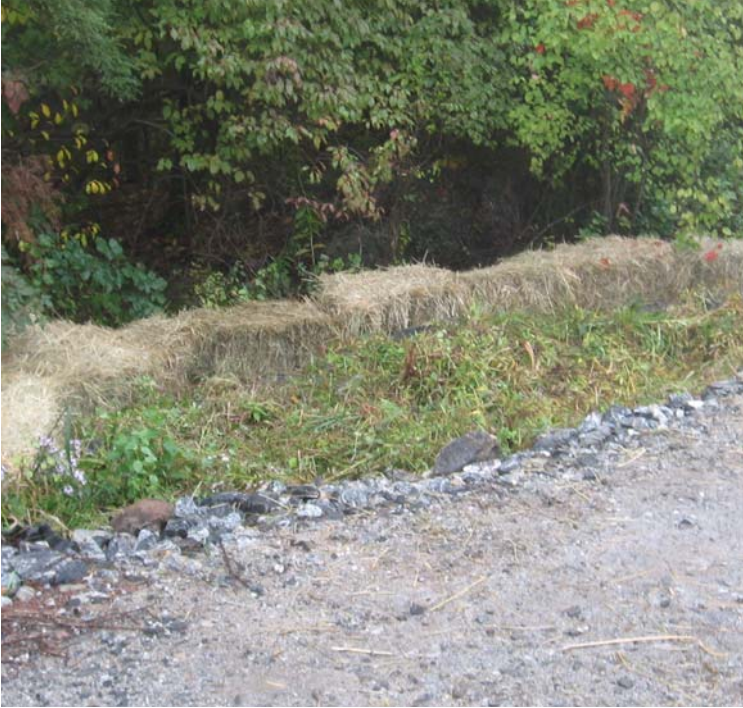
Gaylord Mtn Rd (Hamden): Sediment has been removed from the stone trap and a new line of haybales was installed.

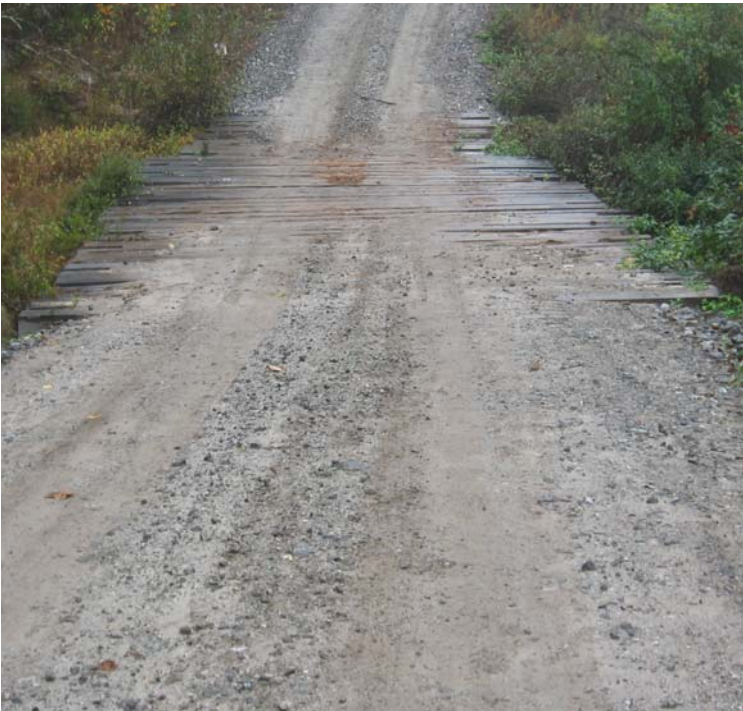
Brooksvale Ave (Hamden): A view of the wetland crossing at wetland #100. Sediment migration from the access road is not an issue at this crossing.

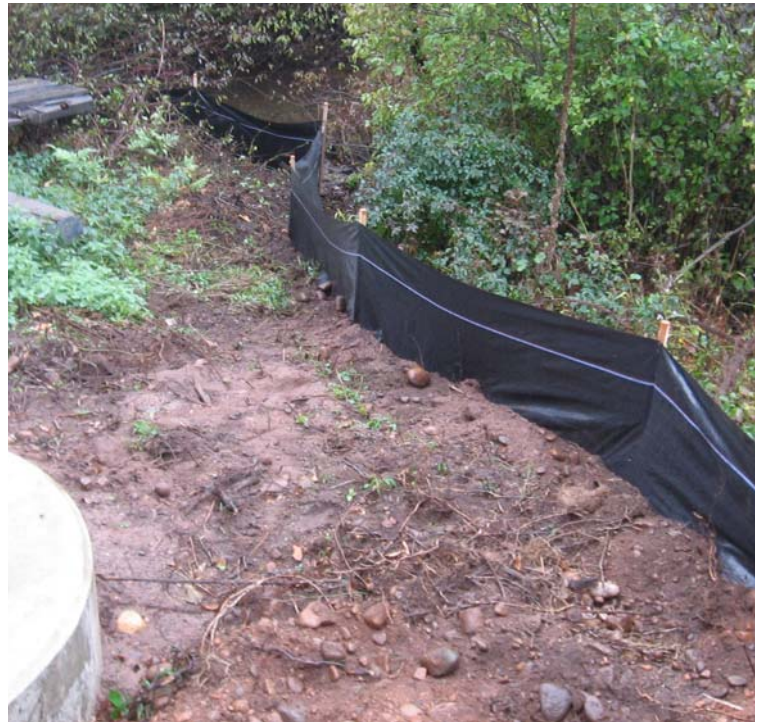
Willow St (Hamden): Silt fence has been installed along Willow Brook.
