Docket No. 272 – Development and Management Plan Inspection

Segment 3 Underground Line

Date: October 4, 2007

Location: East Devon Substation to the Housatonic River Crossing

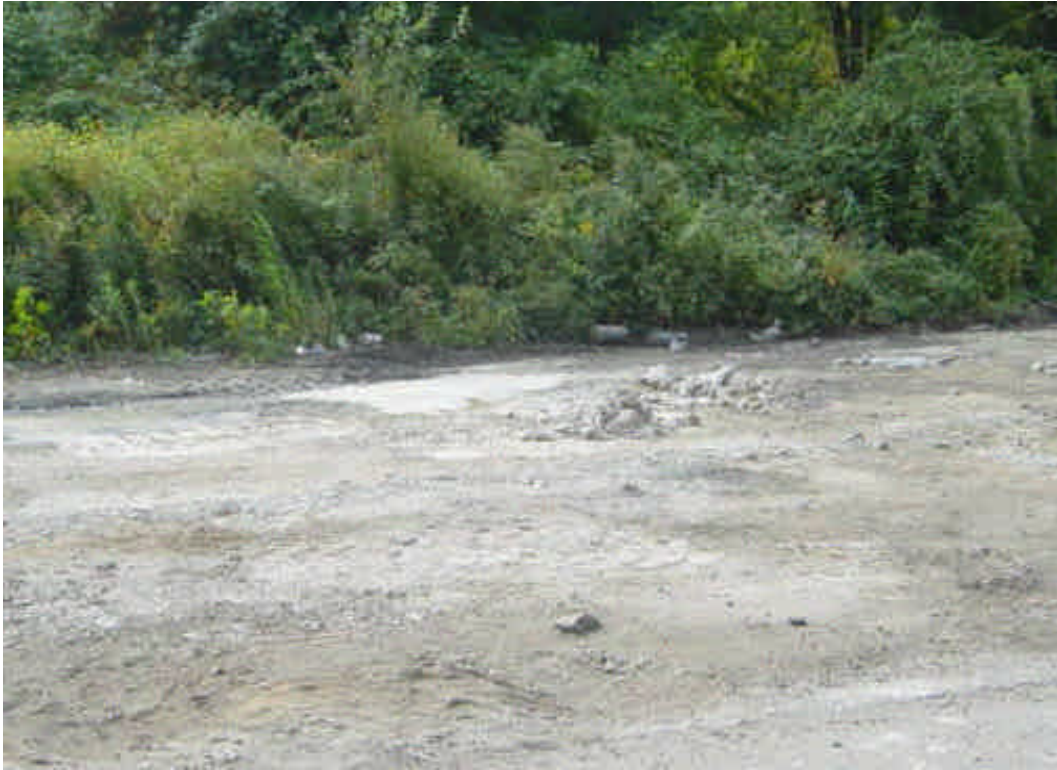
Concrete washouts continue to be observed near sta. #1017. M/N contractors are not currently working in this area and have stated that the washouts are not from project related activities and are the result of other construction in the area.

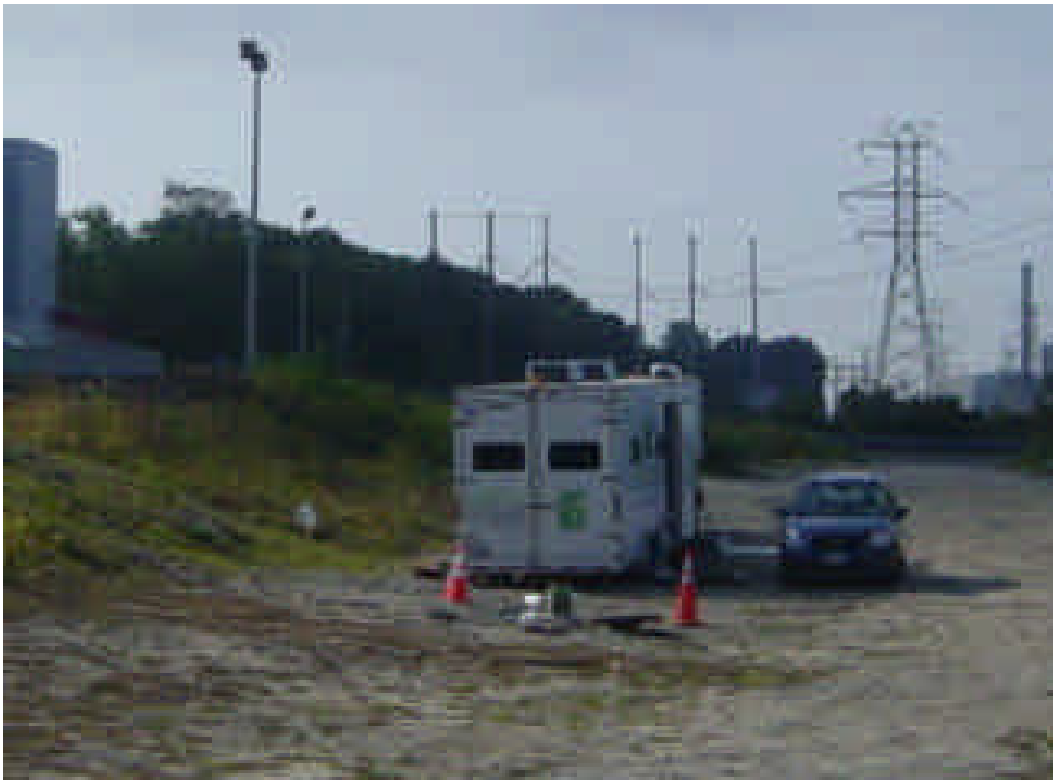
Electrical crews were observed working at vault #5.
