**Docket No. 272 – Development and Management Plan Inspection**

**Segment 3 Underground Line**

**Date:** October 11, 2007

**Location:** East Devon Substation to the Housatonic River Crossing

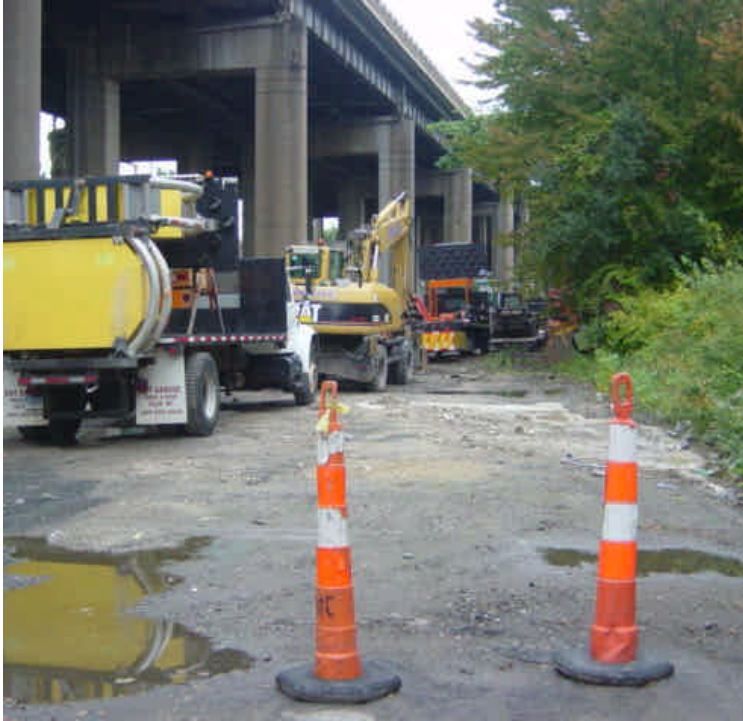
<p>Other contractors continue to work in the area of sta. #1015-1020 (vault #1). These activities are not part of the Middletown/Norwalk project but the work impedes any further stabilization in this area. 8/27 - 10/11/07</p>	<p>If feasible, it would be beneficial to apply seed/mulch to the areas where M/N erosion controls were removed. 10/11/07</p>	<p>Area is being disturbed by other construction activities not part of the M/N project.</p>
	<p>The stone berm that has been installed in an effort to reduce the accumulation of fine sediment to the entrance to the yard continues to function as intended. 10/11/07</p>	<p>Monitor to ensure the effectiveness of the stone berm during rain events. Remove accumulated sediment outside of yard if vegetation continues to be sparse. 10/11/07</p>	<p>NA</p>

**Construction activities that are not part of the M/N project have continued near sta. #1015-1020 (vault #1) for several months. This continues to disturb soil in the area and concrete washouts are a regular occurrence.**

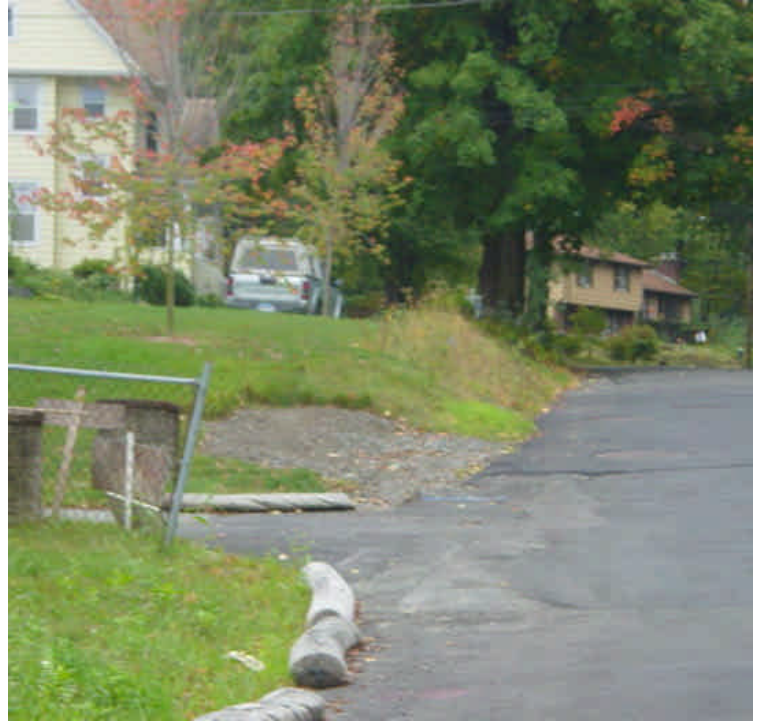
**Exposed soil on the slope near sta. #1049 (vault #3) remain temporarily stabilized and contained with hard-pack and barrier controls.**

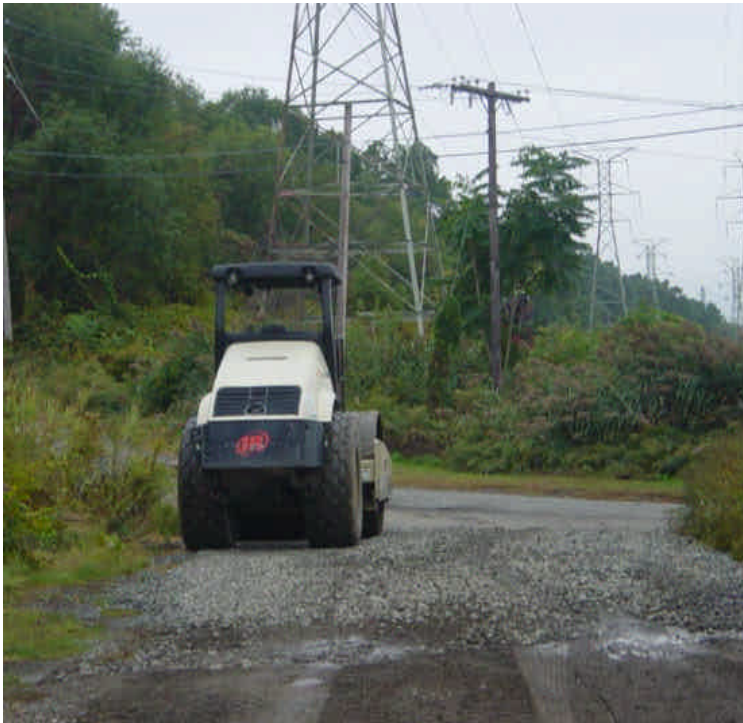
<p>Spills and Material Storage</p>	<p>Reserve spill cleanup materials/kits were observed in the storage yard. 10/11/07</p> <p>Material (gravel) was overtopping the established storage bins, beyond the perimeter controls of the yard. (noted since 4/25) 10/11/07</p>	<p>Continue to bring spill kits to active work sites. 10/11/07</p> <p>Contractors stated the materials will be removed when the area is restored. 10/11/07</p>	<p>NA</p> <p>Contractors stated that the materials will be removed when the yard is restored.</p>
<p>Additional Observations</p>	<p>Construction activities that are not part of the M/N project have continued near sta. #1015 to #1020 (vault #1) for several weeks. This continues to disturb soil in the area and concrete washouts are a regular occurrence. 10/11/07</p> <p>Equipment was being stored at sta. #1051 near the entrance to the ROW and less than 100' from the adjacent resource area. Equipment appears to be related to work on the</p>	<p>Further stabilization on the part of M/N contractors would be difficult in this area. 10/11/07</p> <p>Equipment should be stored at least 100-feet from resource areas. 10/11/07</p>	<p>Non-jurisdictional to this D&amp;M plan. Noted for the record.</p> <p>Equipment does not appear to be associated with this portion of the project. Noted for the record.</p>

**Equipment was being stored at sta. #1051 near the entrance to the ROW and less than 100' from the adjacent resource area. Equipment appears to be related to work on the overhead wires.**

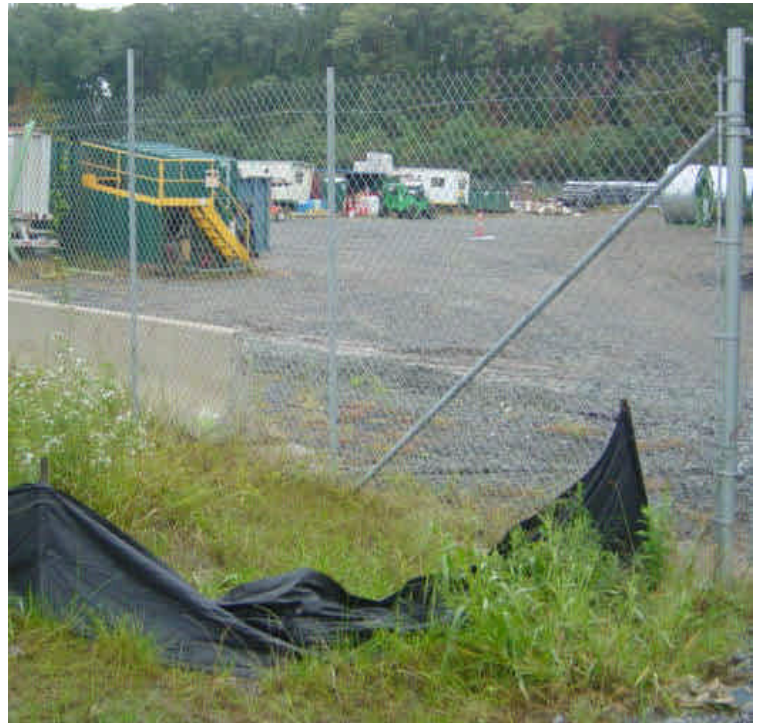
**A small section of silt fence near the entrance to the Shelland St. laydown yard is sagging but continues to function. This yard appears to be idle as work has shifted to other areas of the project.**

Areas of Inspection	Observation	Recommended Action	Corrected Action
	A small section of silt fence near the entrance to the yard is sagging but continues to function. 10/11/07	When feasible, repair sagging section of silt fence. 10/11/07	Needs attention when feasible.
Inland Wetland and Watercourse encroachment and mitigation	Inland Wetland resource areas are located near station from #1012 to 1021, # 1051, and #1053. Stations #1117 to 1118 are located in a resource area. 10/11/07	Monitor resource areas to ensure that non-permitted encroachment or impacts do not occur 10/11/07	NA
Staging, Storage, and Parking Areas	A contractor lay-down yard is located in Milford off of Shelland St. Jersey barriers are set up as bins to contain stockpiled materials. Stone is in place throughout the yard to reduce mud and subsequent tracking. Yard has been idle for several weeks as work has shifted to other areas of the project. 10/11/07	See erosion control section and spills and material storage section for more details. Contain material within established storage area and limits of the yard. 10/11/07	NA
