**Docket No. 272 – Development and Management Plan Inspection**

**Segment 3 Underground Line**

**Date:** October 25, 2007

**Location:** East Devon Substation to the Housatonic River Crossing

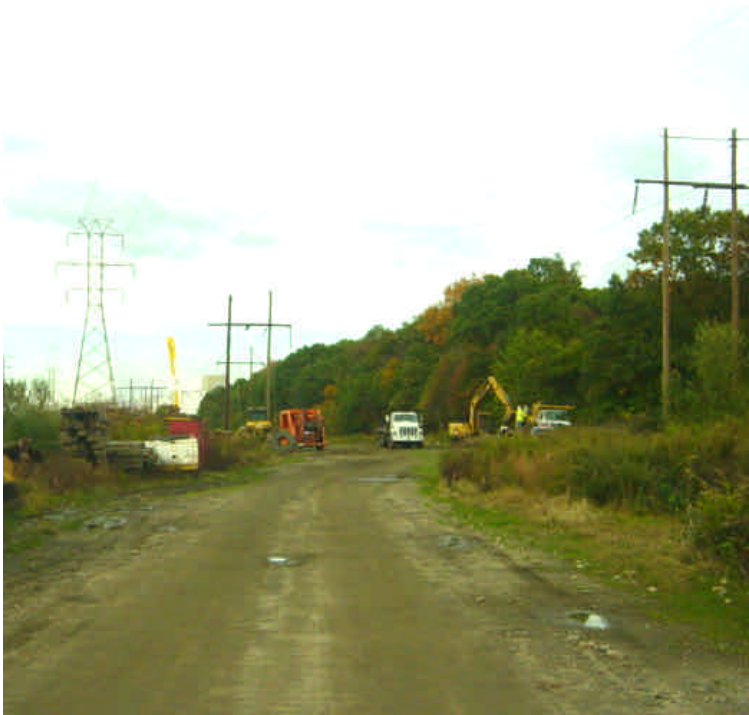
Work noted on the overhead lines along the cross country section between sta. #1051 to #1080 which overlaps the Segment 3 route.

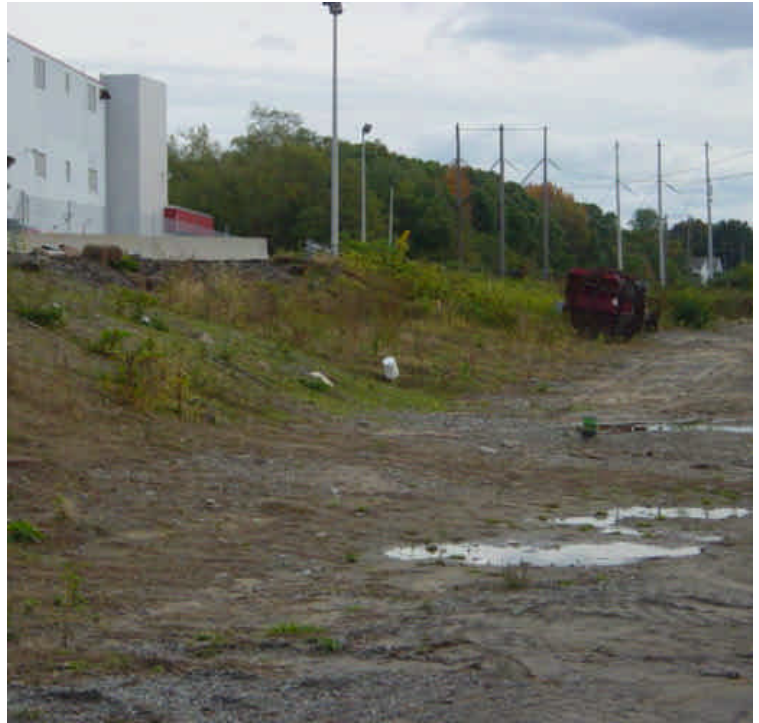
The exposed soil along the slope near sta. #1080 has re-vegetated naturally (approximately 50% coverage). The slope will be fully restored in the future. A plan is being worked out with the landowner.

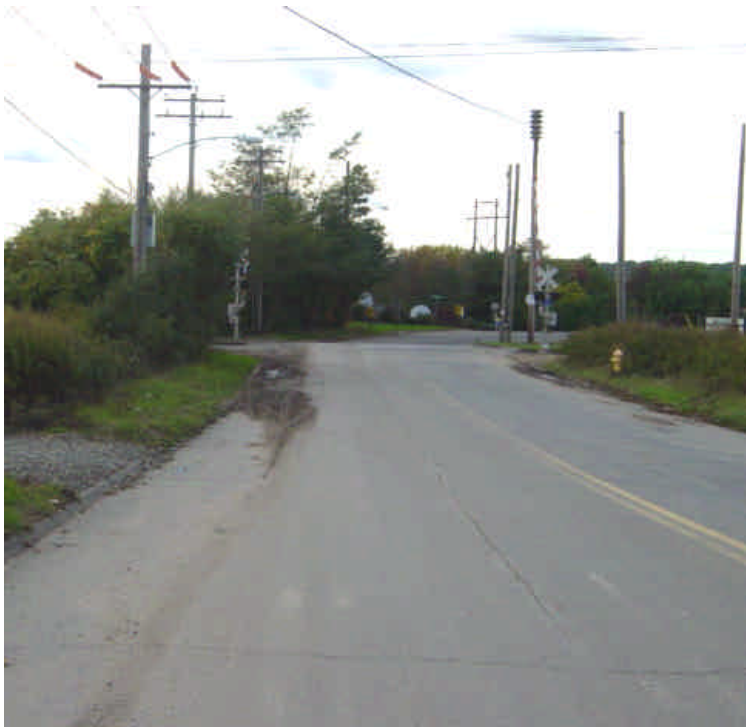
Tracking was evident along Caswell Street, but does not appear to be associated with this portion of the project.

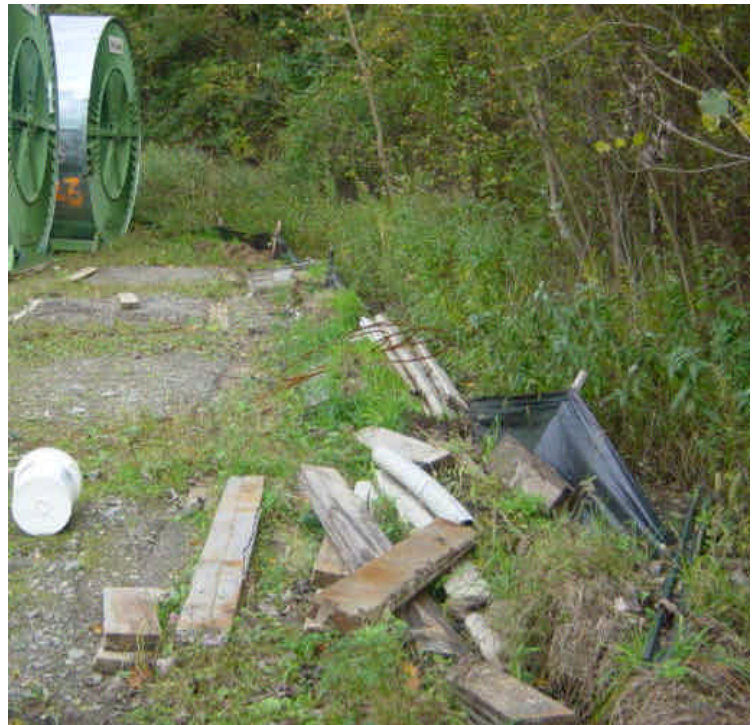
Sections of silt fence along the south side of the Shelland St. laydown yard is sagging. The area is well vegetated and the silt fence continues to function. This yard appears to be idle as work has shifted to other areas of the project.
