Docket No. 272 – Development and Management Plan Inspection

Segment 4a Underground Line

Date: October 4, 2007

Location: Singer Substation to Fairfield/Westport Town Line

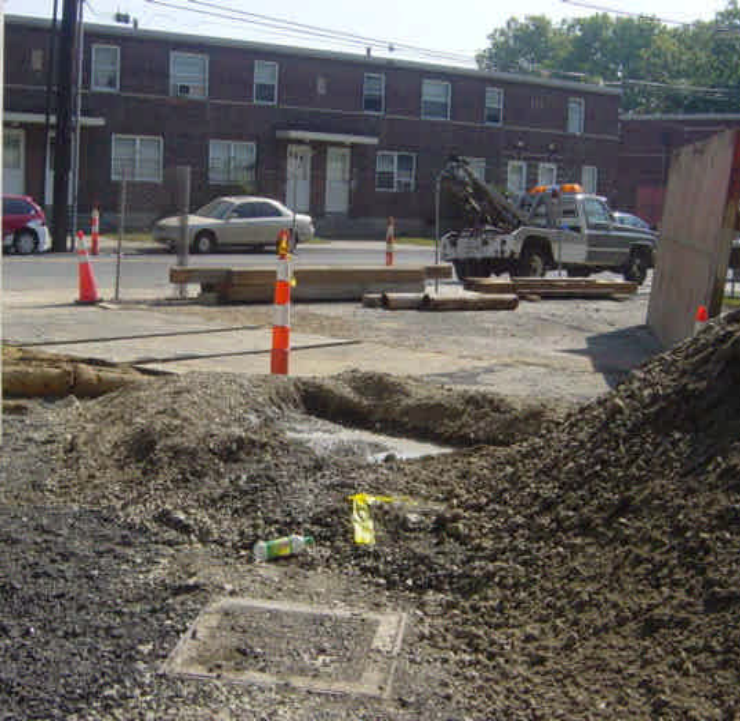
A small, designated concrete washout area was observed near the trench work at Sta. #771-#772.

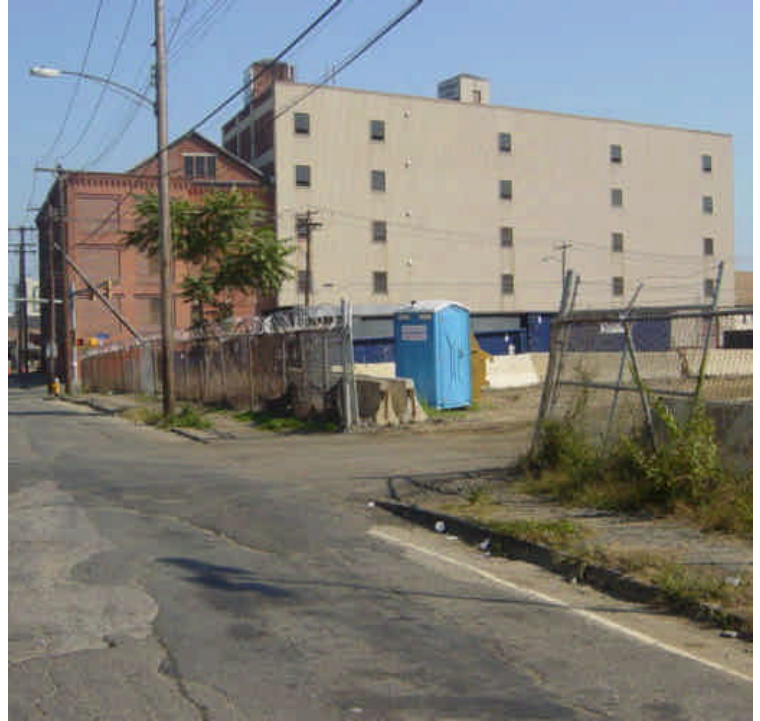
Calcium chloride was applied to exposed soils at the storage yard at Railroad Ave. and Myrtle Ave., associated with the Glenbrook Cable project in order to control dust. The downstream catch basins have been protected with silt sacks. (This area is not related to the M/N project but is located along a portion of the route.)

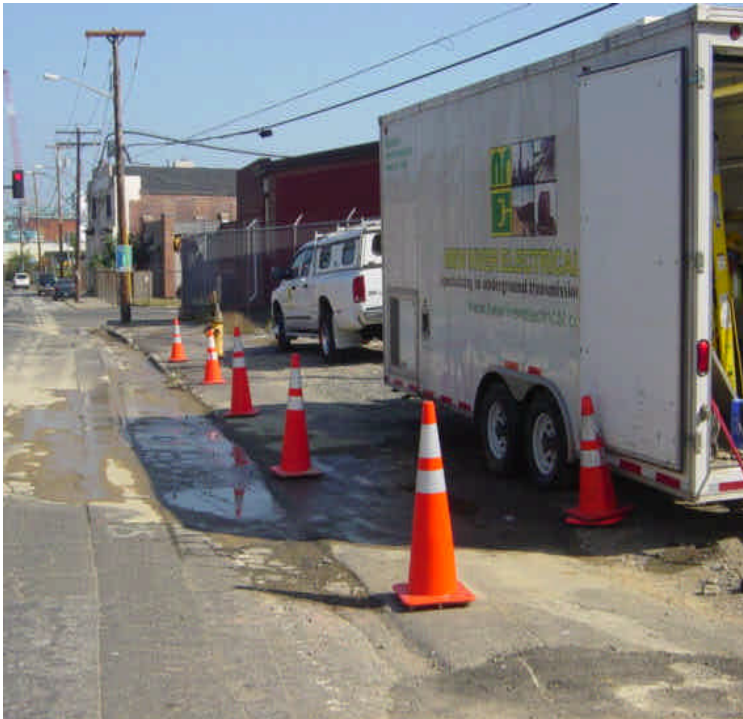
Silt and runoff were observed along the roadway near sta. #790 which was attributed to the ongoing vault work. A downgradient catch basin was not protected. Runoff or dewatering from future vault work activities should be contained and catch basins should be protected to prevent sedimentation.
