Docket No. 272 – Development and Management Plan Inspection

Segment 4a Underground Line

Date: October 18, 2007

Location: Singer Substation to Fairfield/Westport Town Line

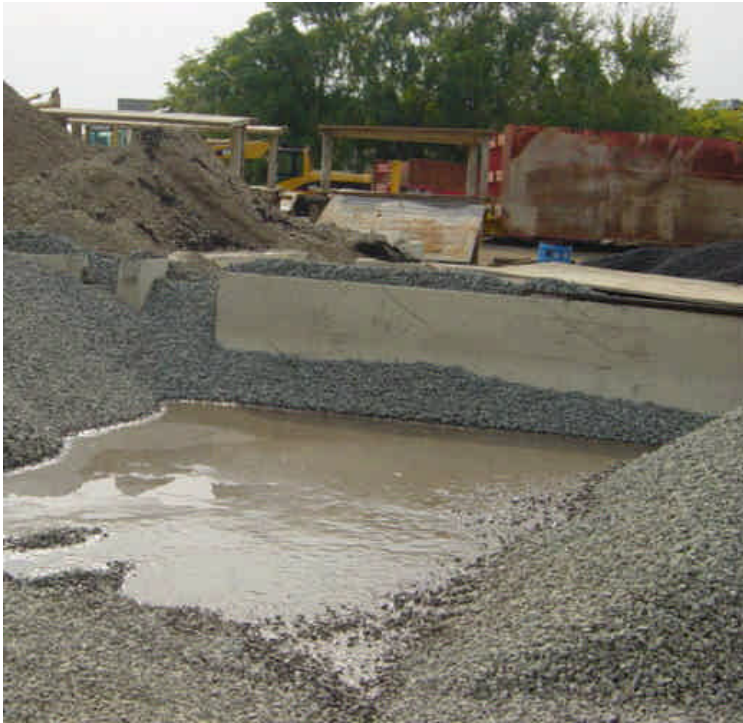
Concrete slurry washout had been performed within a contained stone stockpile area in the Kings Highway lay-down yard. Eventually, the material should be removed and properly disposed of.

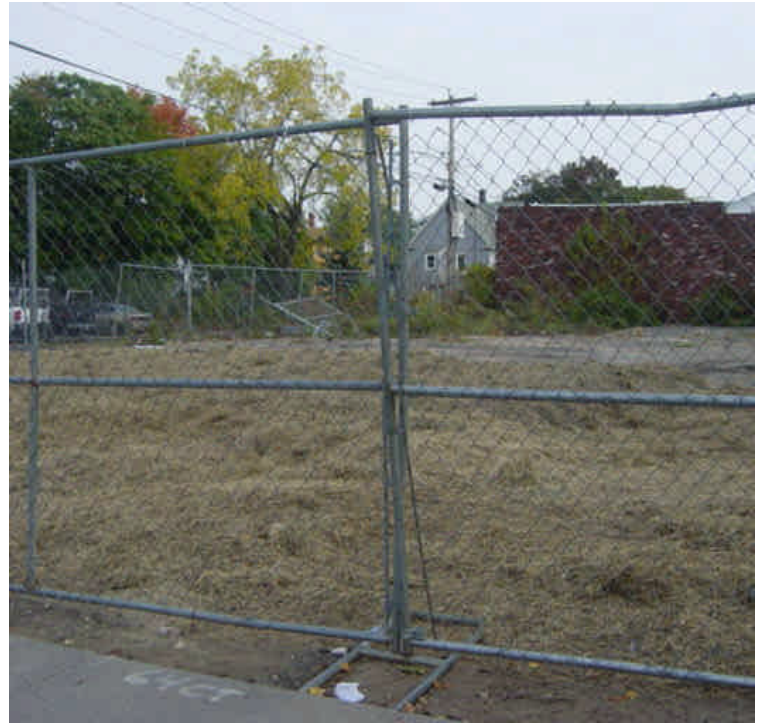
Hay mulch has been applied to the exposed soils near sta.#695. 10/18/07	Continue to monitor for permanent restoration efforts and final stabilization. 10/18/07	Temporary stabilization efforts were noted.
State species of concern, threatened and endangered species.	According to the D&M plan, state-listed species are not located in this work area.	None	NA
Vegetative clearing (including trees to save or danger trees noted) or stabilization	Vegetation continues to establish in the hydro-seeded areas at sta. #596 (vault #36) and sta. #612 (vault #37), and has reached 75% cover in some areas. 10/18/07	Continue to monitor until final stabilization is achieved. See erosion control section for more details on vault #37. 10/18/07	Grass cover is increasing.
	Soil/ hard pack remains exposed but contained near sta. #471 (vault #28), sta. #680 (vault #41), & sta. #801 (vault #49). 10/18/07	Continue to monitor and provide final stabilization when feasible. 10/18/07	NA

Hay mulch has been applied over the exposed soils near sta. #695. Permanent restoration efforts will be necessary in this area.
