Docket No. 272 – Development and Management Plan Inspection

Segment 4a Underground Line

Date: October 25, 2007

Location: Singer Substation to Fairfield/Westport Town Line

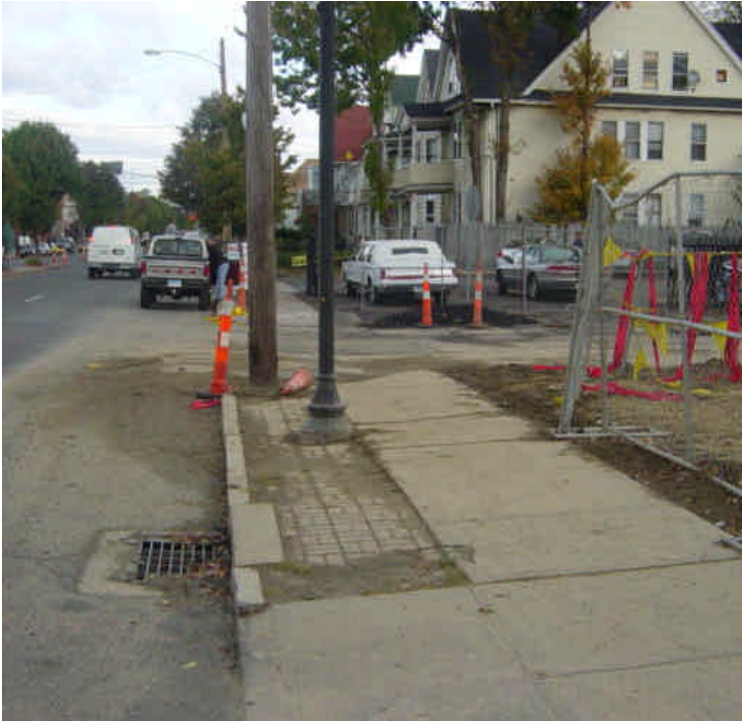
Hay mulch remains over the exposed soils near sta.#695. 10/25/07	Permanent restoration efforts required in this area. 9/26-10/25/07	Temporary stabilization efforts were noted.
State species of concern, threatened and endangered species.	According to the D&M plan, state-listed species are not located in this work area.	None	NA
Vegetative clearing (including trees to save or danger trees noted) or stabilization	Vegetation continues to establish in the hydro-seeded areas at sta. #596 (vault #36) and sta. #612 (vault #37), and has reached 90% cover in some areas. 10/25/07	Continue to monitor until final stabilization is achieved. See erosion control section for more details on vault #37. 10/25/07	NA
	Soil/ hard pack remains exposed but contained near sta. #801 (vault #49). The area near sta. #680 (vault #41) has been paved, any additional stabilization	Continue to monitor and provide final stabilization when feasible. 10/25/07	The vault #41 area has been paved.

Heavy sediment accumulation near sta. #695 (vault #42) was observed along the shoulder and sidewalk areas. The source of the accumulation was unclear but may have been generated by the placement of a temporary stockpile in this area during a previous workday. Sweep roadway and provide permanent restoration efforts in this area.

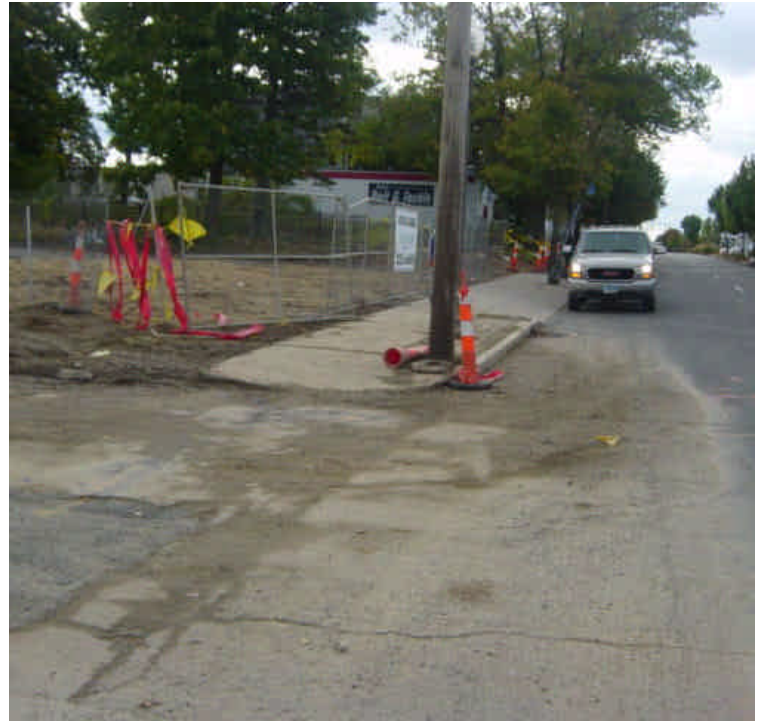
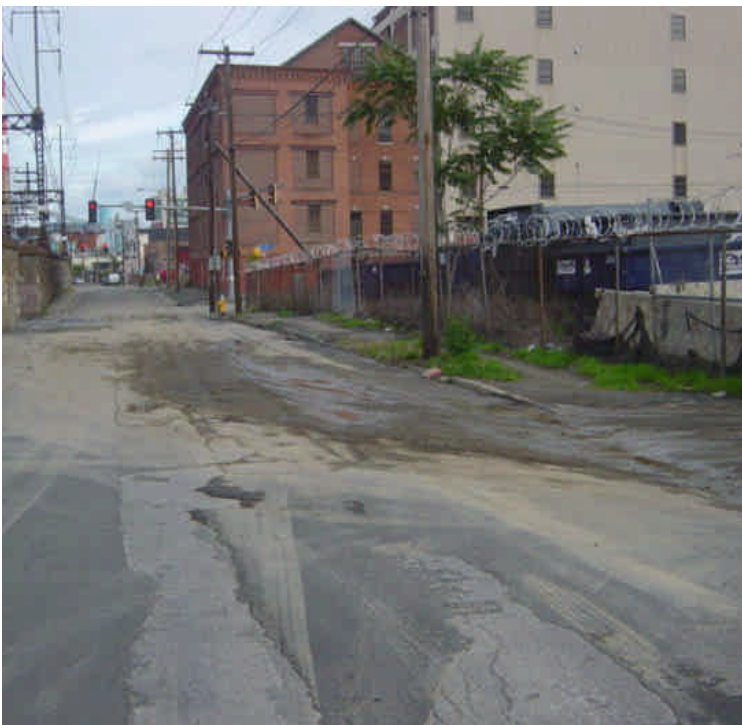
Additional Observations	The downgradient catch basins near the storage yard at Railroad Ave. and Myrtle Ave., associated with the Glenbrook Cable project remain protected with silt sacks. Heavy sediment tracking was evident along the roadway. 10/25/07	Noted for the record since a portion of the project route overlaps this area. This yard is not jurisdictional to the M/N project. 10/25/07	NA

Heavy sediment tracking was evident along the roadway near the storage yard at Railroad Ave. and Myrtle Ave., associated with the Glenbrook Cable project. The down gradient catch basins remain protected with silt sacks. Although this area overlaps the M/N project route, it is not M/N project related.

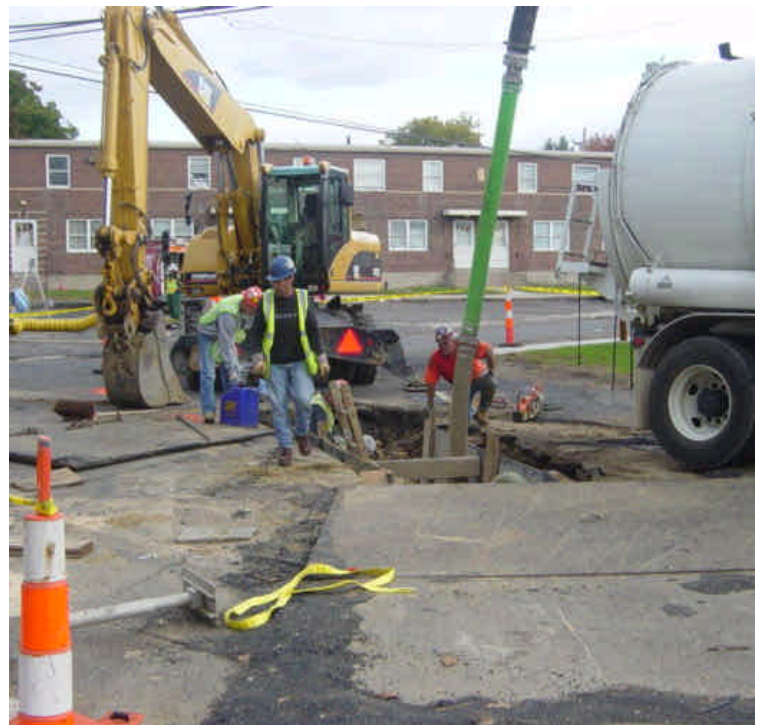
Trenching and backfill work continues near sta. #771-#772.
