Docket No. 272 – Development and Management Plan Inspection

Segment 4b Underground Line

Date: October 4, 2007

Location: Fairfield/Westport Town Line to Westport Avenue in Norwalk

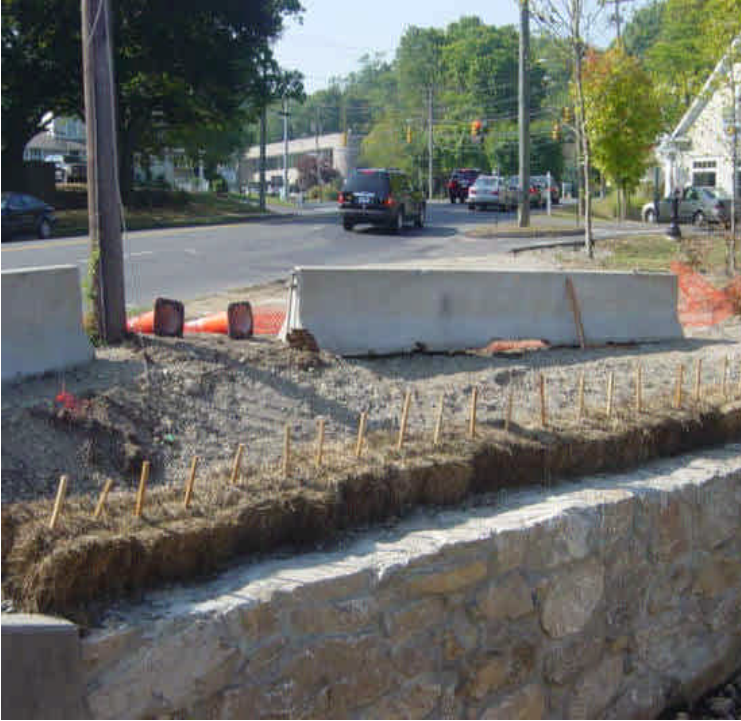
Both photos were taken at sta. #217 (Stony Brook). Left: Erosion controls remain between the hard-pack material and the brook. Right: Exposed soil has been seeded but mulch is recommended for stabilization.

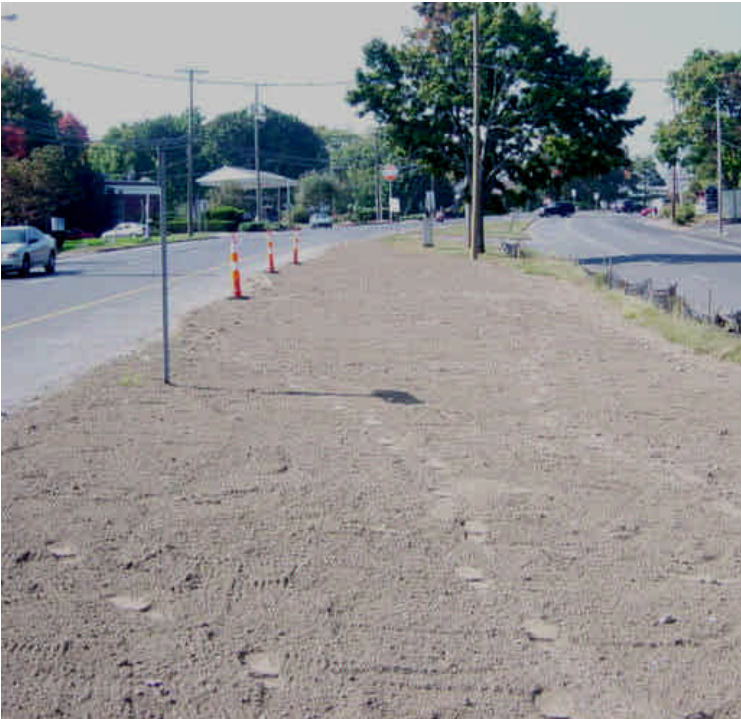
Topsoil has been spread near sta. #316-318. Seed and mulch is still required for stabilization of exposed soils.

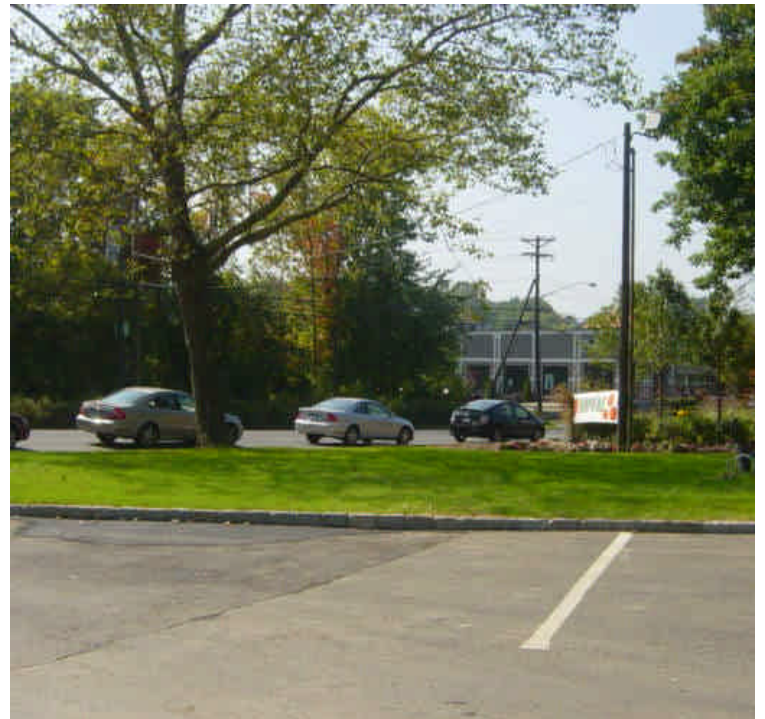
Area near sta. #360 has been fully stabilized and restored with good grass cover.

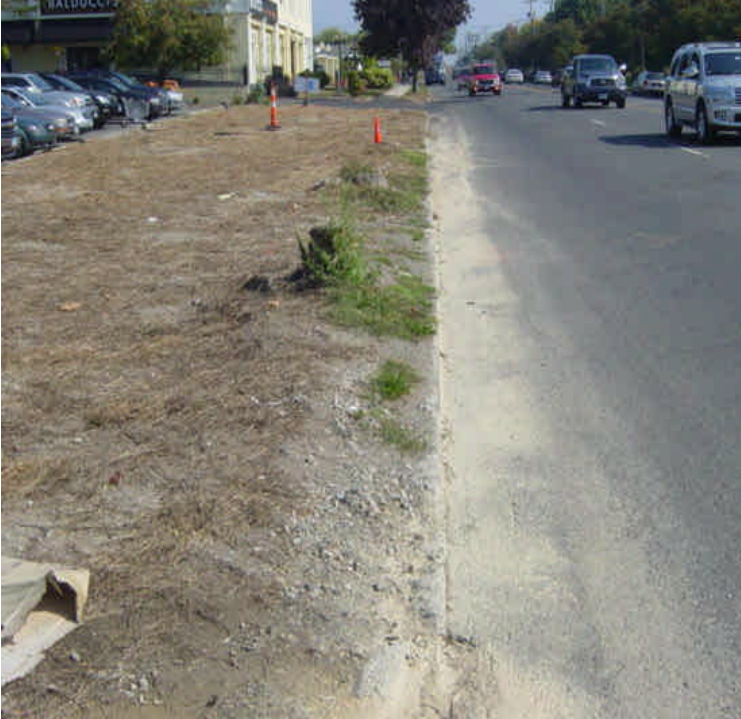
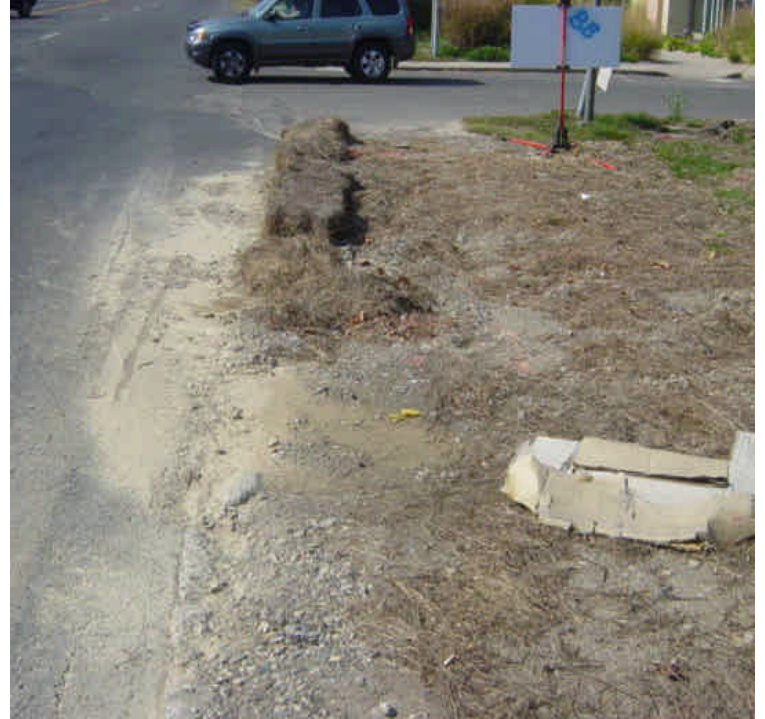
A minor amount of sediment from run-off was visible along the curb near sta. #838 (vault #23), which was previously covered with hard-pack and stabilized with hay mulch. Sweep roadway as necessary. Continue restoration/stabilization efforts and monitor until area is permanently stabilized.

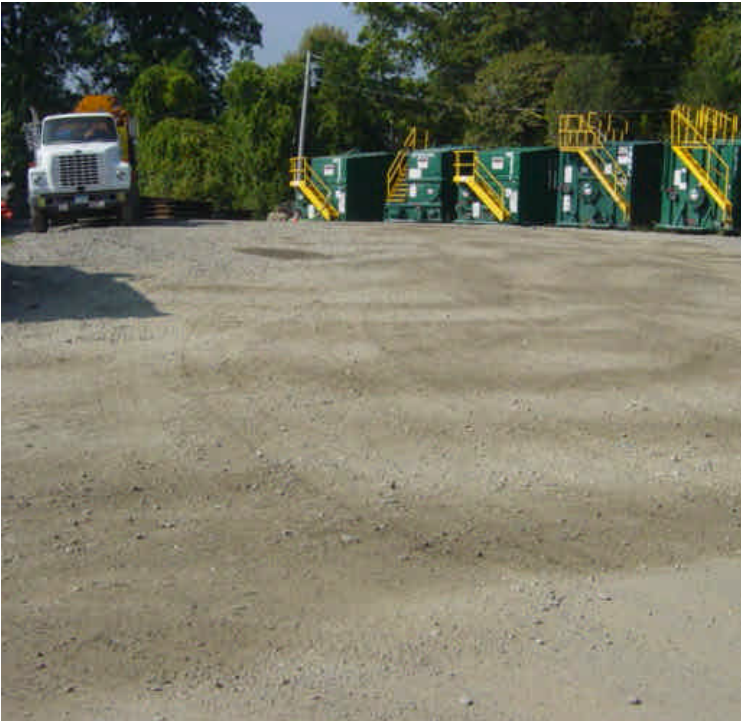
The Sherwood Island lay-down yard was recently watered down in an effort to control airborne dust migration.

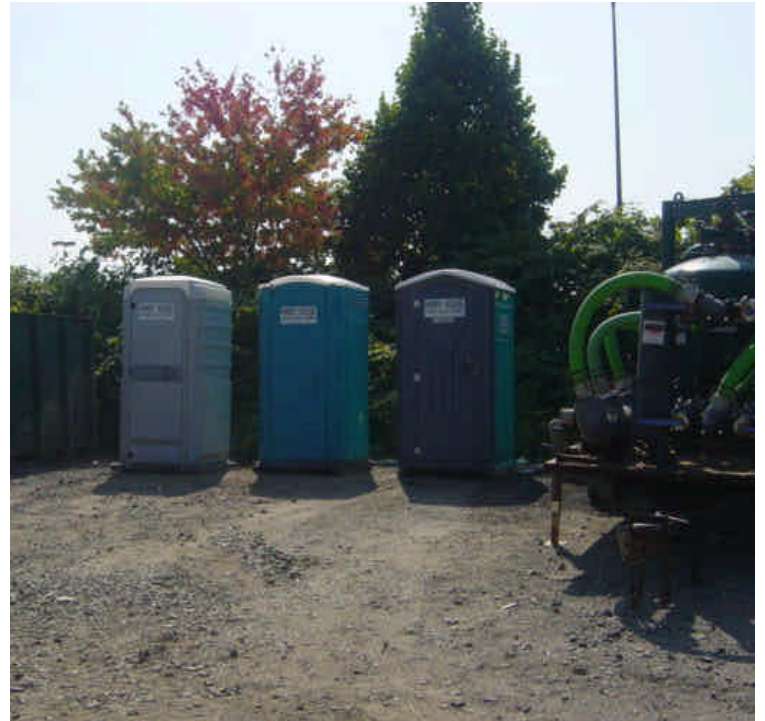
Areas of Inspection	Observation	Recommended Action	Corrected Action
	were previously located within 50-feet of the adjacent watercourse and have been appropriately relocated. 10/04/07	sanitary facilities in an area that is at least 100-feet from the watercourse, if feasible. 10/04/07	facilities have been relocated.
<b>Additional Observations</b>	None 10/04/07	None 10/04/07	NA

Portable sanitary facilities at the King's Highway lay-down yard were relocated away from the nearby watercourse.
