**Docket No. 272 – Development and Management Plan Inspection**

**Beseck Switching Station Inspection**

**Date:** September 4, 2007

**Location:** Beseck Switching Station

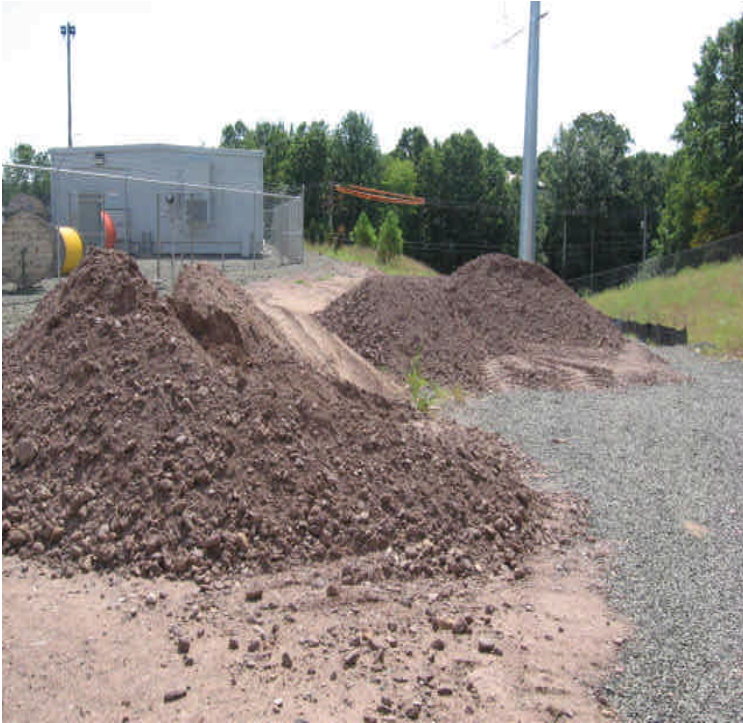
<b>Previous access to the west of the site has been re-established by 1A contractors. Soil stockpiles remain along the access. Haybales remain across the site entrance and mulch/seed remain on exposed soils. 9/4/07</b>	<b>Even though work in this area was previously listed as part of Beseck activities, 1A contractors are now responsible for active work here. Please review 1A reports for more information. 9/4/07</b>	<b>NA- Not jurisdictional to this report. Please see 1A reports for details.</b>

**A view of stockpiles along the western access road.**

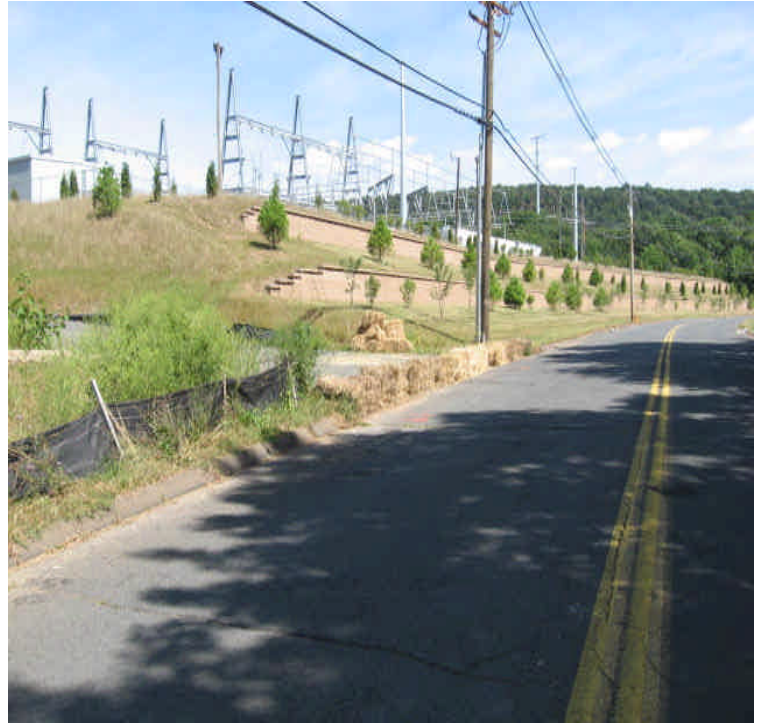
**Haybales remain in place across the western site access drive.**

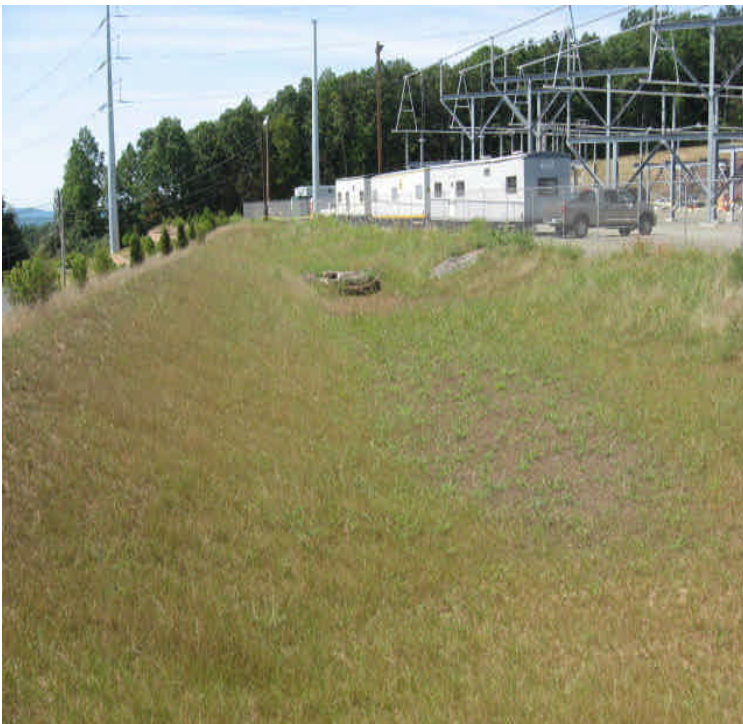
**View of the detention basin and sediment trap. Vegetative cover was well established**

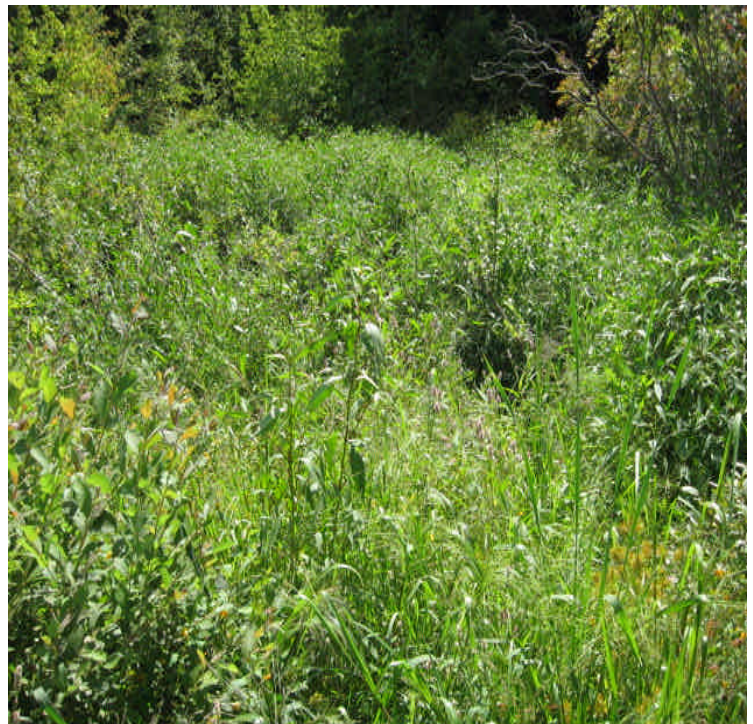
<p><b>Inland Wetland and Watercourse encroachment and mitigation</b></p>	<p><b>Sediment accumulation was noted within the outlet and wetlands across Carpenter Lane. Haybales still don't appear capable of containing all sediment during peak flows. The wetland has revegetated and is stable over the area of accumulated sediment. It appears removal of sediment would cause more disturbance at this point. 9/4/07</b></p>	<p><b>Several areas in the wetland have sediment accumulation as a result of past run-off from the site. Due to the full vegetative cover in the wetlands, it is not advised to remove sediment from the wetlands at this time. When sediment was visible, the area had standing water. Now that the water has receded, vegetative cover is in place. However, sediment accumulation at the culvert should be removed by hand as soon</b></p>	<p><b>Needs attention at the culvert during optimal dry weather.</b></p>

**View of the vegetative cover that has established within the wetlands across Carpenter Lane.**

Areas of Inspection	Observation	Recommended Action	Corrected Action
		<p>as possible as the drain and wetlands are dry. Upon finalization of all work areas on and adjacent to the site, haybales should be removed and the area seeded with a wetland seed mix. 9/4/07</p>	
<p>State species of concern, threatened and endangered species.</p>	<p>According to the D&amp;M plan, state-listed species are not located in this work area. 9/4/07</p> <p>Several different species of frogs, turtles, and salamanders have been noted in wetlands south of Carpenter Ln. and east of Beseck this spring and last year. 9/4/07</p>	<p>None. 9/4/07</p> <p>Although these species were not state-listed, it indicates good habitat. Continue to make good efforts to reduce impacts to these wetlands to the extent possible. 9/4/07</p>	<p>NA</p> <p>NA</p>
<p>Vegetative clearing or stabilization</p>	<p>Some of the hydroseeded and landscaped areas around site are at the 75% vegetative cover mark. Erosion control mats remain in place on steep slopes. Minor washouts have been noted on the slope located on the western boundary despite the establishing cover. 8/14-9/4/07</p> <p>All grading and landscaping appears complete. 9/4/07</p>	<p>Monitor site closely, especially during heavy rains and continue to make good efforts to stabilize washouts. Continue to monitor the area for vegetative cover, until fully stabilized. Hand seed the sparse areas of vegetation to increase stabilization as needed. 9/4/07</p> <p>Monitor areas for full stabilization. 9/4/07</p>	<p>Grass cover is almost fully established in hydroseeded areas. Washouts need attention when feasible</p> <p>NA</p>
