Docket No. 272 – Development and Management Plan Inspection

Beseck Switching Station Inspection

Date: September 11, 2007

Location: Beseck Switching Station

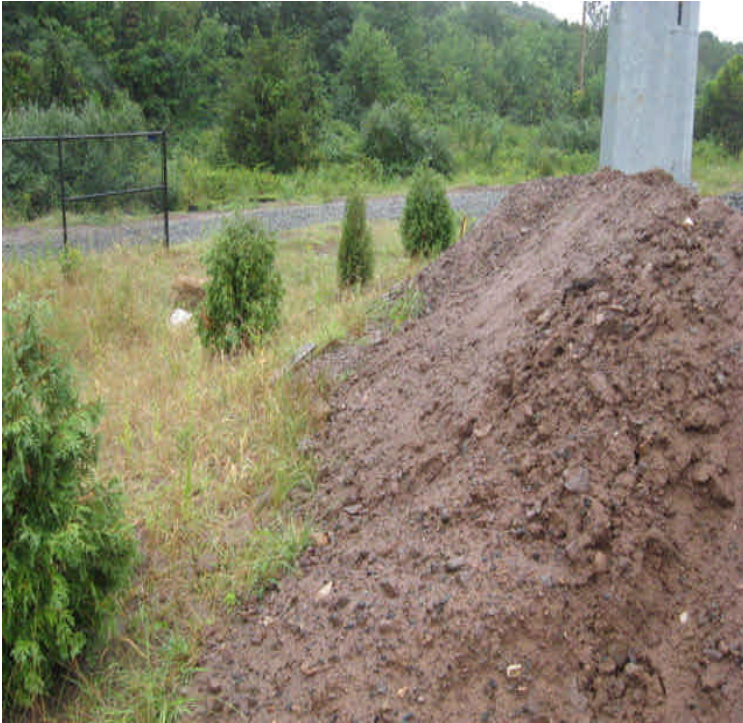
A view of stockpiles now noted in the eastern access road.

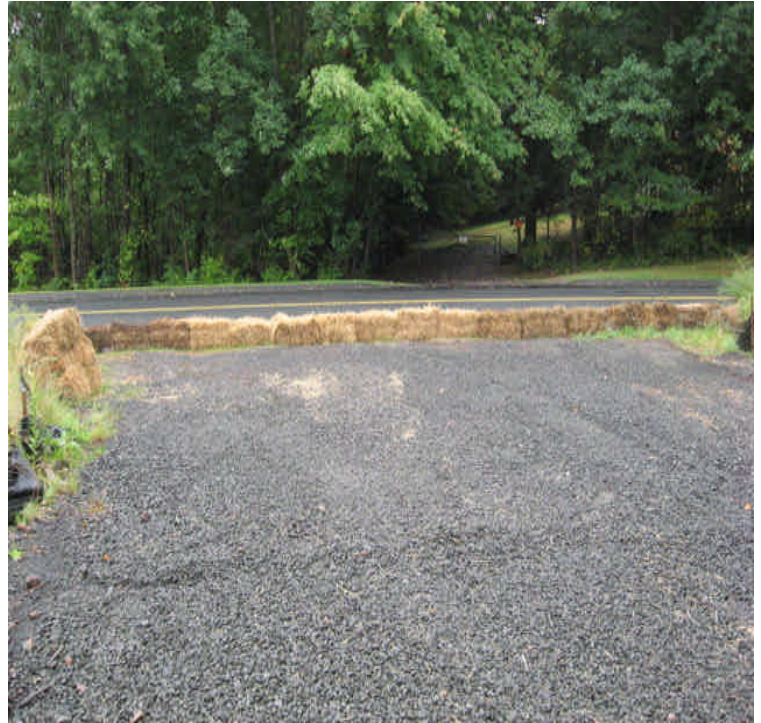
Previous access to the west of the site has been re-established by 1A contractors. Soil stockpiles remain along the access. Haybales remain across the site	Even though work in this area was previously listed as part of Beseck activities, 1A contractors are now responsible for active work here. Please review 1A reports for	NA- Not jurisdictional to this report. Please see 1A reports for details.

Haybales remain in place across the western site access drive.

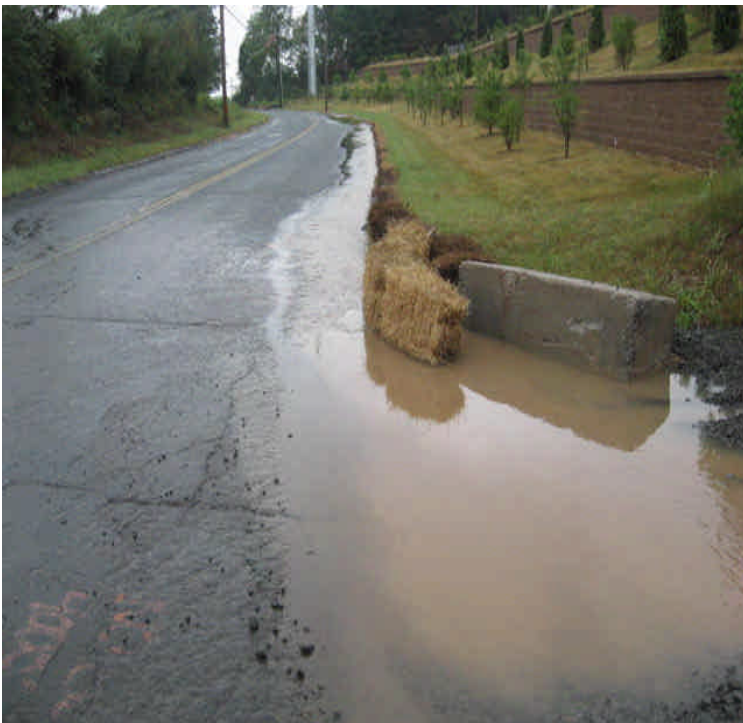
Areas of Inspection	Observation	Recommended Action	Corrected Action
Access roads and adjacent roadways	Turbid water was noted flowing from the eastern site entrance after a period of heavy rain. Sediment onsite is fine and difficult to control during larger storms. A few haybales remain in place but run-off was flowing around to the offsite catch basins. 9/11/07	Continue to monitor controls in an attempt to contain and filter the run-off until the site is fully stabilized. Stone should be refreshed as needed. If soil/stockpiles exposed by 1A contractors need additional controls to prevent run-off, they should be involved in the solutions here. 9/11/07	Needs regular attention
	Stone was placed in the eroded channels/washouts along the western site entrance. 9/11/07	Continue to monitor the area for washouts and turbid run-off. 9/11/07	Stone was added to the access road washouts.
	The stone access east of Beseck remains in place to reduce tracking to the main pad. Turbid run-off was noted ponding on the access. 9/11/07	Continue to maintain and work out schedule with 1A contractors to share responsibility. 9/11/07	Not Applicable (NA)

Turbid run-off at the eastern site access during the storm which brought over 1-inch of rain. Despite all the stabilization measures, exposed soil is still creating run-off issues from the site. If 1A contractors are creating stockpiles, as part of their work, they will have to be part of solutions here.

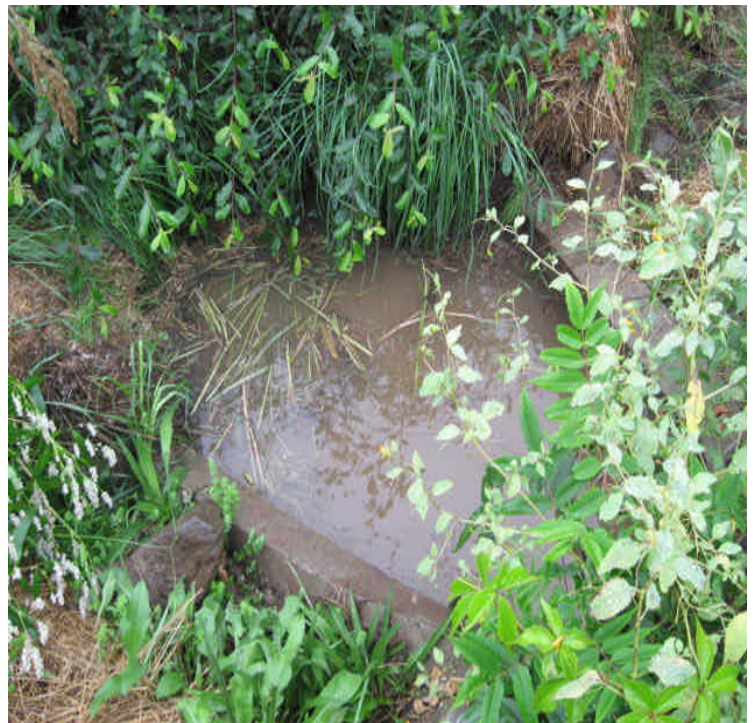
<p>Inland Wetland and Watercourse encroachment and mitigation</p>	<p>Sediment accumulation was noted within the wetlands across Carpenter Lane. Haybales still don't appear capable of containing all sediment during peak flows. The wetland has revegetated and is stable over the area of accumulated sediment. It appears removal of sediment would cause more disturbance at this point. Turbid water was present in the wetlands again due to a 1"+ storm 9/11/07</p>	<p>Several areas in the wetland have sediment accumulation as a result of past run-off from the site. Due to the full vegetative cover in the wetlands, it is not advised to remove sediment from the wetlands at this time. Upon finalization of all work areas on and adjacent to the site, haybales should be removed and the area seeded with a wetland seed mix. 9/11/07</p>	<p>Continue to evaluate and add controls as needed.</p> <p>Sediment was removed from the drain outlet prior to the storm.</p>

Turbid water starting to fill the storm drain across Carpenter Lane.
