Docket No. 272 – Development and Management Plan Inspection

Beseck Switching Station Inspection

Date: September 25, 2007

Location: Beseck Switching Station

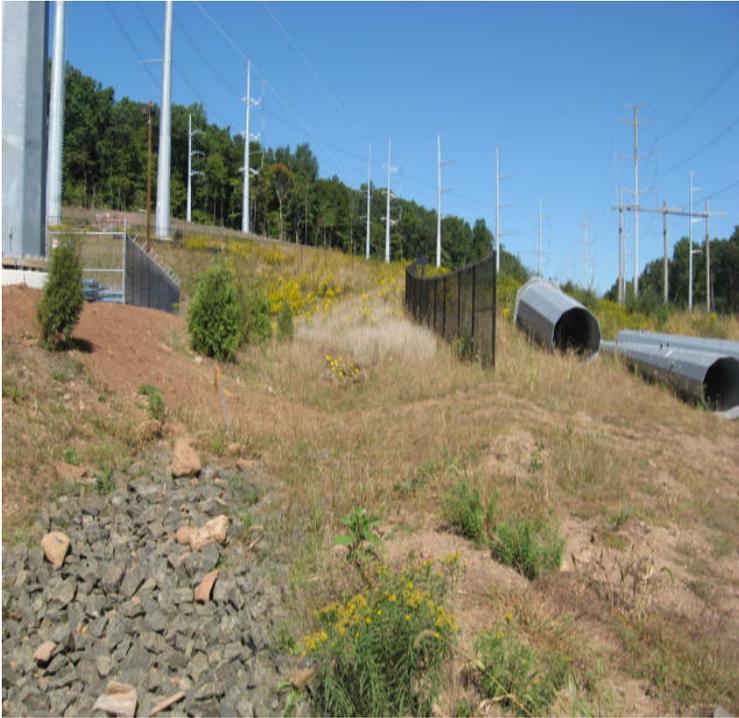
Soil stockpile was removed along the eastern access road (1A responsibility) and eroded channel was filled.

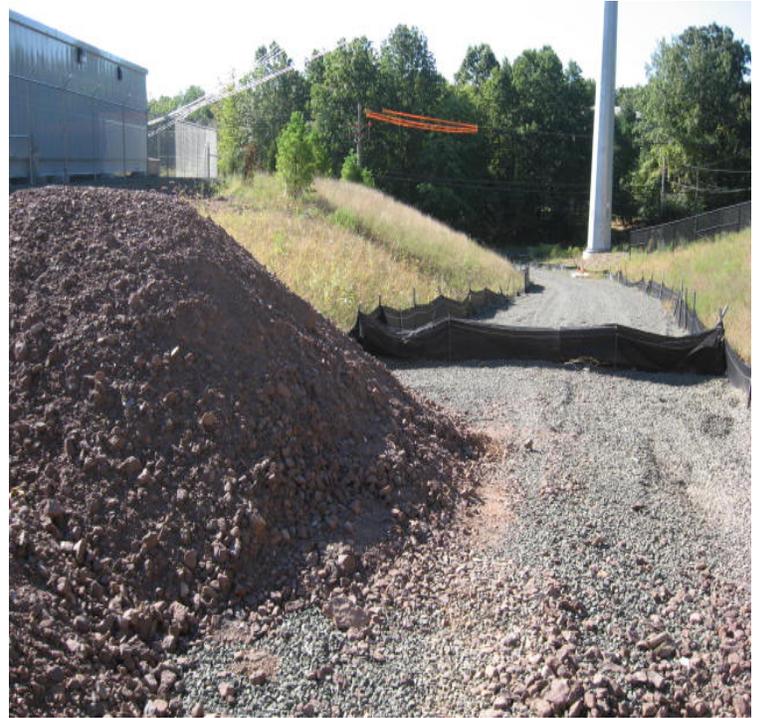
View of the stockpile and small washouts/eroded channels at the western access drive. Silt fence installed and several washouts filled.

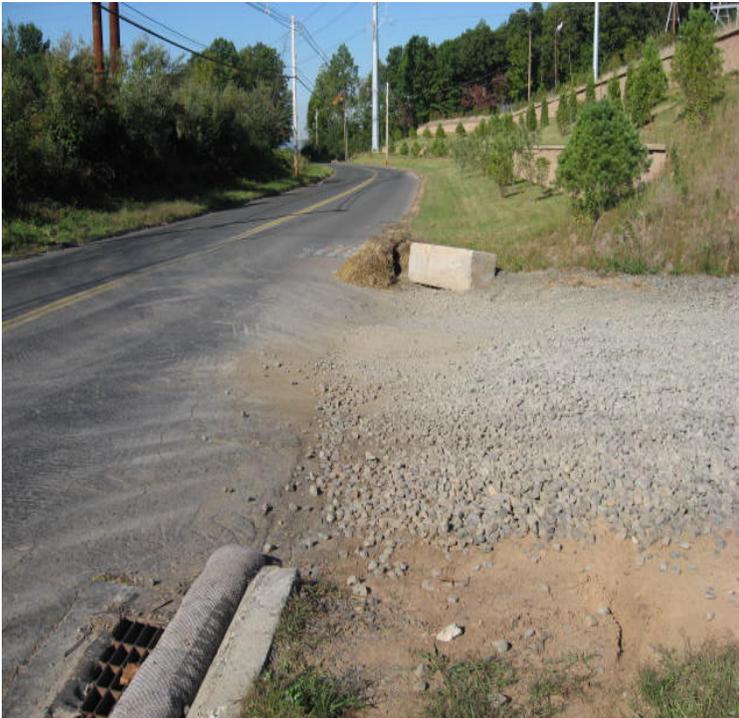
View of the eastern site entrance. The roadway had been recently swept and no run-off was observed.

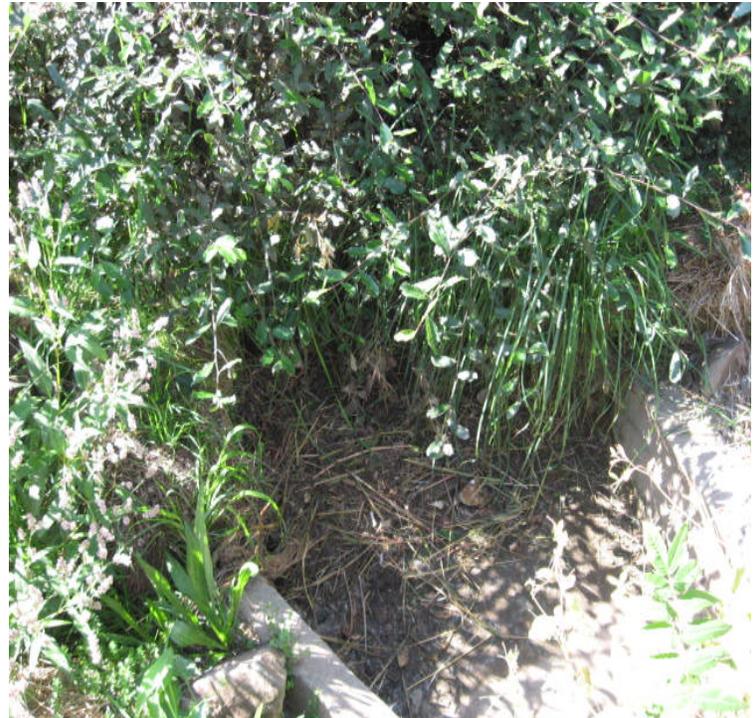
View of the dry storm drain at Carpenter Lane. Continue to remove sediment as needed.
