**Docket No. 272 – Development and Management Plan Inspection**

**East Devon Substation Inspection**

**Date:** September 14, 2007

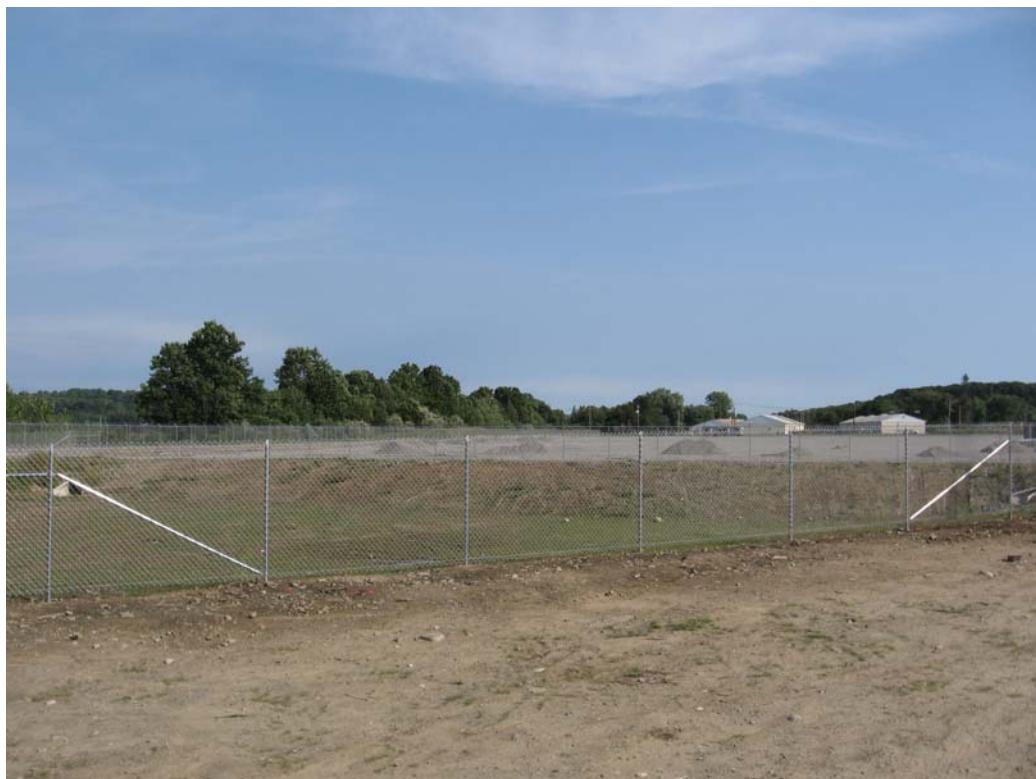
A view of the Substation site from the southern boundary.
