**Docket No. 272 – Development and Management Plan Inspection**

**East Devon Substation Inspection**

**Date:** September 28, 2007

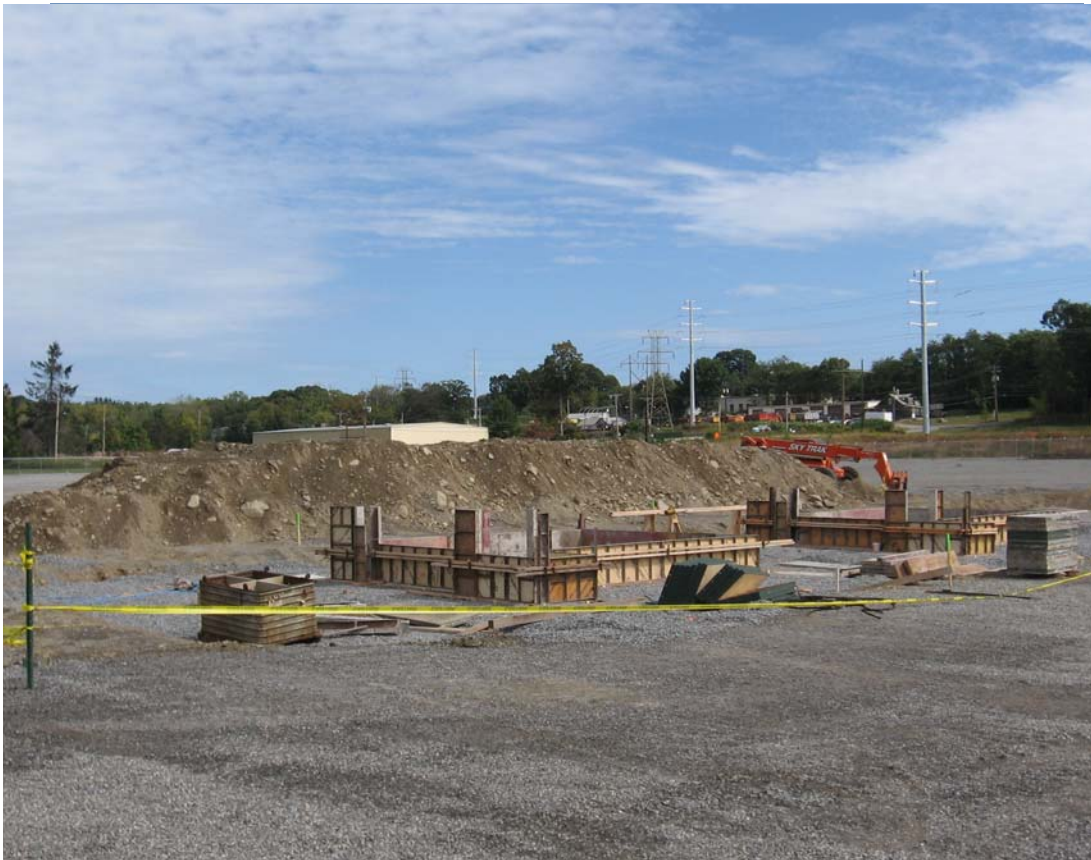
Foundation and site construction	Foundation work has begun this week. 9/28/07	None at this time. 9/28/07	NA
Erosion and Sediment Controls	The retaining wall and mulch berm continue to contain soils and prevent off site sedimentation.	Continue to monitor and improve controls as necessary. 9/28/07	NA at this time

A view of the foundation work at the East Devon Substation.
