Docket No. 272 – Development and Management Plan Inspection

The Connecticut Light and Power Company Certificate of Environmental Compatibility and Public Need for the construction of a new 345-kV electric transmission line and associated facilities between Scovill Rock Switching Station in Middletown and Norwalk Substation in Norwalk, Connecticut, including reconstruction of portions of existing 115-kV and 345-kV electric transmission line, the construction of Beseck Switching Station in Wallingford, East Devon Substation in Milford, (and Singer Substation in Bridgeport), modifications at Scovill Rock Switching Station and Norwalk Substation, and the reconfiguration of certain interconnections.

Segment 1a Inspection

Date: September 10, 2007

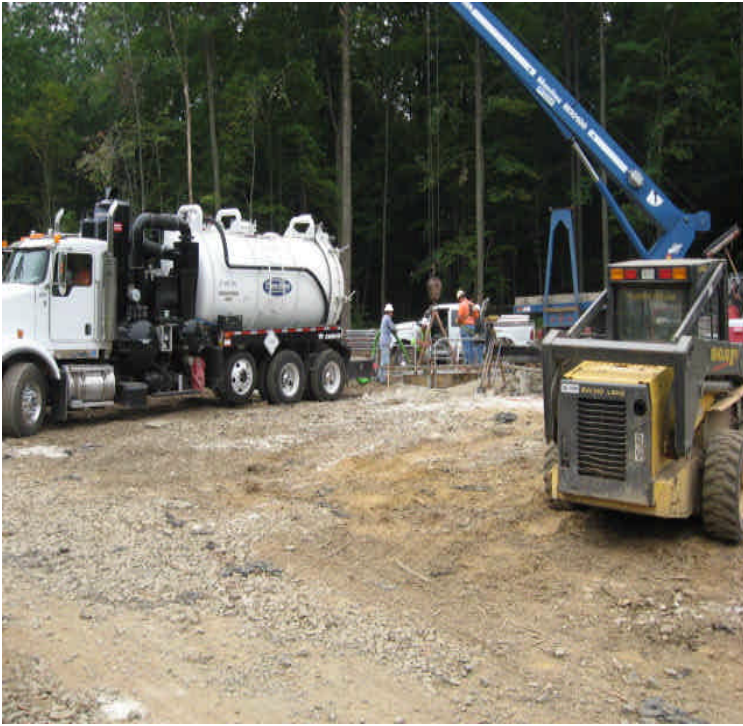
Shunpike Rd: Crews were dewatering a foundation and pumping into a settling tank for containment.

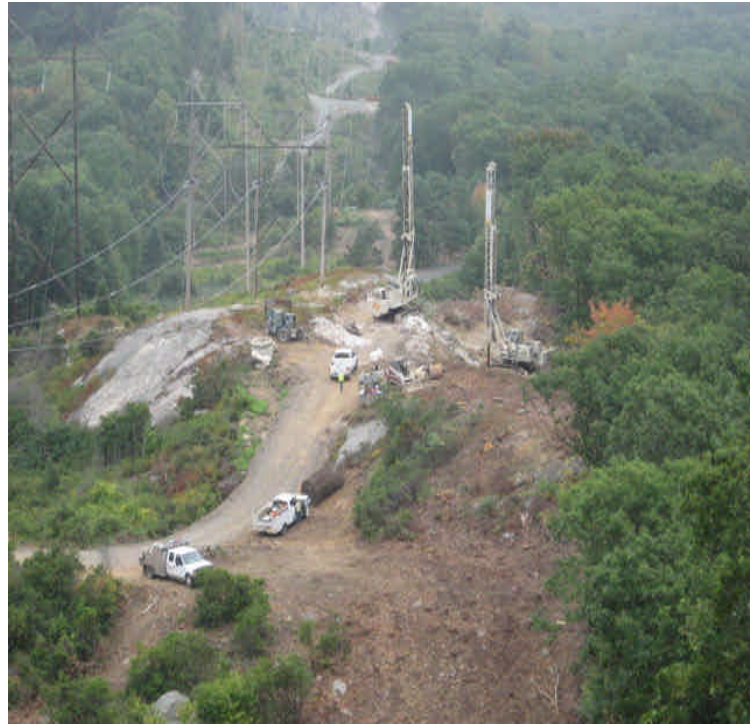
Shunpike Rd: View of drilling and foundation installation.

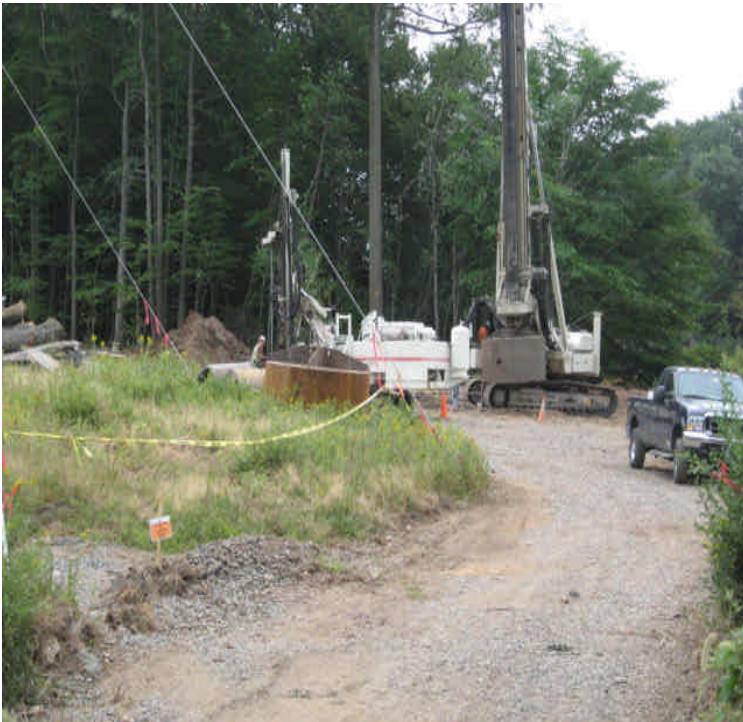
Bartholomew Rd: Crews were drilling a new foundation.

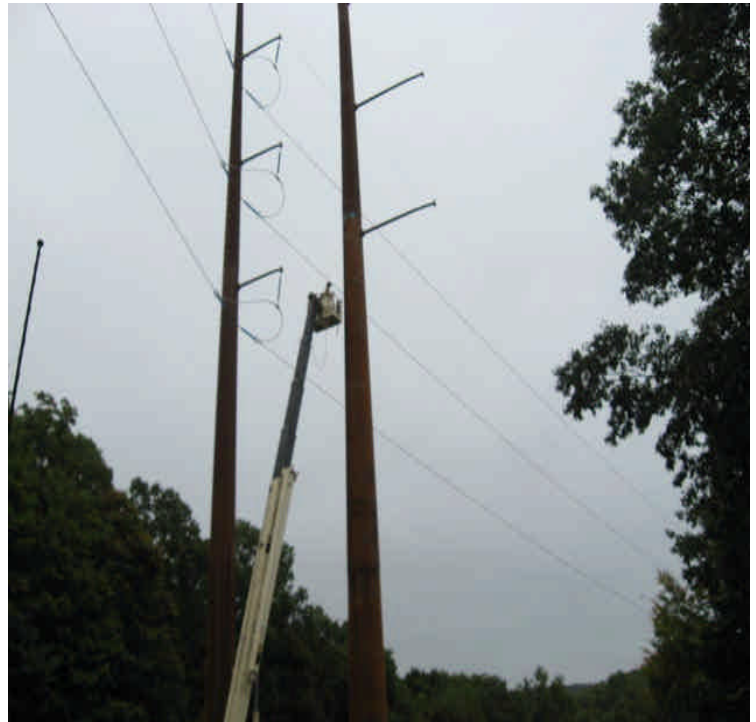
Black Walnut Dr: Crews were performing wire work; Installing pull boxes.

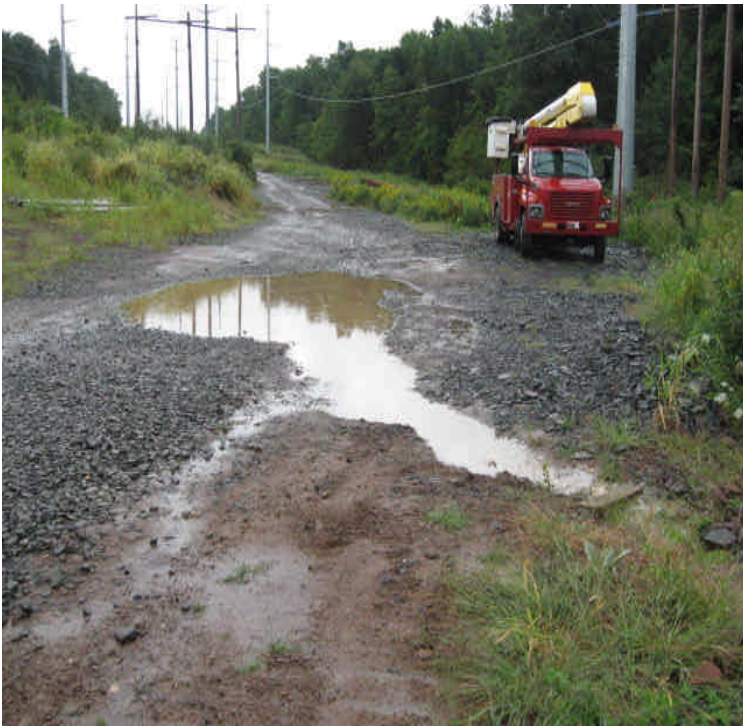
Carpenter Lane (north): Turbid water was noted flowing off-site during a heavy rain storm on 9/11/07.

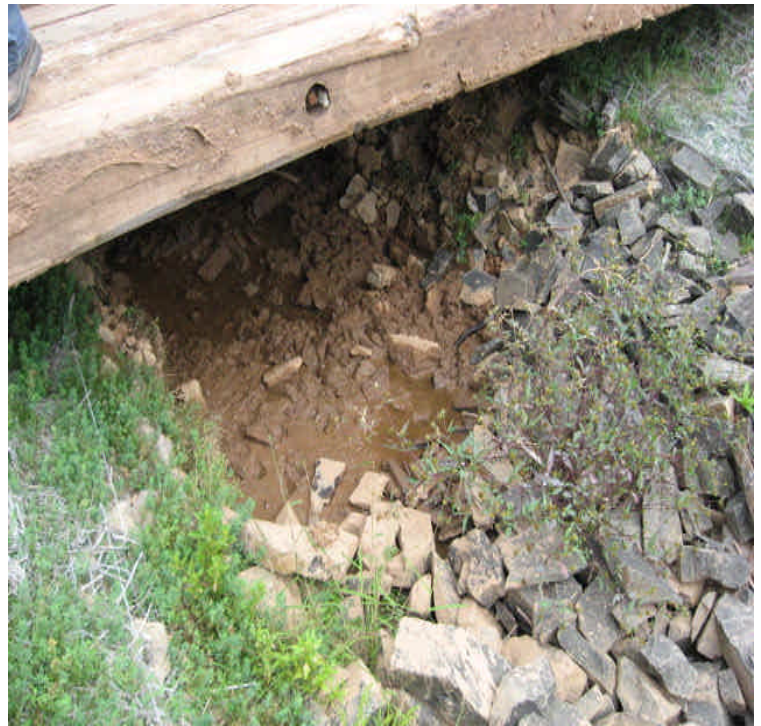
East Meriden SS (North): Timber mats were recently relocated and placed over the riprap stream bypass. This caused sediment to fall from the underside and accumulate in the channel.

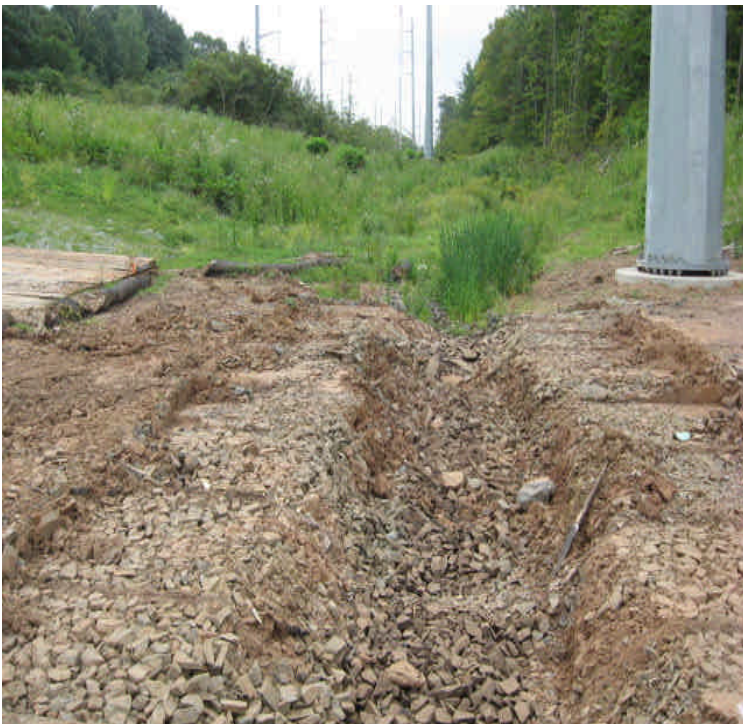
East Meriden SS (North): The original stream channel that had been filled/redirected for the work was carved out. Remove remaining fill and stabilize the adjacent areas. Remove the riprap bypass before accessing or working at the new pad site.

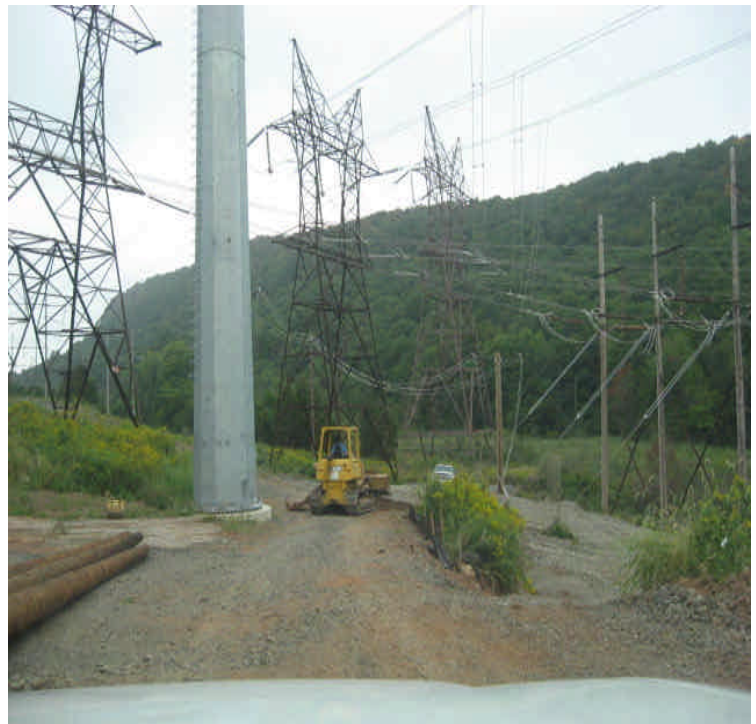
Black Pond Jct: New pad site is in place at the edge/within wetlands.
