Docket No. 272 – Development and Management Plan Inspection

Segment 1b (Royal Oaks Bypass) Inspection

Date: September 4, 2007

Field Inspector: Matt Creighton, BSC Group

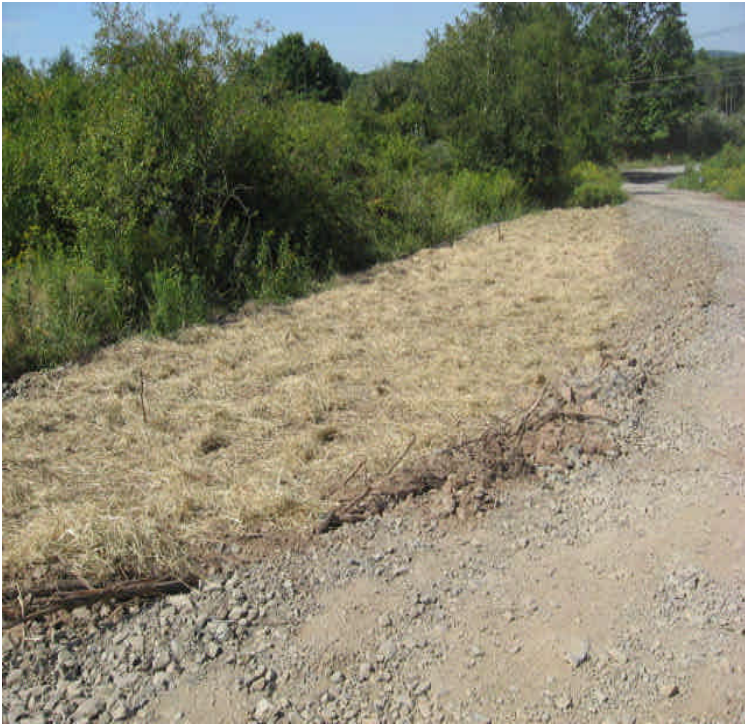
A portion of the access road has been removed and graded. The area along the road was mulched and seeded.

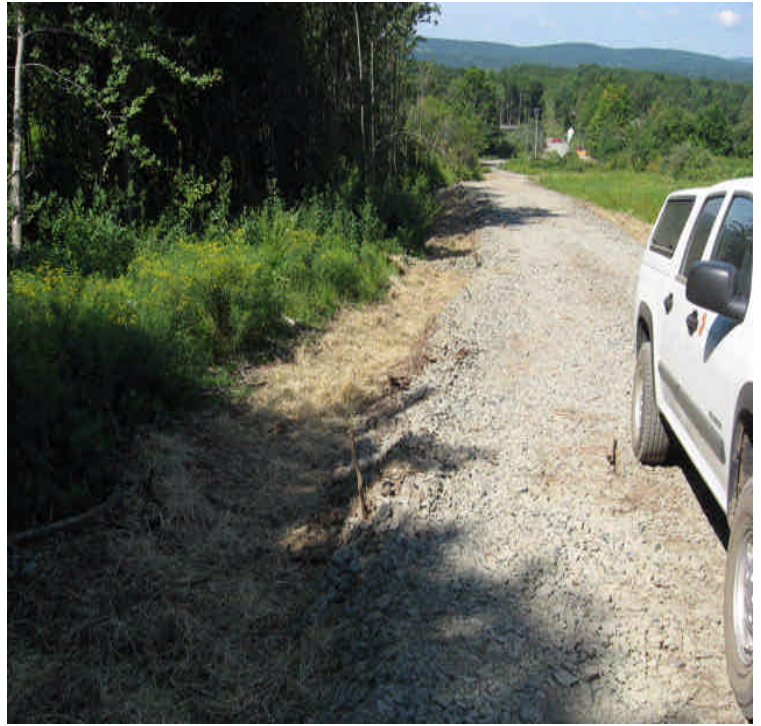
View of a drainage channel along the road with check dams, hay mulch and seed.

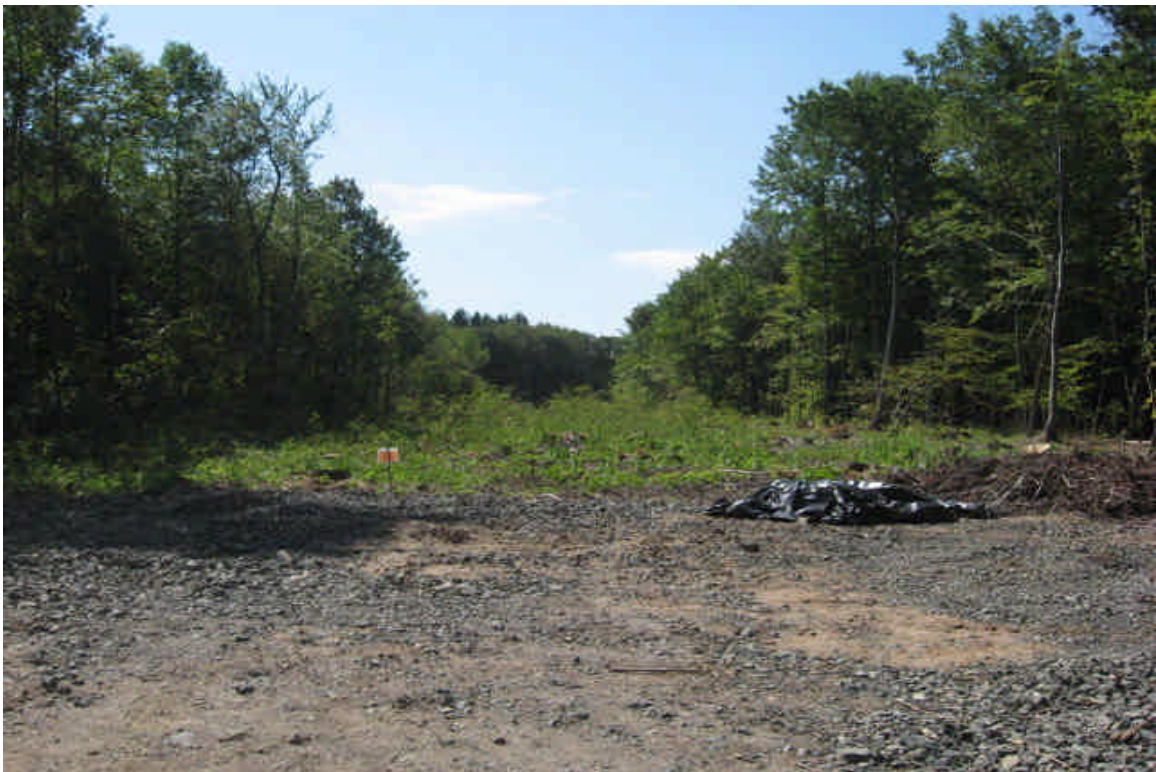
View looking across the no access area towards Little Lane. Regrowth of vegetative cover was noted.
