Docket No. 272 – Development and Management Plan Inspection

Segment 1b (Royal Oaks Bypass) Inspection

Date: September 10, 2007

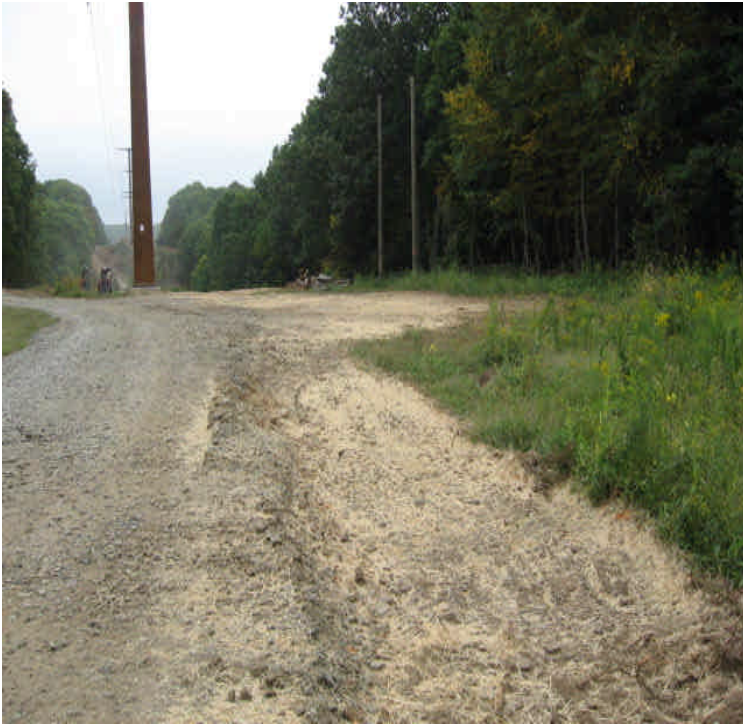
A section of the access road has been removed and graded. The area along the road was mulched and seeded.

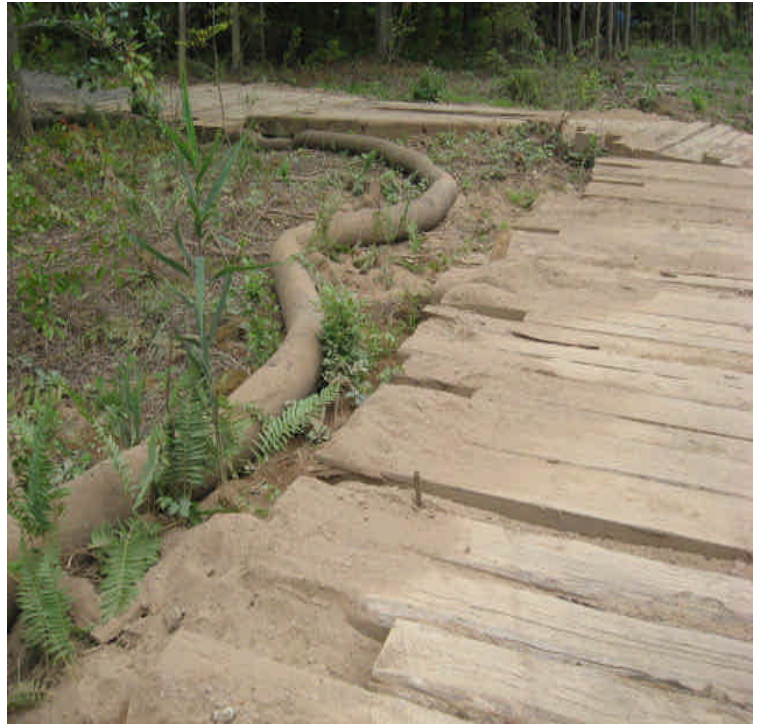
Timber mats were cleaned. However, some of the sediment has migrated to the controls and edge of the mat within the wetland.

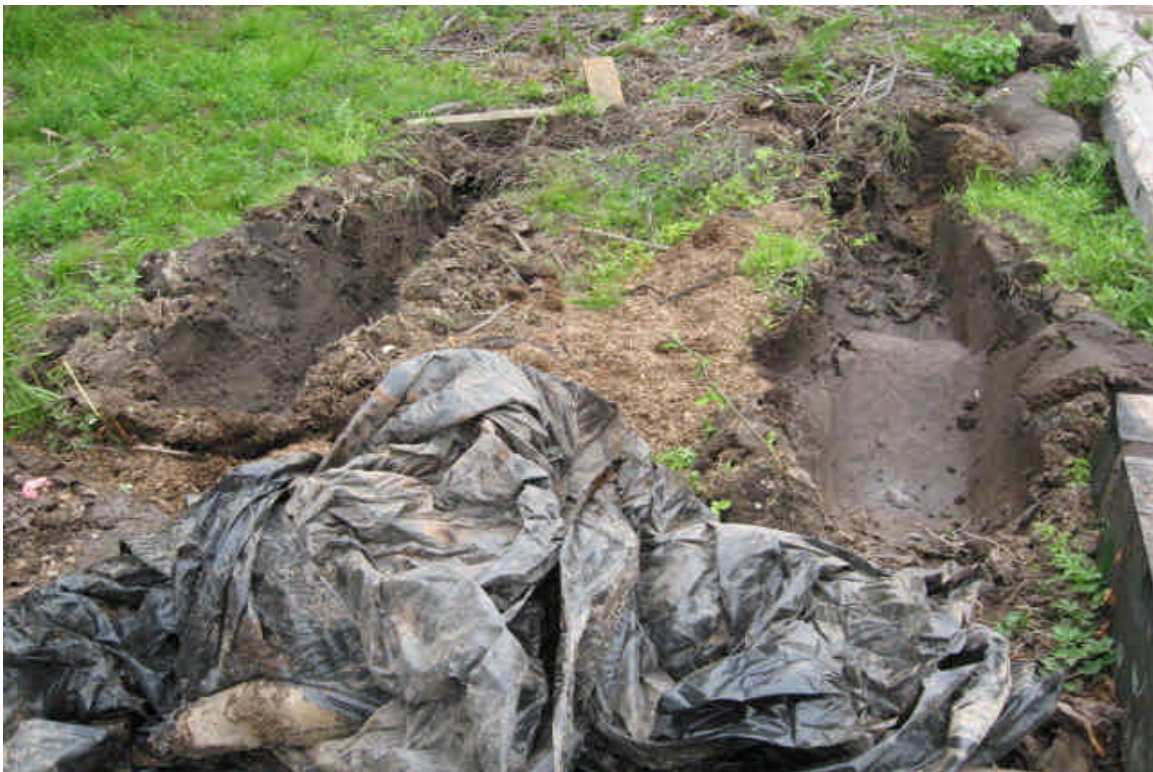
Looking across the no access area towards Little Lane. Some deep equipment ruts were noted at the edge. Carefully regrade the area and remove debris.
