Docket No. 272 – Development and Management Plan Inspection

Segment 1b (Royal Oaks Bypass) Inspection

Date: September 17, 2007

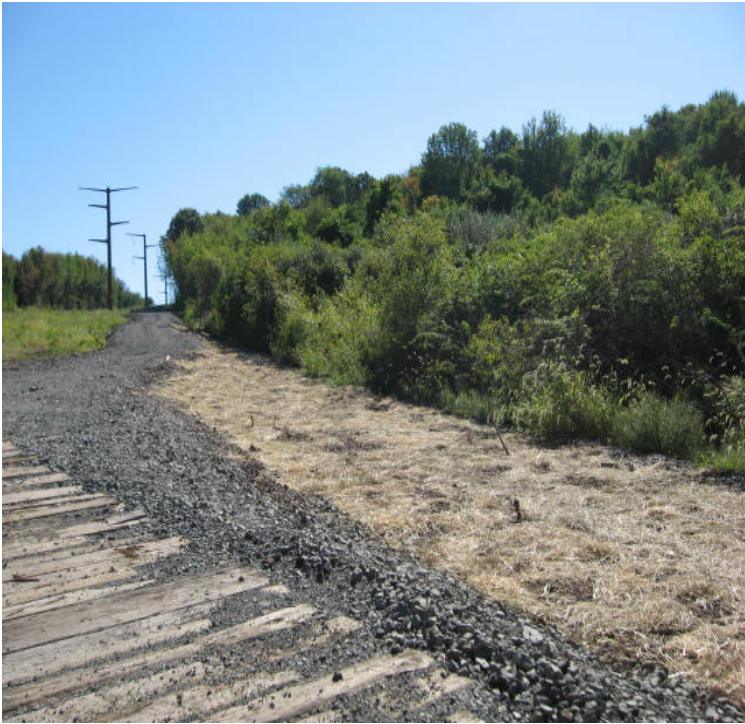
A section of the access road has been removed at Route 17 east. The disturbed area along the road was regraded, mulched, and seeded.

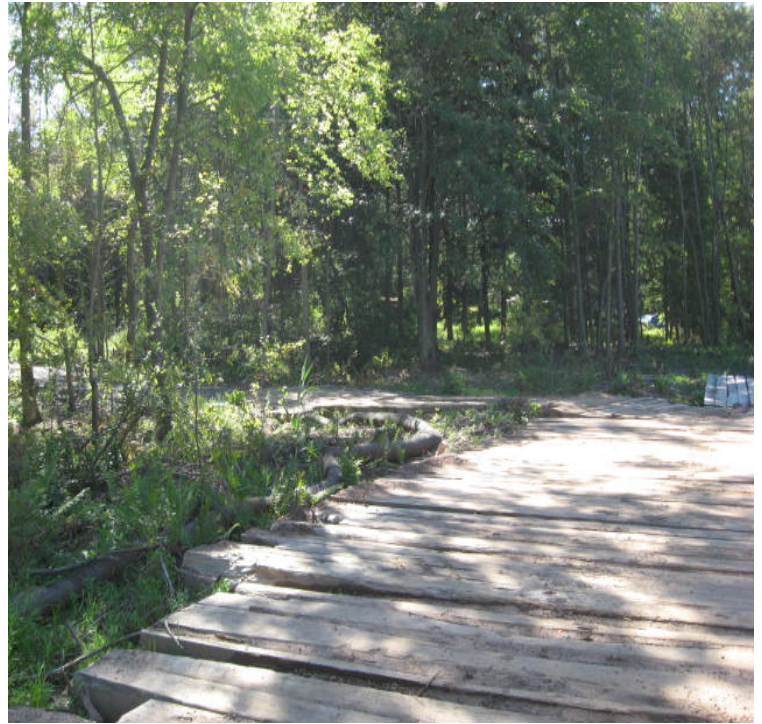
Areas of Inspection	Observation	Recommended Action	Corrected Action
	<p>Sediment tracking from foundation work was swept and removed from timber mats near structure # 24580 (north of the 1A intersection off Little Ln.). However, in the process, some sediment was swept over the controls and into the wetlands. 9/17/07</p> <p>Ruts from equipment were noted under a plastic tarp along the wetland edge at structure # 24580. 9/17/07</p> <p>Grass cover was becoming established in the previously disturbed area connecting two ponds east of Rte 17. 9/17/07</p>	<p>when work is complete. See erosion control section. 9/17/07</p> <p>Monitor and add controls as needed. If feasible, sediment should be removed by hand from the wetland. 9/17/07</p> <p>Remove tarp from wetland and carefully regrade the ruts. Seed the disturbed area with a wetland seed mix.. 9/17/07</p> <p>Continue to monitor area for final stabilization. Consider placing construction fencing to prevent any future impacts. 9/17/07</p>	<p>Sediment was removed from timber mat but some sediment was accidentally swept over controls.</p> <p>Needs attention.</p> <p>Grass cover is establishing.</p>

Timber mats were cleaned near structure #24580, but some sediment was swept over the controls and into the wetland in this section.

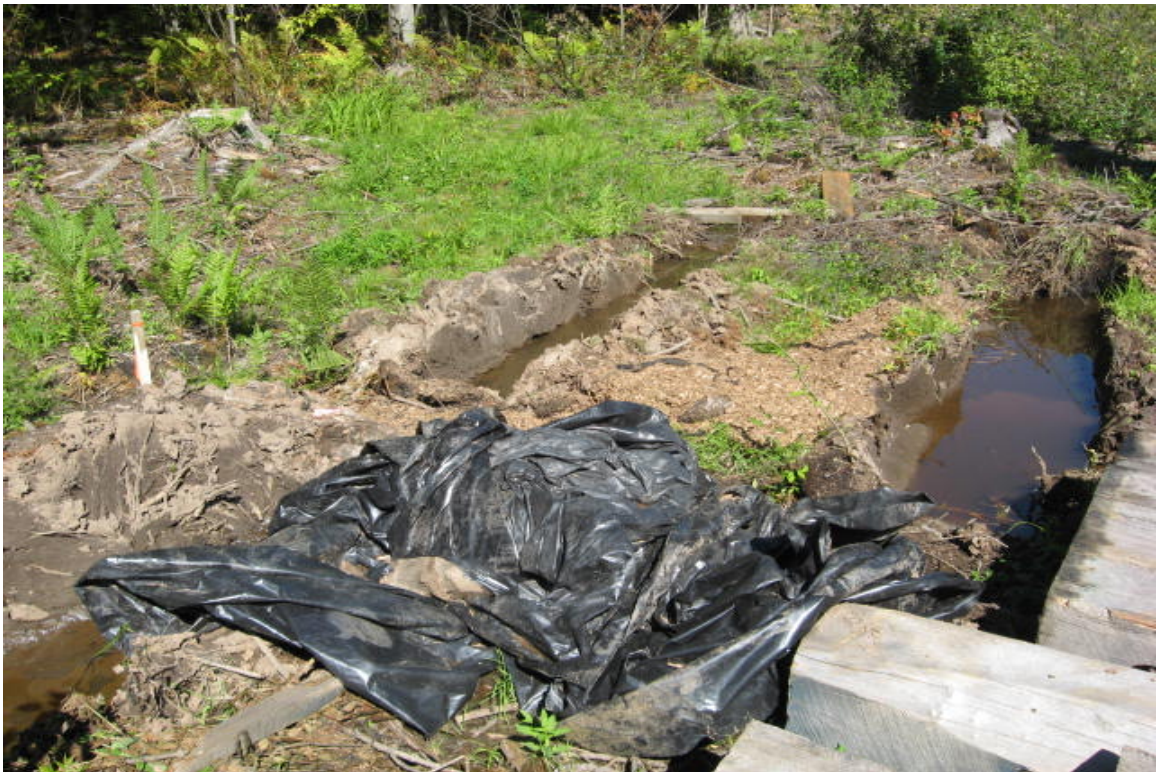
Equipment ruts were noted along the wetland edge within the no access area of Rte 17. Remove tarp from wetland and carefully regrade the ruts. Seed the disturbed area with a wetland seed mix.
