Docket No. 272 – Development and Management Plan Inspection

Segment 1b (Royal Oaks Bypass) Inspection

Date: September 24, 2007

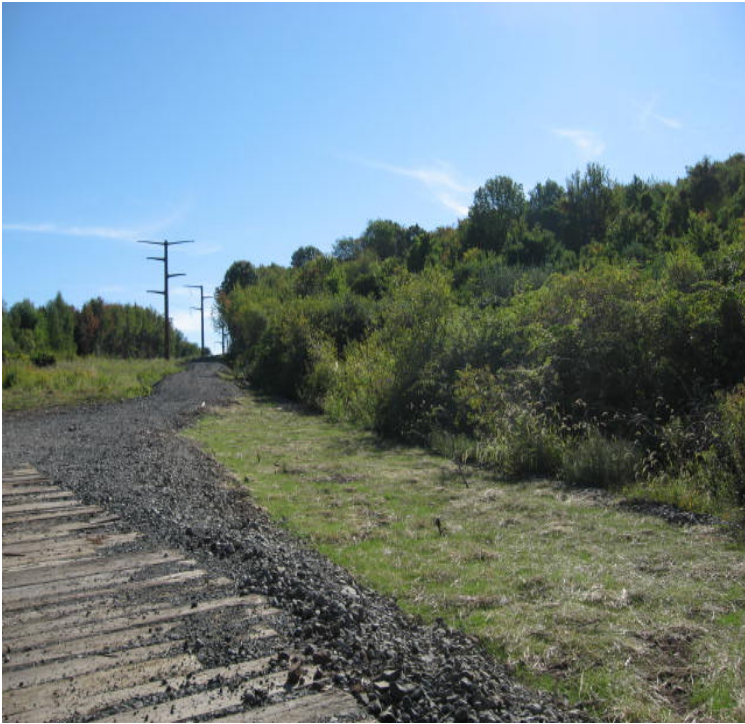
A section of the access road has been removed at Route 17 east. The disturbed area along the road was regraded, mulched, and seeded.

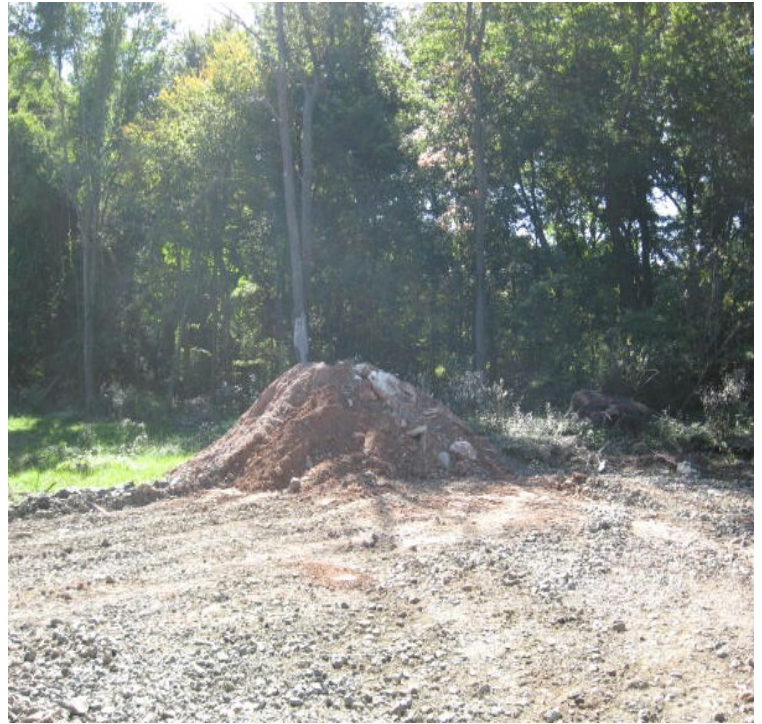
Areas of Inspection	Observation	Recommended Action	Corrected Action
	A soil stockpile was noted near the Black Walnut Drive access. No controls were observed. 9/24/07	Remove pile or add appropriate controls. 9/24/07	Needs attention
Inland Wetland and Watercourse encroachment and mitigation	<p>Access road is in place west of Rte 17 in the receiving yard wetlands. Three streams were crossed with culverts. Controls and mulch are in place adjacent to the roads, culvert flow was currently clear. 9/24/07</p> <p>Timber mat access road in place in wetlands west of Rte. 17 near Little Ln. Equipment ruts were noted under a plastic tarp within the wetlands at the edge of the mats. 9/24/07</p> <p>Sediment tracking/accumulation was removed from timber mats west of Rte 17. However, some of the sediment was swept over controls and into wetlands. Also equipment tracks were noted within the wetlands. 9/24/07</p>	<p>Monitor area closely for erosion and run-off. Add controls as needed to prevent road run-off. Wetland crossings are temporary and material will have to be removed when work is complete. 9/24/07</p> <p>See erosion control & access roads sections. Continue to minimize impacts to the extent possible and add controls as needed. Ruts should be carefully repaired/ regraded and the disturbed area should be seeded. 9/24/07</p> <p>If feasible, sediment should be removed by hand from the wetland. 9/24/07</p>	<p>Needs evaluation.</p> <p>Needs attention.</p> <p>Needs attention.</p>

Soil stockpile noted near Black Walnut Dr. access. Remove pile or add appropriate controls.

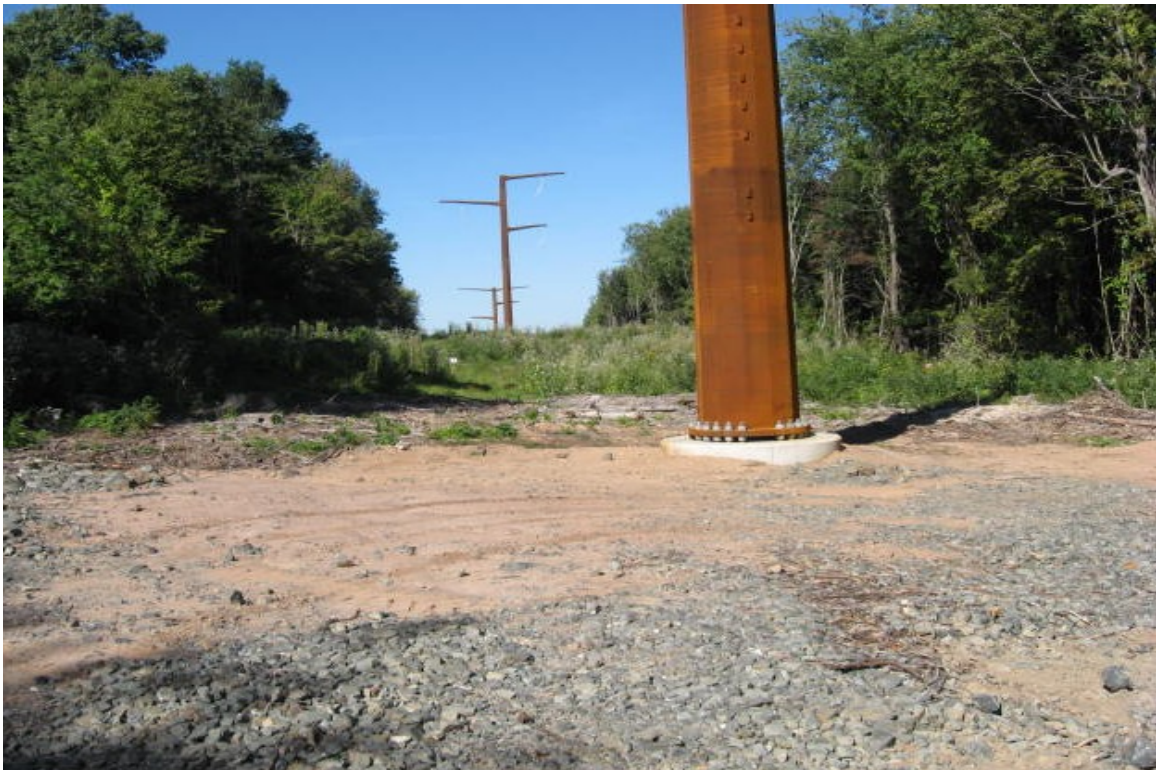
Sediment was noted at the edge of the no access area near the receiving yard this week. 9/24/07	Clean sediment from stone pad if feasible and add controls as necessary. 9/24/07	Needs attention
	Sediment tracking/accumulation noted on timber mats west of Rte 17 (near structure # 24580) was removed. However, some of the sediment was swept over controls and into wetlands. Also equipment tracks were noted within the wetlands. 9/24/07	Monitor and add controls as needed. Regrade the ruts and stabilize the area. See Inland wetland section. 9/24/07	Needs attention

Sediment was observed at the edge of the no access area near the receiving yard. Continue to monitor and add controls as needed.
