Docket No. 272 – Development and Management Plan Inspection

Segment 2a Inspection

Date: September 25, 2007

Location: Segment 2a – Beseck Switching Station to Cheshire/Hamden Town Line

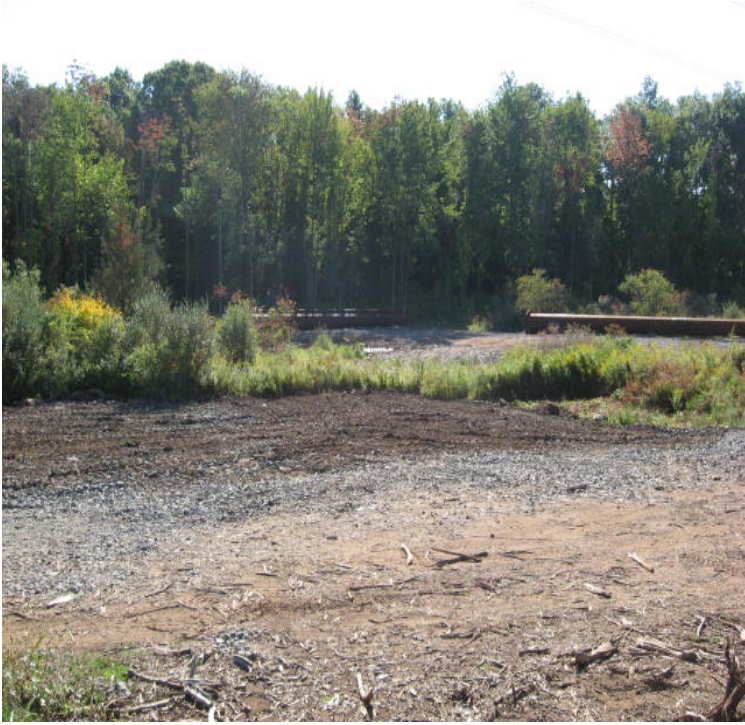
Carpenter Ln: View of the new staging area within the wetlands.

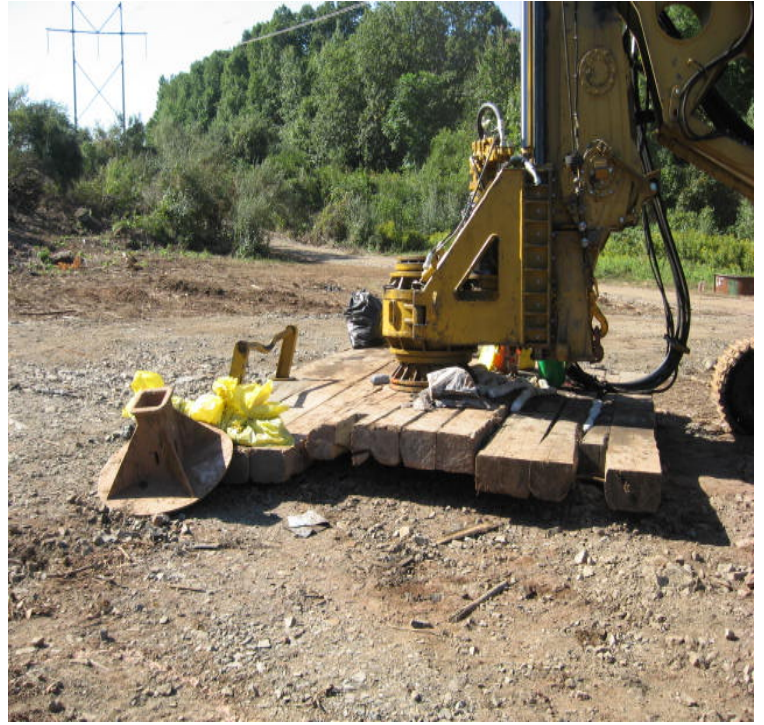
Durham Rd: Leaking equipment was noted here this week. Proper spill controls were in place.

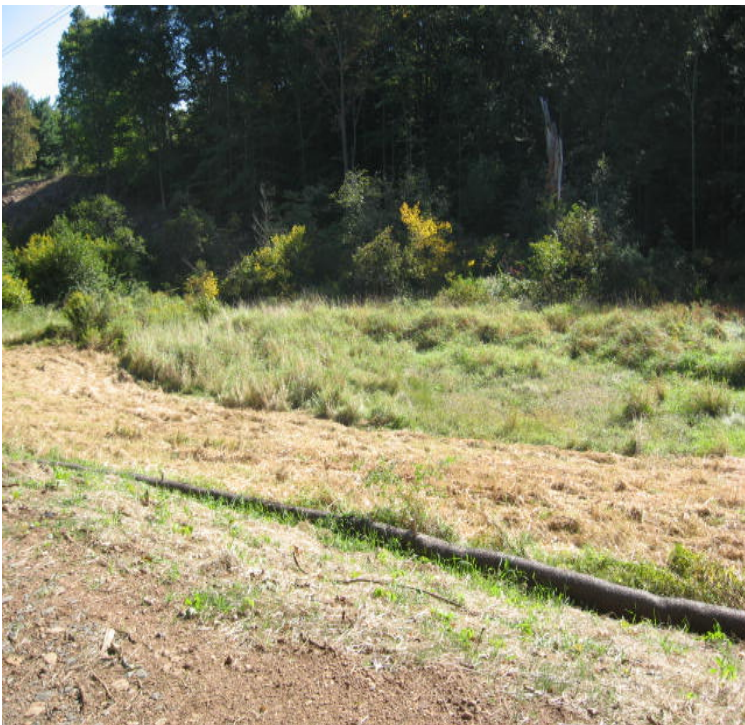
Liney Hall Ln: Fiber rolls remain in place here. Area around pool (amphibian breeding habitat) has been mowed

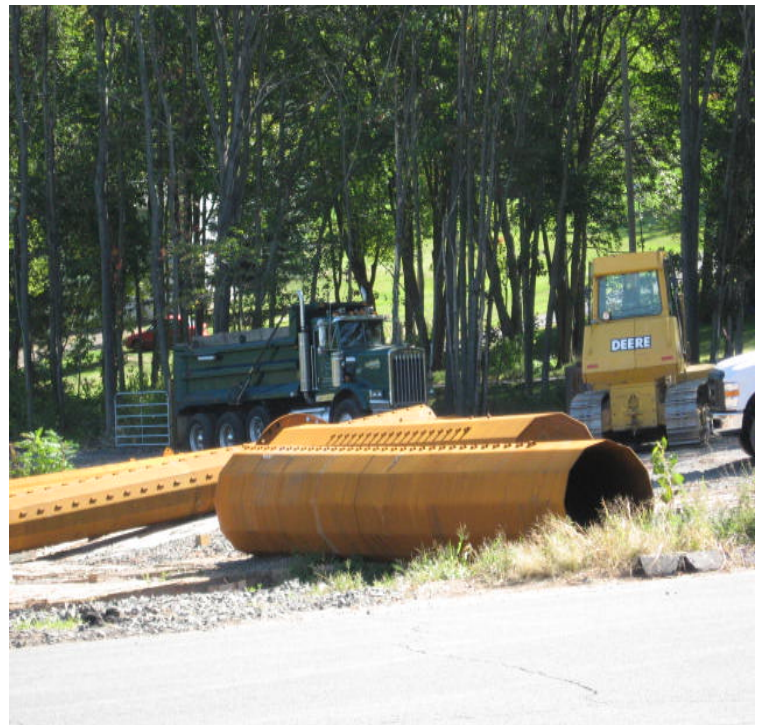
Powers Rd: Restoration efforts continue adjacent to wetlands here.

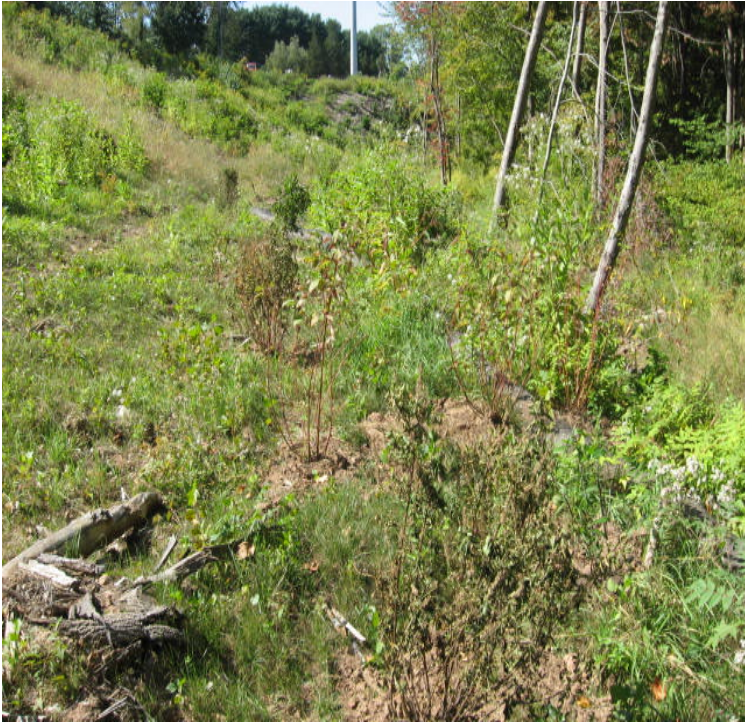
Harrison Rd: Shrubs were planted by hand along the stream channel.

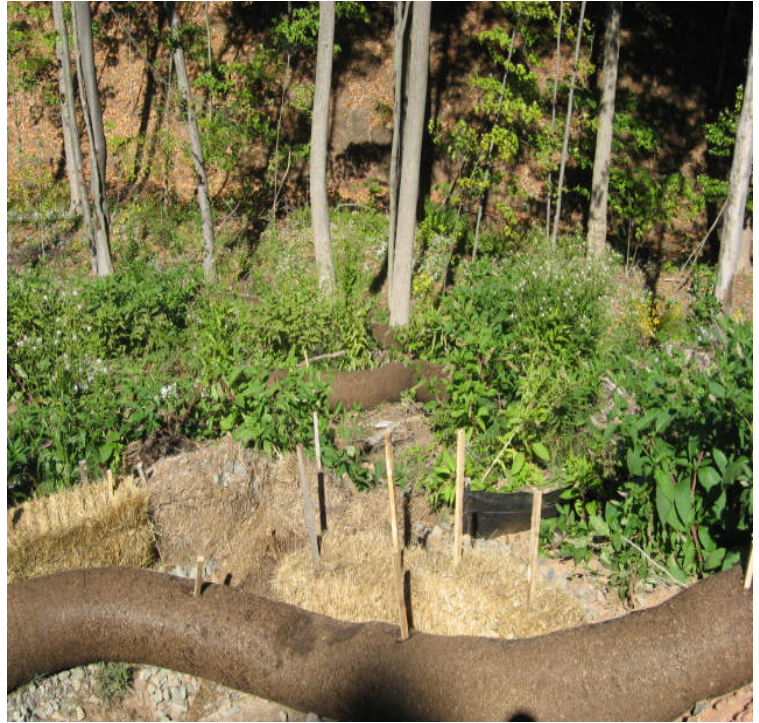
Harrison Rd: Haybales and a silt sock are in place at the sediment trap and along the slope.

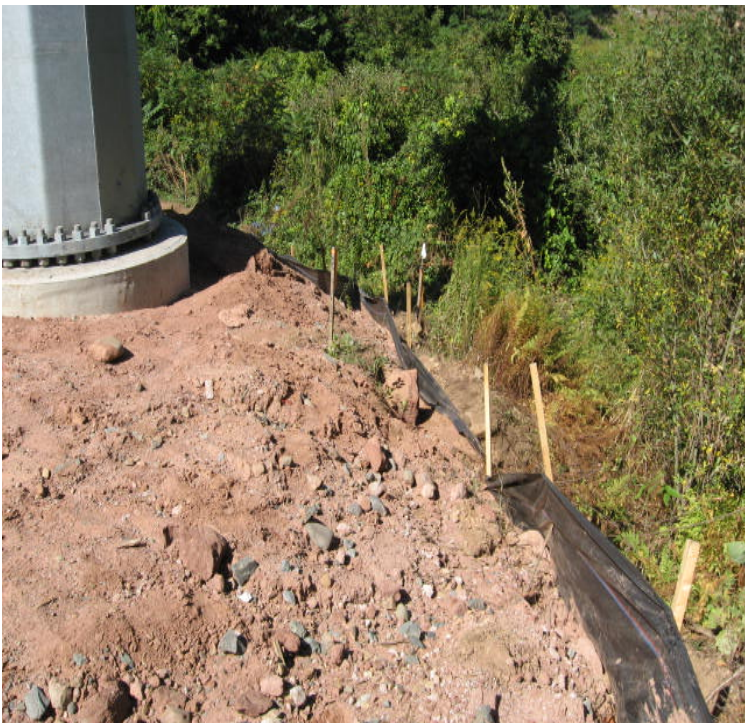
Docker Dr: Exposed soil resulting from recent foundation work has overwhelmed controls near the wetland here.

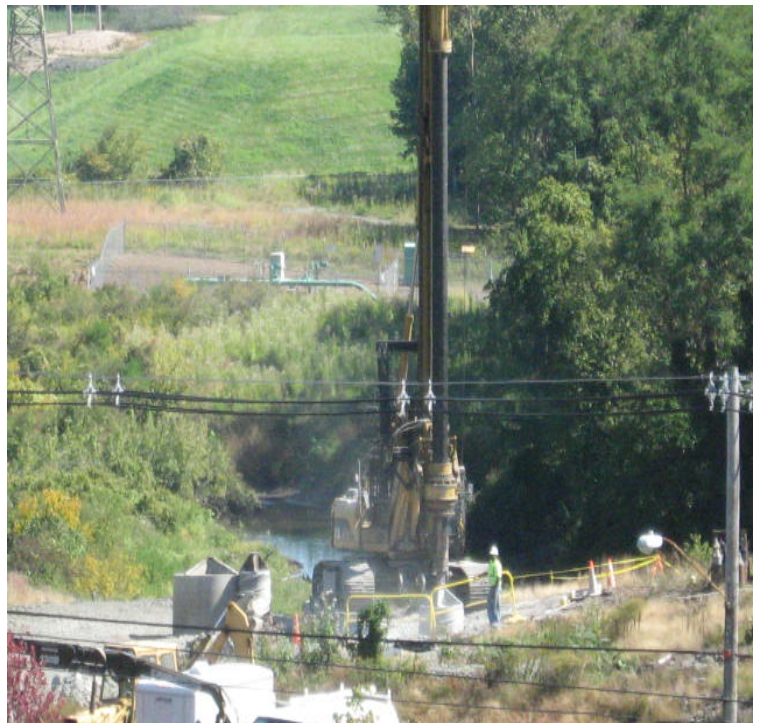
South Turnpike: Foundation drilling continues in this section. Controls are in place.

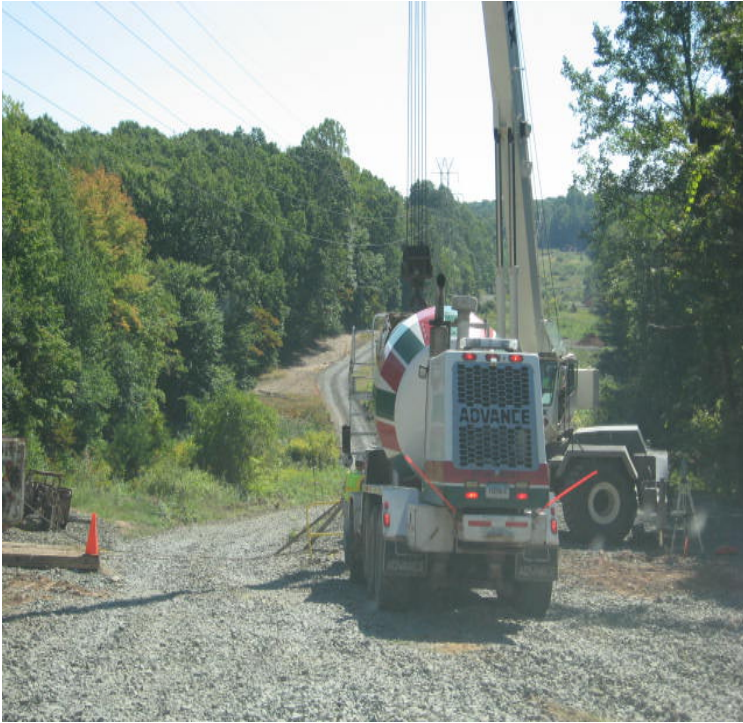
Tuttle Ave: Concrete was being poured here this week.

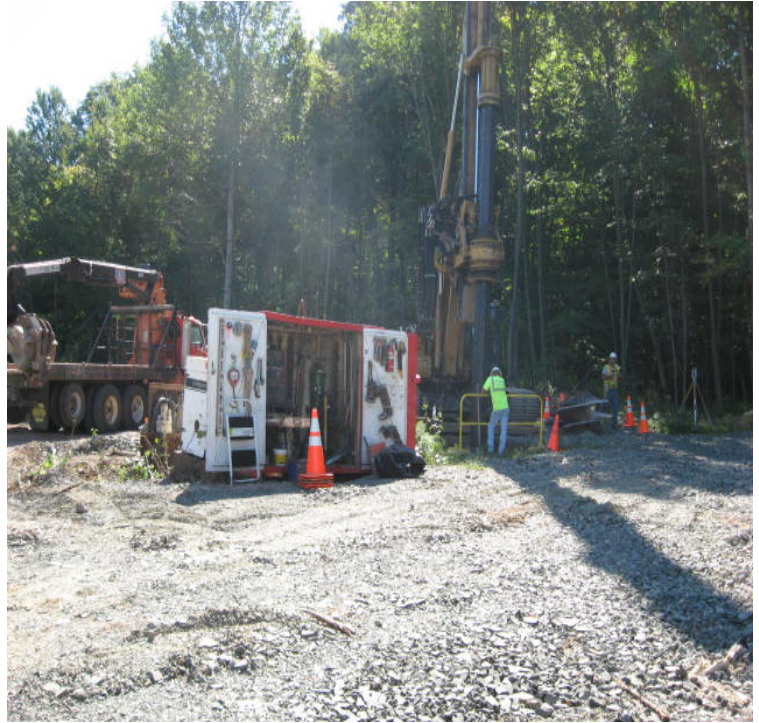
Tuttle Ave: Foundation drilling continues.

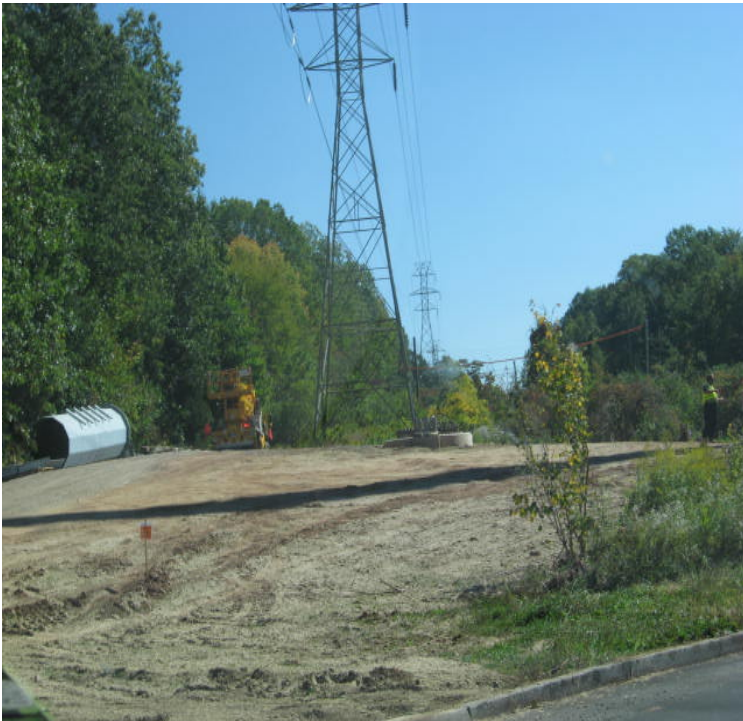
Old Farms Rd: Exposed soils were hydroseeded, but some ruts were noted here.

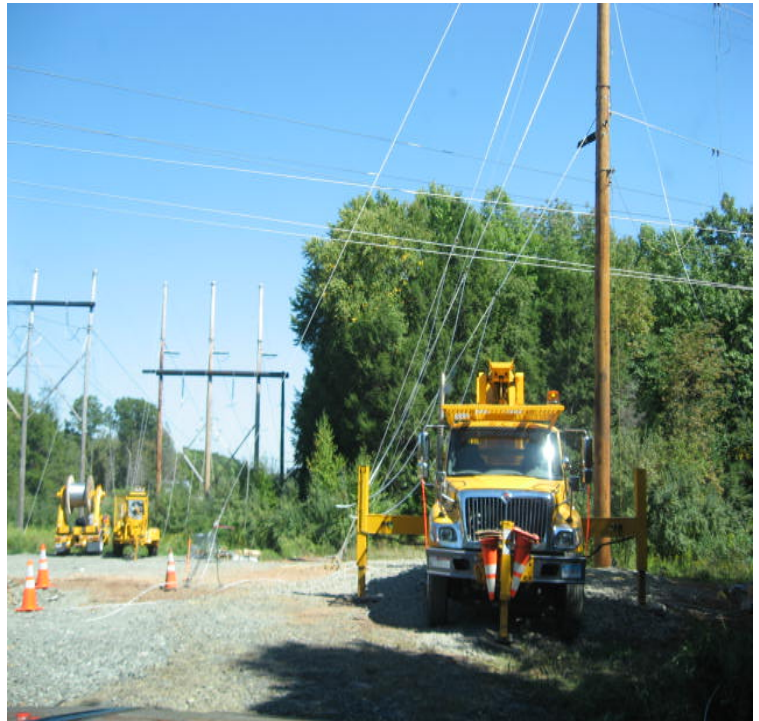
Old Farms Rd: Line pulling equipment is onsite.
