Docket No. 272 – Development and Management Plan Inspection

Segment 2b Inspection

Date: September 6, 2007

Location: Segment 2b – Cheshire/Hamden Town Line to East Devon Substation

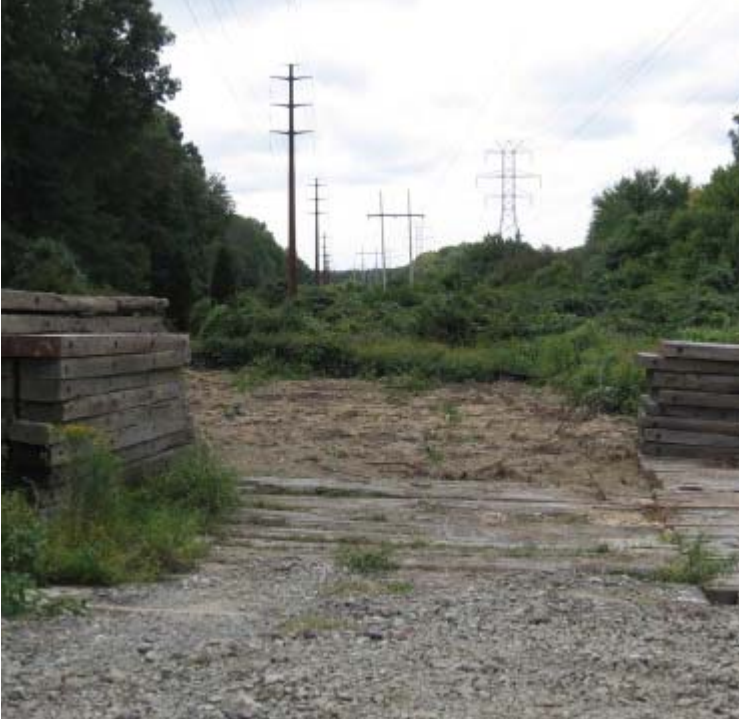
Racebrook Rd (Orange): Exposed soils from pad reclamation activities have been temporarily stabilized with mulch.

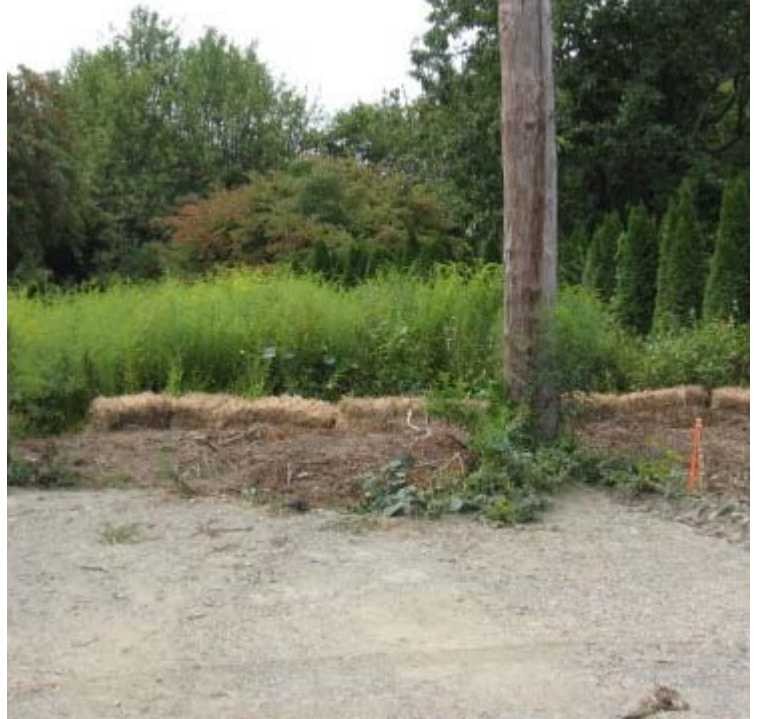
Hall Dr. (Orange): Pad reclamation activities continue. Additional erosion controls are recommended along the wetland boundary here.

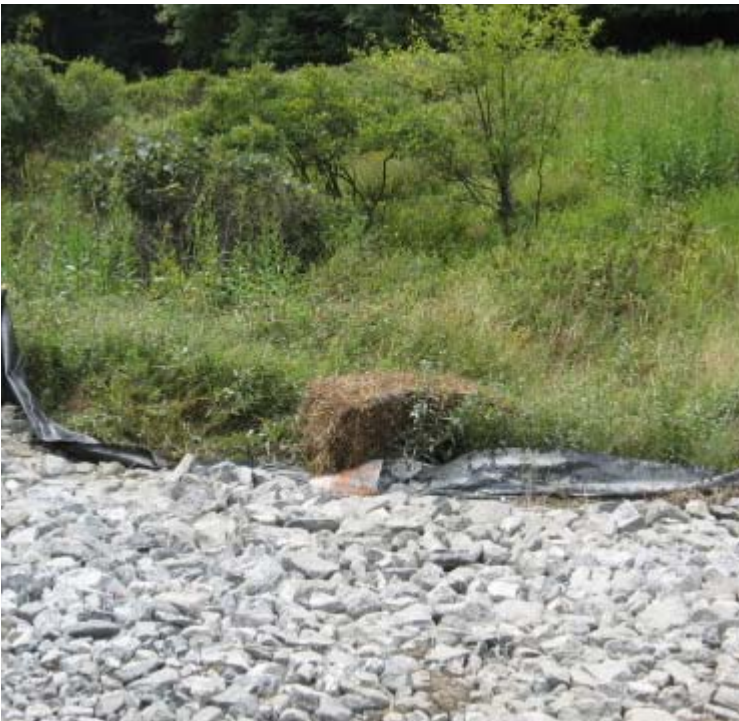
Clearview Lane to Route 15 (Woodbridge): Silt fence is in need of repair at structure #3903.

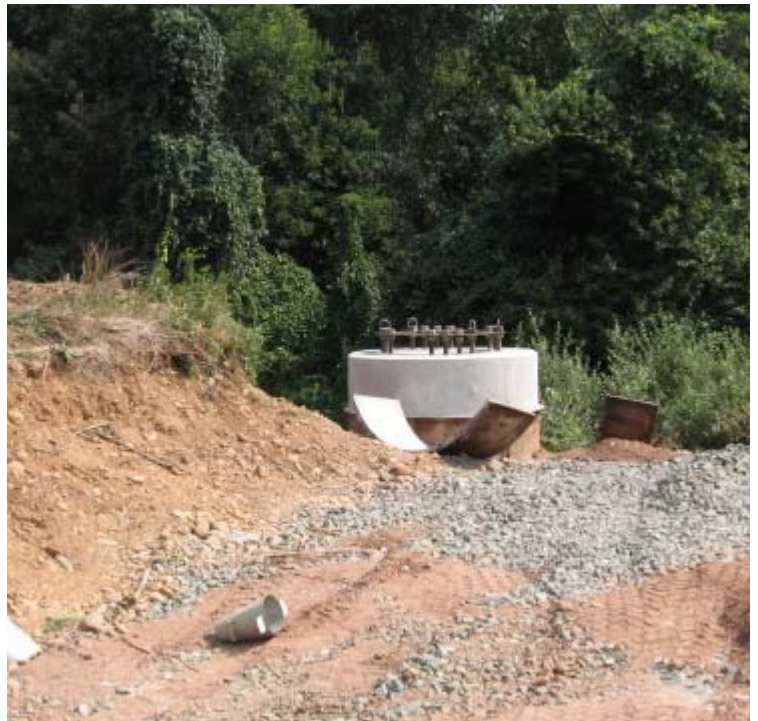
Willow St. (Hamden): Structure #4011 has been installed.
