Docket No. 272 - Development and Management Plan Inspection

Segment 2b Inspection

Date: September 28, 2007

Location: Segment 2b – Cheshire/Hamden Town Line to East Devon Substation

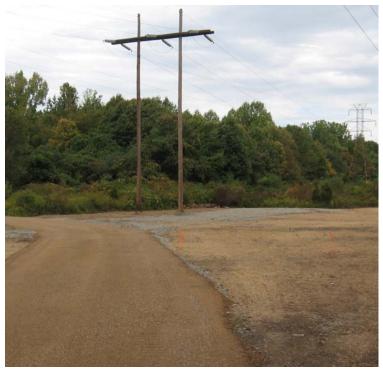
Eisenhower Park (Milford): Pad Reclamation and access road upgrades are complete in this area.

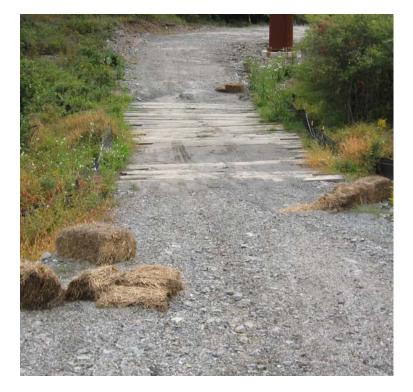
Litchfield Turnpike (Bethany): Additional controls are needed where sediment from the access road has migrated into the wetland.

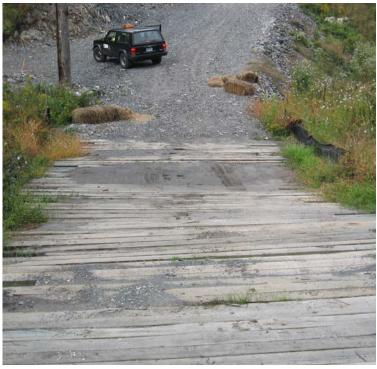
Litchfield Turnpike: Sediment should be cleaned from the timber mats as soon as possible and removed from the wetland when mats are lifted.
