Docket No. 272 – Development and Management Plan Inspection

Segment 3 Underground Line

Date: September 5, 2007

Location: East Devon Substation to the Housatonic River Crossing

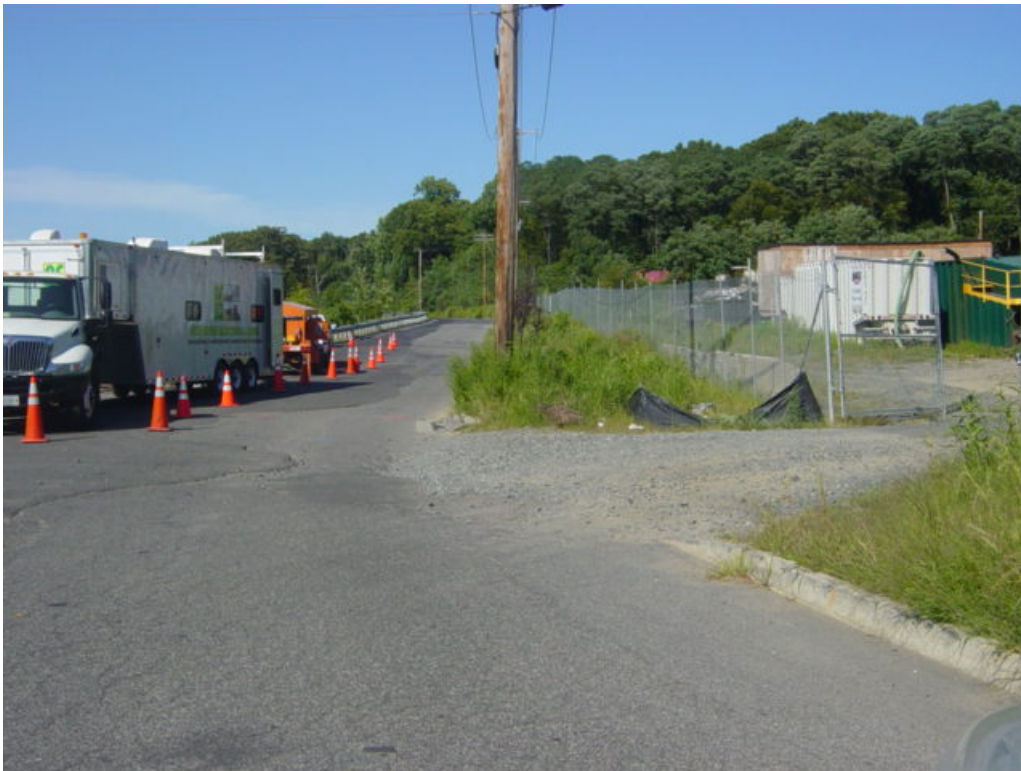
Photograph of the electrical work at vault #6 (left) and the Milford Lay-down yard stone construction entrance (right).
The stone entrance has migrated into the roadway.

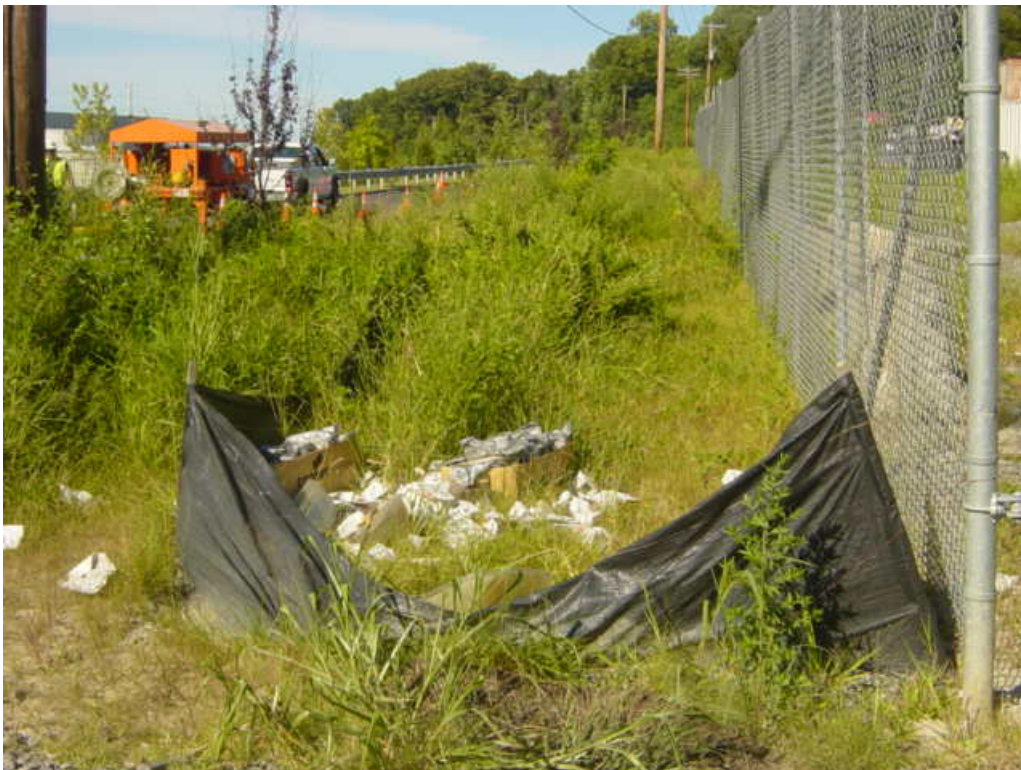
Non-project related debris remains just outside the entrance to the Milford yard.
Although this is not the contractors' responsibility, consider disposing of it to maintain aesthetics along the project route.
