Docket No. 272 – Development and Management Plan Inspection

Segment 3 Underground Line

Date: September 11, 2007

Location: East Devon Substation to the Housatonic River Crossing

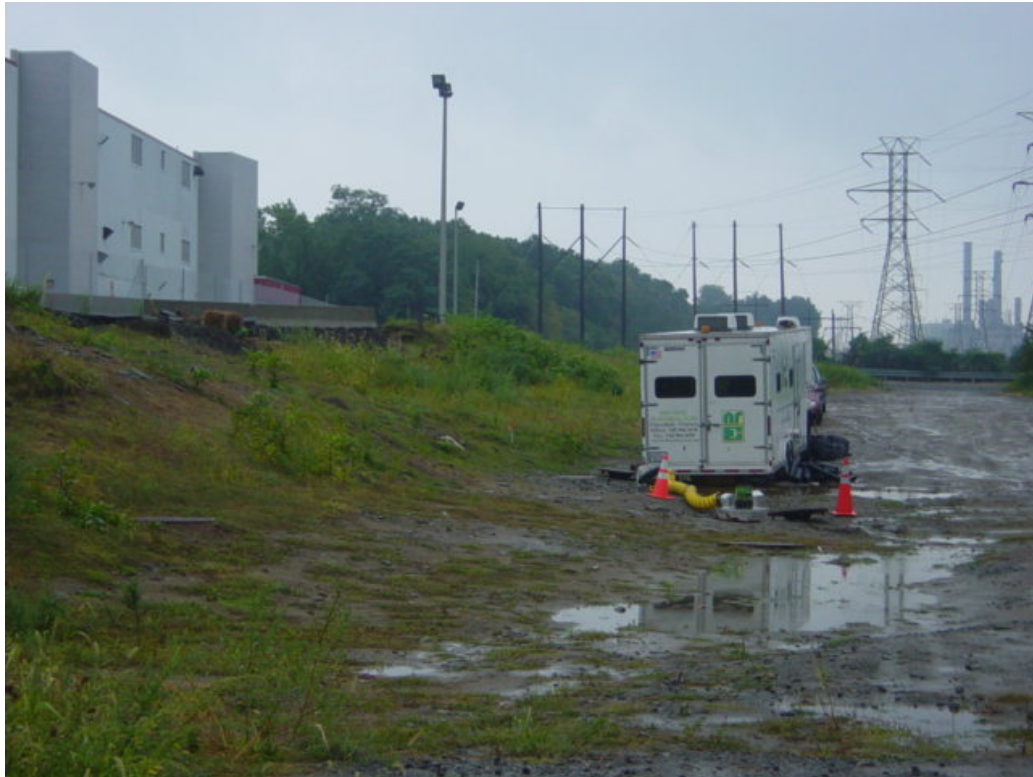
Photograph of electrical work at vault # 5 during heavy rains. Partially exposed slope remains stable.

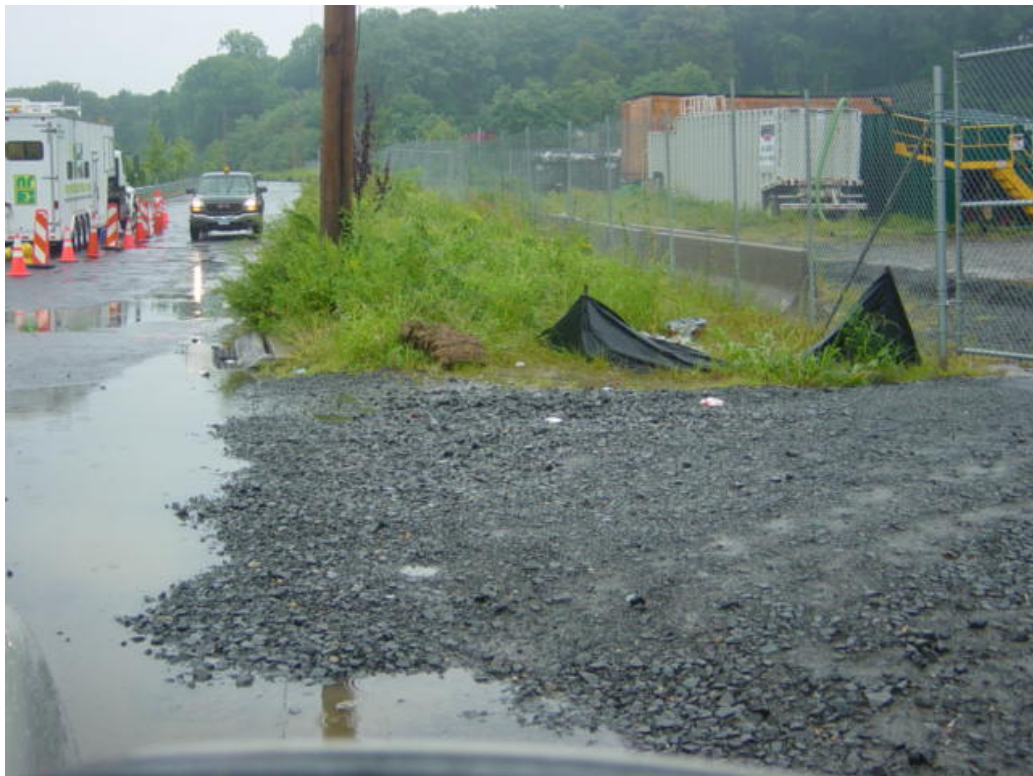
Non-project related debris remains just outside the entrance to the Milford yard and the stone construction entrance has migrated into roadway.
