Docket No. 272 – Development and Management Plan Inspection

Segment 4a Underground Line

Date: September 11, 2007

Location: Singer Substation to Fairfield/Westport Town Line

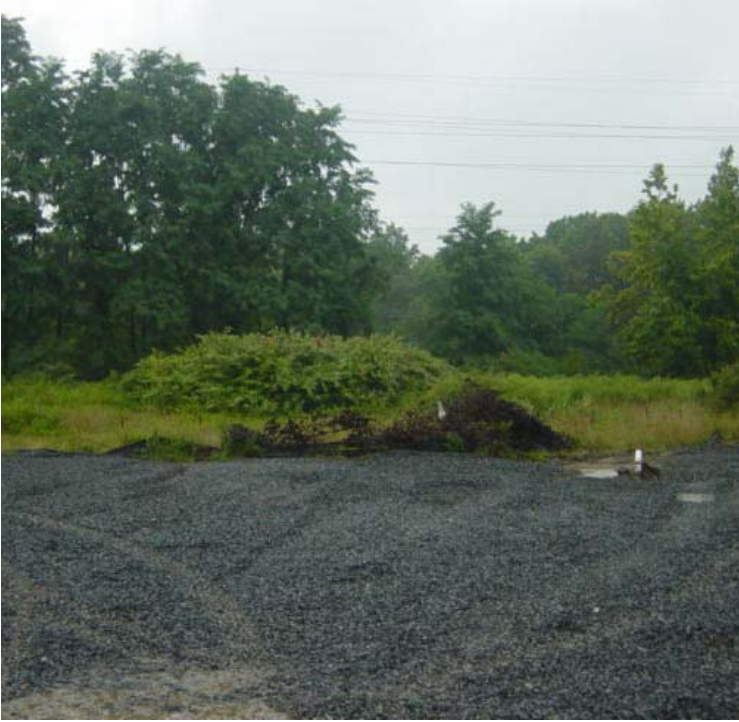
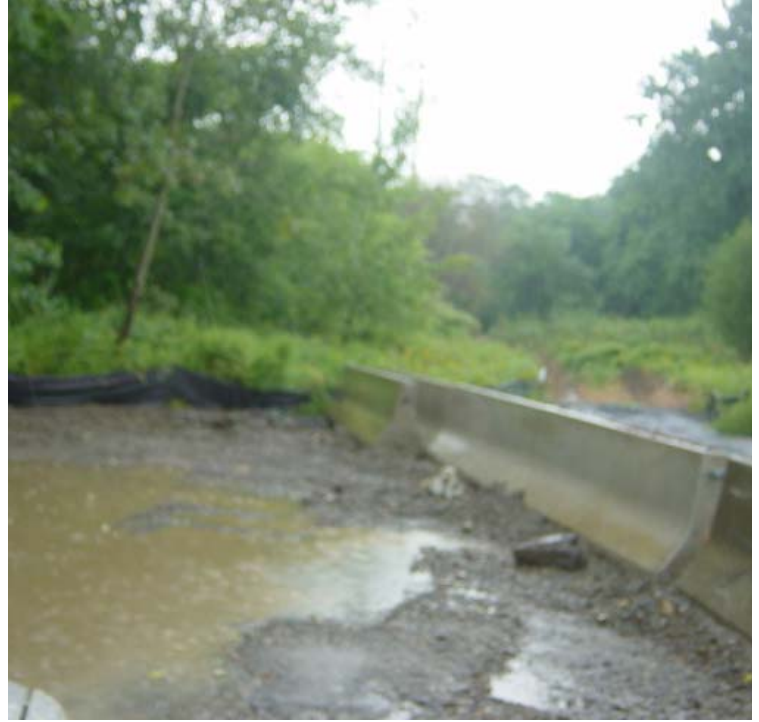
Both photographs were taken within the King's Highway lay-down yard. Left: Stone has been added to an area of the yard that is consistently muddy. Right: Erosion controls have been re-established.

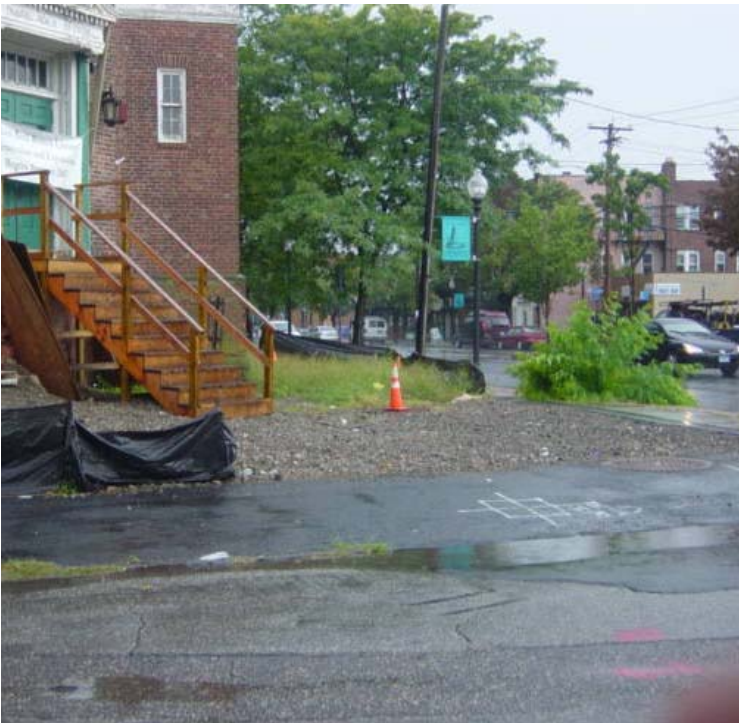
Compromised erosion controls at vault #41 have been removed.

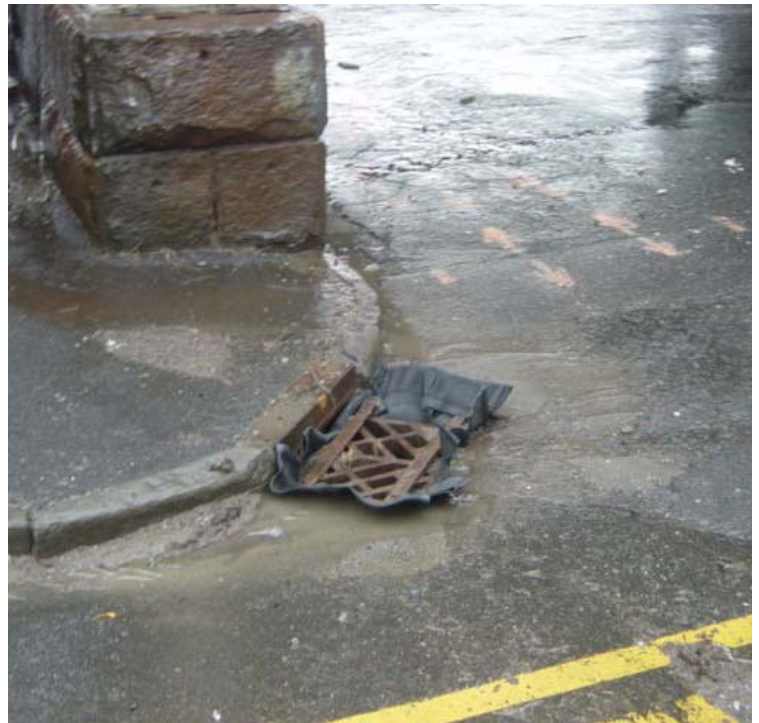
A number of silt sacks have been replaced along Railroad Ave. A few still require cleaning/replacement.

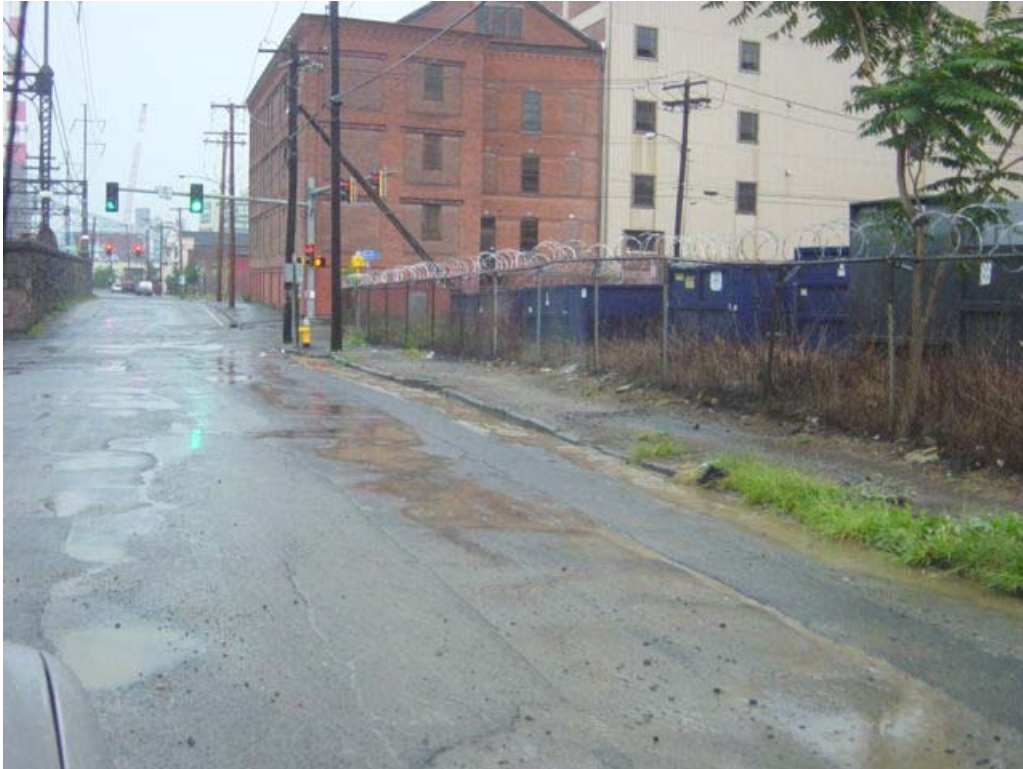
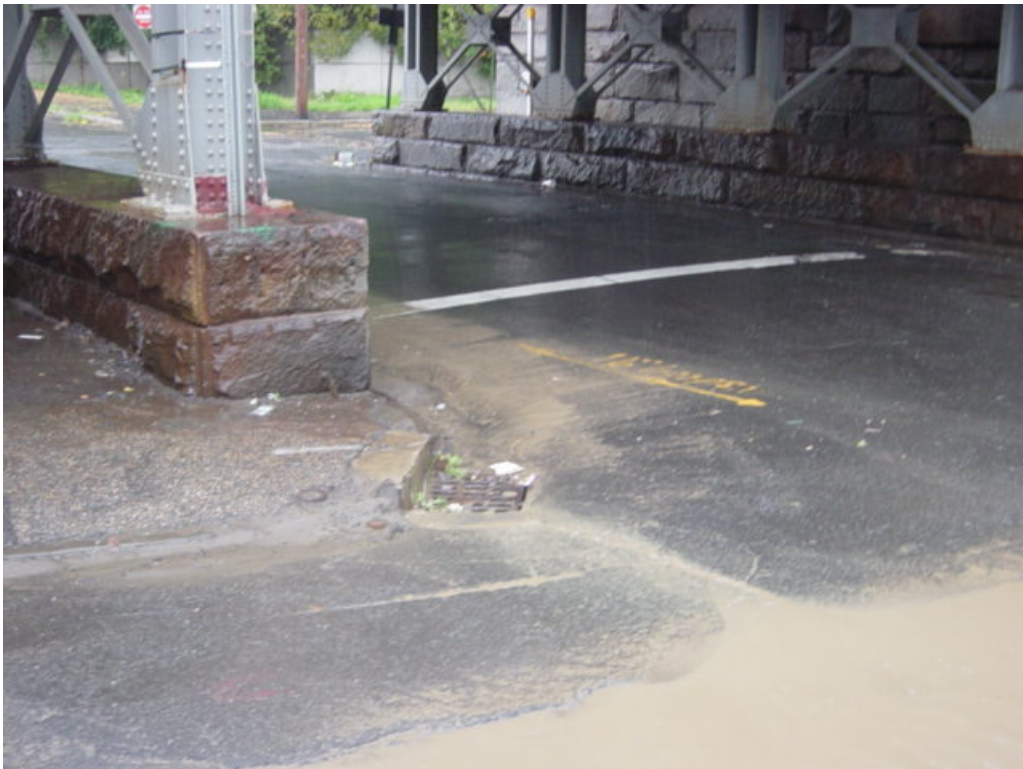
Both photographs show stormwater leaving the lay-down yard at the intersection of Railroad and Myrtle Ave. The yard is not related to this portion of the project, it appears to be part of the Glenbrook Cable portion of the project. Above: Sediment laden stormwater travels from the yard down the edge of the roadway. Below: Sediment laden stormwater (shown above) is entering an unprotected catch basin on Railroad Ave (far left of above photograph).
