Docket No. 272 – Development and Management Plan Inspection

Segment 4a Underground Line

Date: September 18, 2007

Location: Singer Substation to Fairfield/Westport Town Line

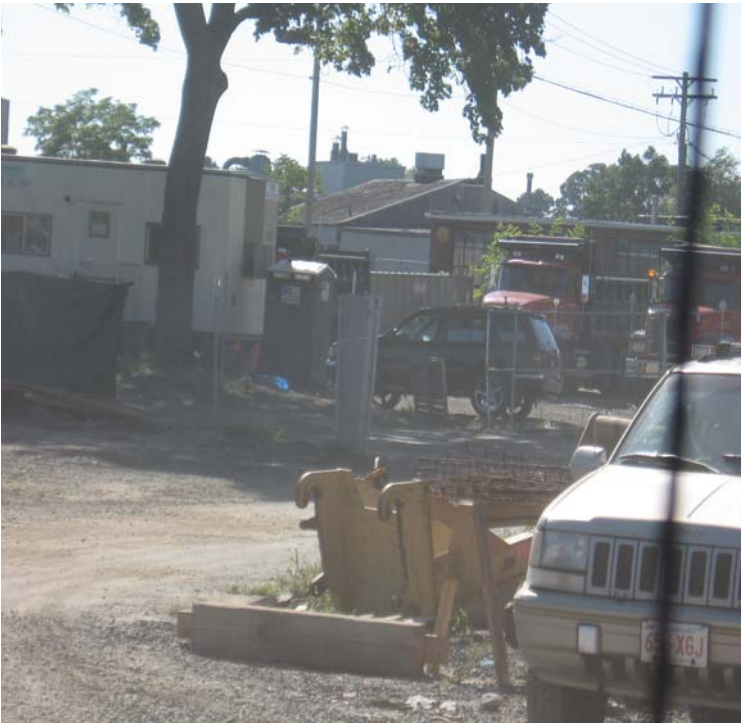
Both photographs were taken within the Bostwick Ave lay-down yard. Left: Airborne dust associated with vehicle traffic was noted within the yard. Right: Fluid filled equipment (sweeper) was removed from the yard.

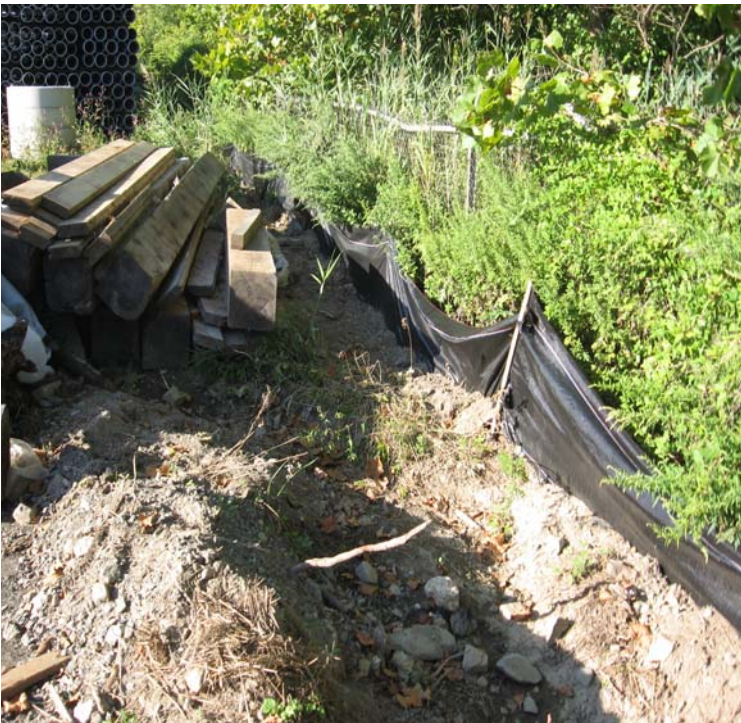
Erosion controls adjacent to the watercourse within the King's Highway lay-down yard have been re-established.

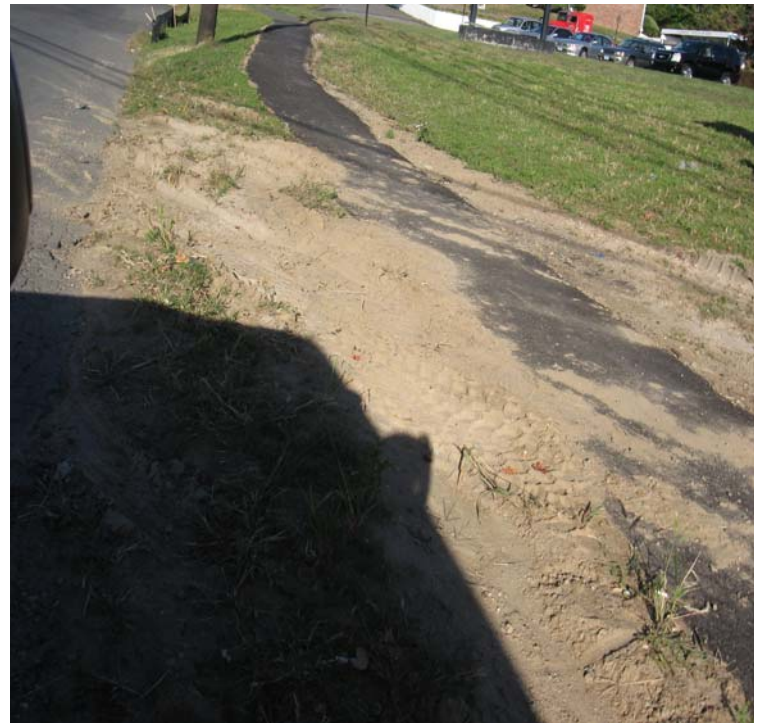
Ruts along the road in front of the Fairfield Inn remain. Recommended stabilizing exposed soils.

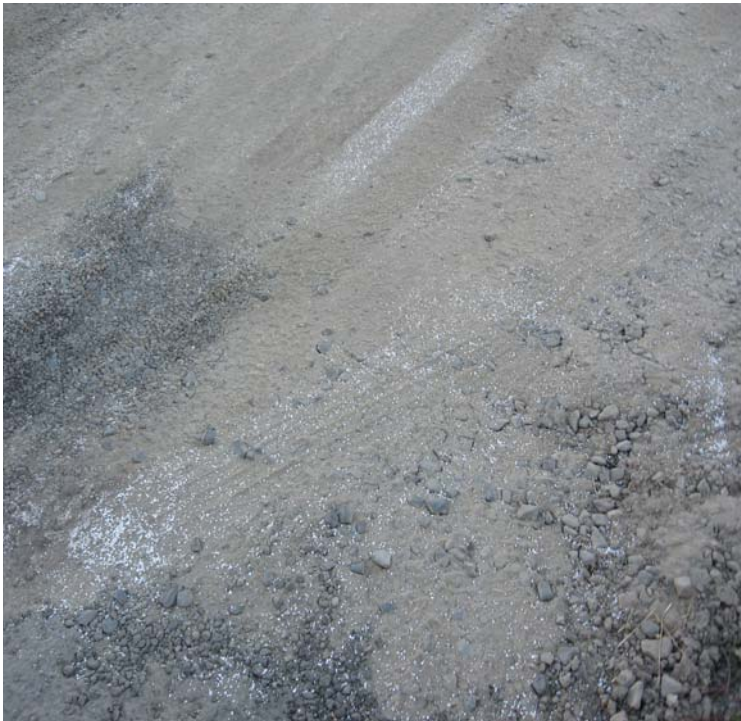
Both photographs are associated with the storage yard for the Glenbrook portion of the project (not project related) located on Railroad Ave. Left: Calcium chloride has been added at the yard. Right: Railroad Ave. has been swept and a silt sack has been installed within the catch basin on the south side of roadway. The catch basin that receives most of the runoff from the yard on the north side of Railroad Ave. remains unprotected.
