Docket No. 272 – Development and Management Plan Inspection

Segment 4a Underground Line

Date: September 26, 2007

Location: Singer Substation to Fairfield/Westport Town Line

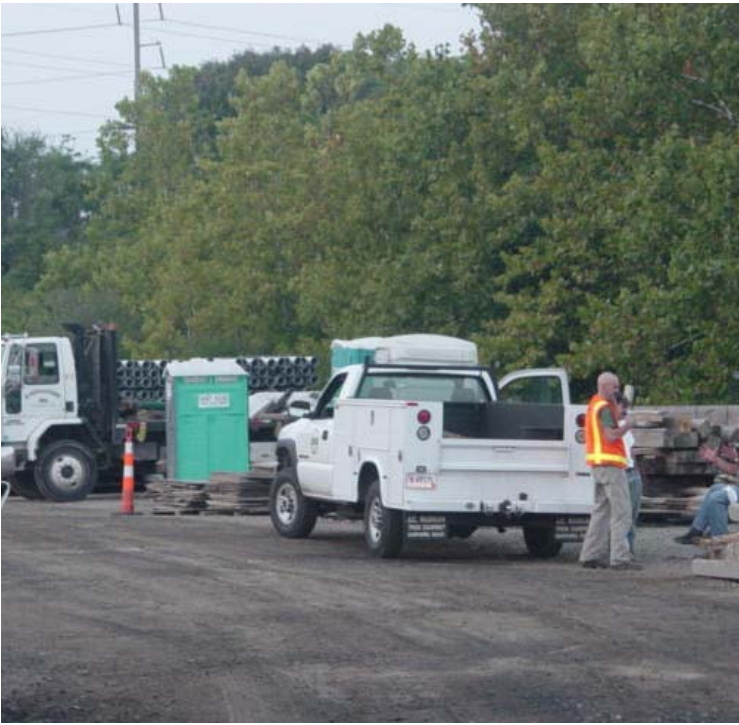
Both photographs were taken within the King's Highway lay-down yard. Left: Portable sanitary facilities were located within 50-feet of adjacent watercourse. Right: Yard was recently watered down to aid in reducing dust migration.

Areas of Inspection	Observation	Recommended Action	Corrected Action
	was noted. 9/26/07 One tree has been removed (In accordance with the D & M Plan) adjacent to vault #42 in preparation for trenching activities. 9/26/07	Vegetation should be restored as necessary upon completion of work in this area. 9/26/07	NA at this time
Dewatering	Dewatering activities were not observed during this week's inspection. 9/26/07	Continue to properly contain and/or filter discharge water when dewatering is required. 9/26/07	NA
Blasting	No blasting has been proposed. 9/26/07	None 9/26/07	NA
Spills and Material Storage	Spill cleanup materials/kits were observed in the storage yards. 9/26/07	Ensure that spill kits are also present with each vehicle during active construction 9/26/07	NA
Kings Highway Lay-down Yard (Fairfield) (Currently being used for Segment 4a and 4b operations.)	Portable sanitary facilities were located within 50-feet of the adjacent watercourse. 9/26/07	Portable sanitary facilities should be relocated to an area at least 100-feet from the watercourse if feasible 9/26/07	Needs attention

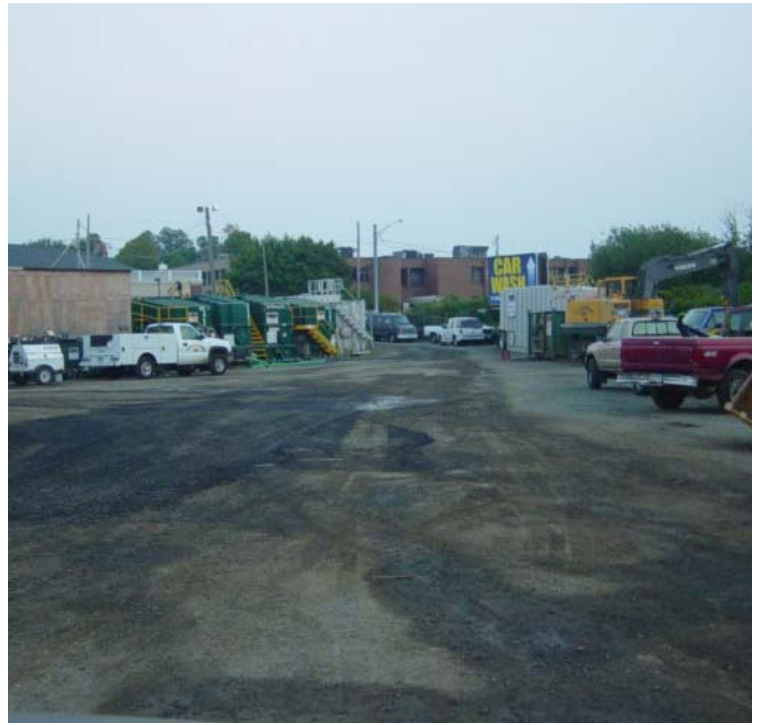
Areas of Inspection	Observation	Recommended Action	Corrected Action
Kings Highway Lay-down Yard (Off Kings Highway, near Rt. 1 rotary)	The yard had been recently watered down in an effort to control dust migration. 9/26/07	Continue to proactively reduce the potential for dust migration. 9/26/07	Dust control practices observed
Inland Wetland and Watercourse encroachment and mitigation	The Kings Highway lay-down yard is located adjacent to potential resource areas and a concrete lined waterway. 9/26/07	See erosion control section. 9/26/07	NA
Staging, Storage, and Parking Areas	A contractor storage yard on Bostwick Ave. contains frac tanks, trailers, and parking. Reserve spill kits are located near the equipment trailers. 9/26/07	Ensure that spill kits are also present with each vehicle during active construction, see Spills and Material Storage and Erosion Control sect2618/07	NA
	A contractor lay-down yard is located off of Kings Highway near the Rt. 1 rotary. Reserve spill kits are located near the equipment trailers. 9/26/07	See Erosion Control and Spills and Material Storage sections. 9/26/07	NA

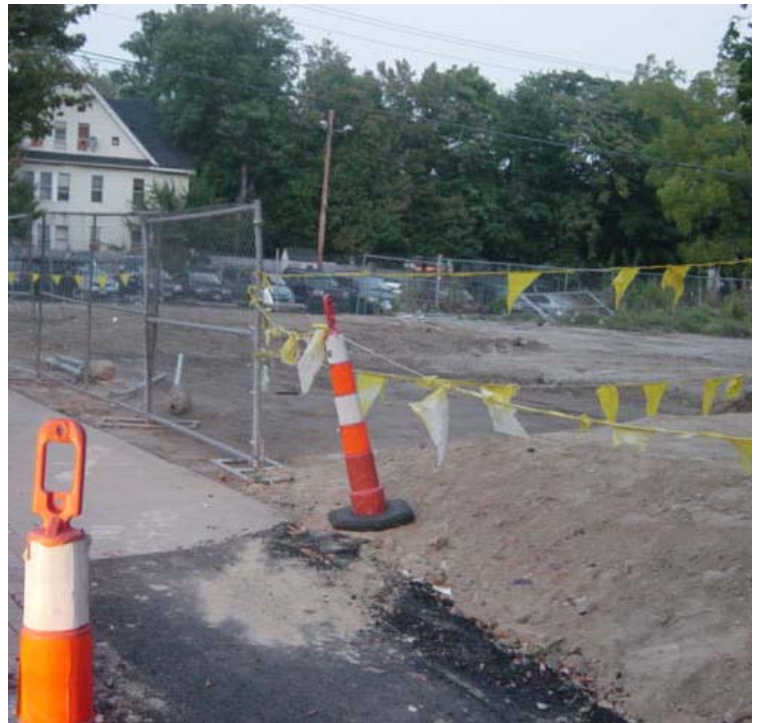
Soils	Soils are exposed as part of the excavation for trench, vault, and utility work. 9/26/07	Most areas are temporarily stabilized. 9/268/07	NA
	A small stockpile off Rt. 1 Pequot Ave. is contained and stable. 9/26/07	See erosion control section. 9/26/07	NA
	Exposed soils were observed near sta.#695. 9/26/07	Contain exposed soils during active construction to prevent sediment migration. If exposed soils are not to be worked within 30 days, they should be stabilized within 7 days of the last activity. 9/26/07	Needs attention
State species of concern, threatened and endangered	According to the D&M plan, state-listed species are not located in this	None	NA

Utility work near sta. #695 has left soils exposed. It is recommended that exposed soils be stabilized or contained to prevent sediment migration.
