Docket No. 272 – Development and Management Plan Inspection

Segment 4b Underground Line

Date: September 5, 2007

Location: Fairfield/Westport Town Line to Westport Avenue in Norwalk

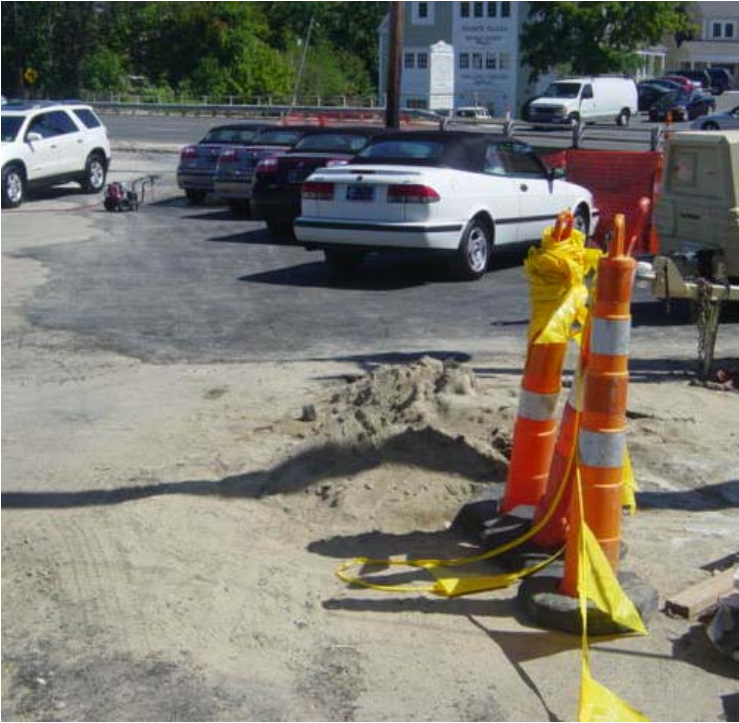
Photograph taken at sta. #217, adjacent to Stony Brook. An uncontained pile of sand was observed within the parking area.

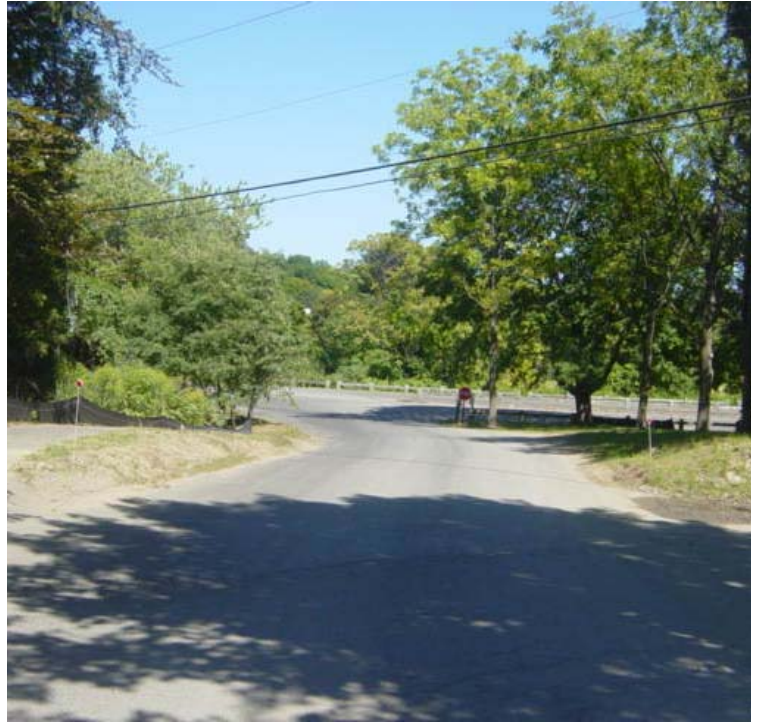
View of the entrance to the Sherwood Island lay-down yard. The roadway is relatively free of tracked sediment.

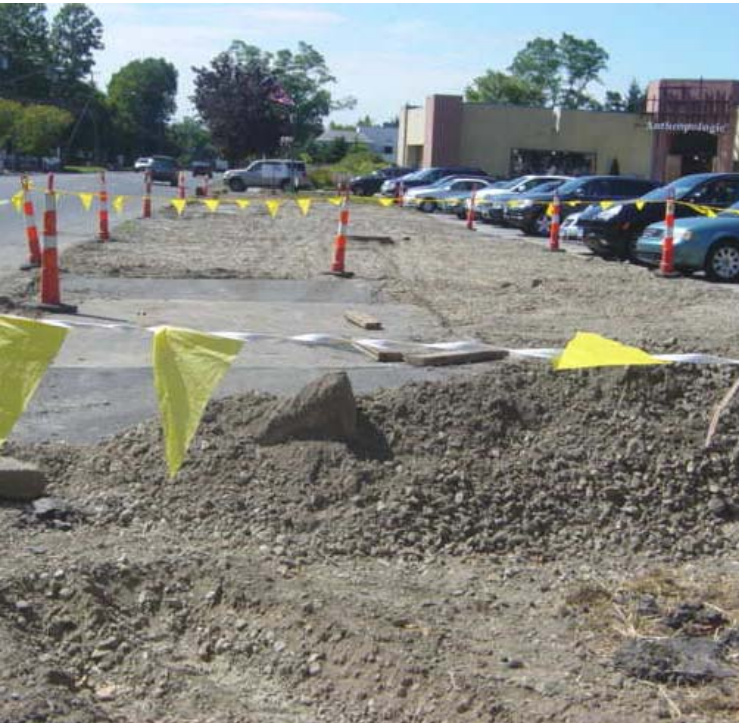
A hard packing material covers the work area at vault #23. Continue to monitor to ensure material does not migrate from the construction area.

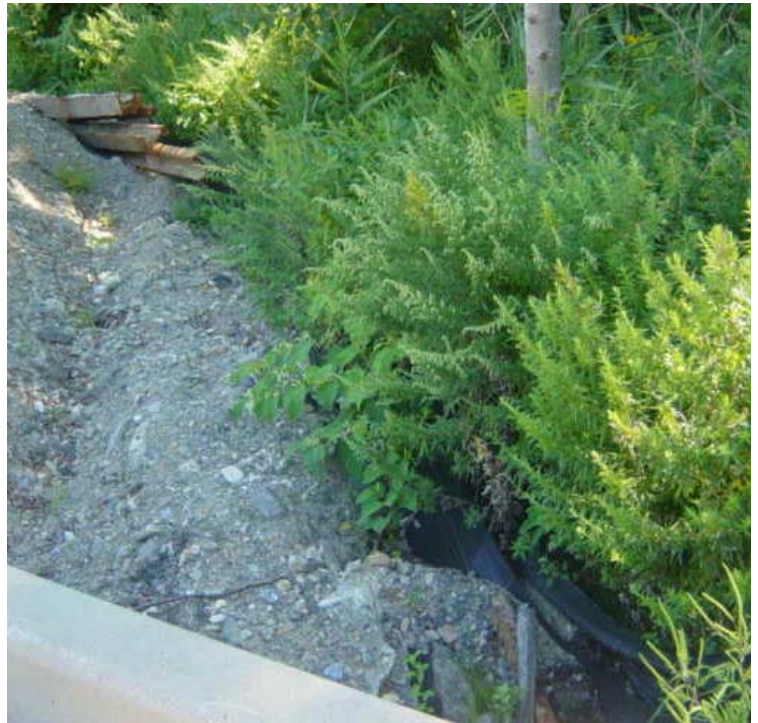
Erosion controls within the King's Highway lay-down yard remain compromised.
