Docket No. 272 – Development and Management Plan Inspection

Segment 4b Underground Line

Date: September 18, 2007

Location: Fairfield/Westport Town Line to Westport Avenue in Norwalk

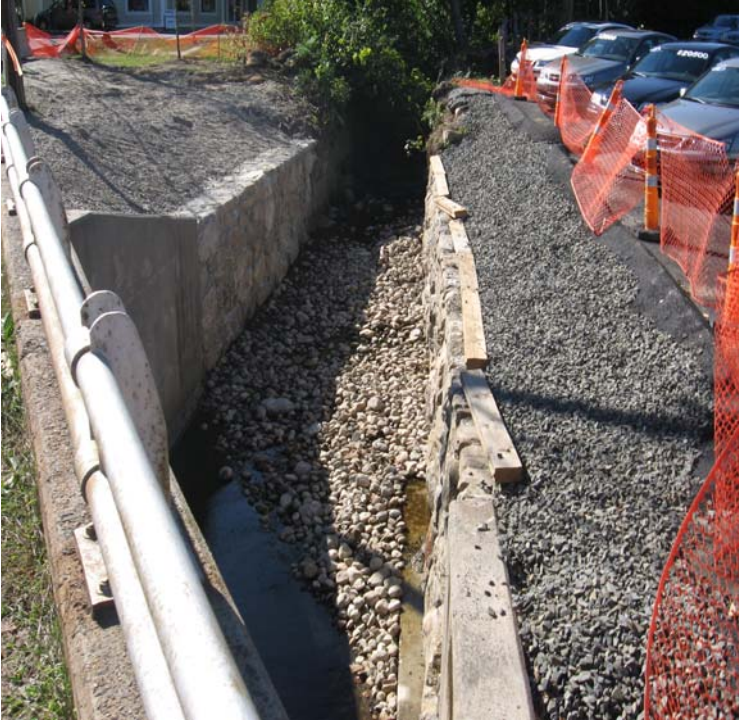
Both photographs were taken near sta. #217 at the Stony Brook crossing. Left: Hard pack on south side of stream remains moderately stable. Signs of minor migration were noted on top of the retaining wall. Right: Tree removed for construction activities remains within the parking area to the north of Stony Brook. Remove and properly dispose of if property owner has not requested for it to remain.

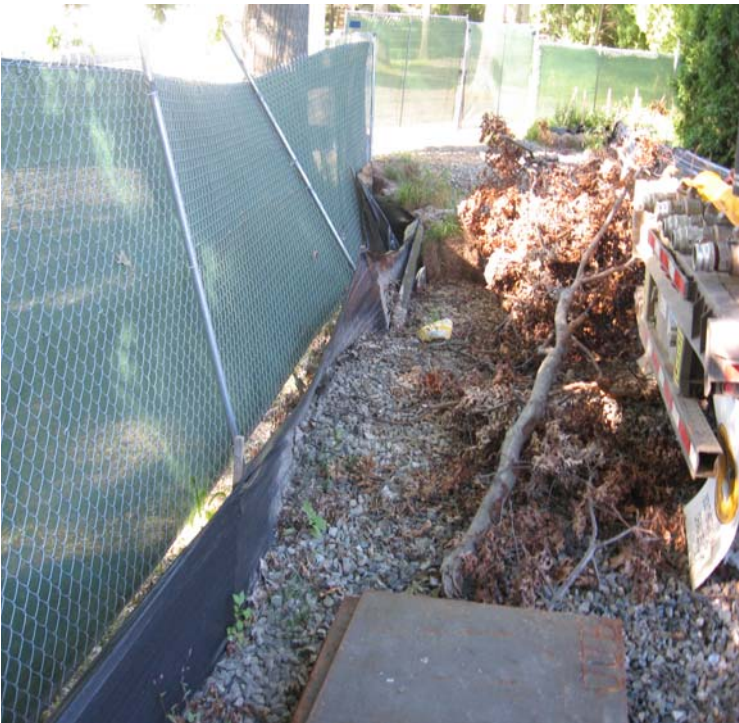
Both photographs were taken within the Sherwood Island lay-down yard. Left: Down limb located near the rear of the yard was removed from the erosion controls. Erosion controls continue to function properly. Right: Fluid filled equipment was being stored on exposed soil in an uncontained/unprotected location.

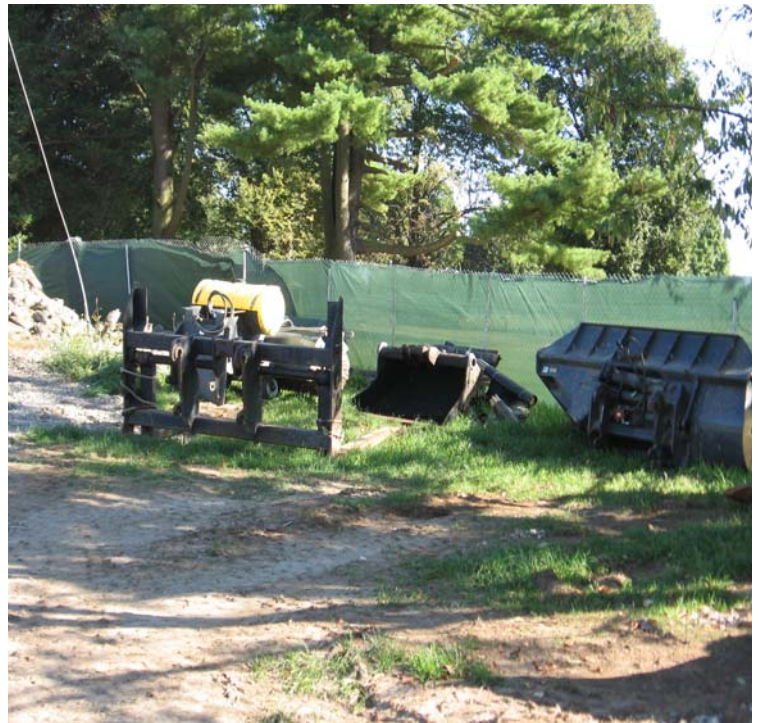
Spills and Material Storage	Spill cleanup materials/kits were observed in the storage yard. 9/18/07	Ensure that spill kits are also present with each vehicle during active construction. 9/18/07	NA
	All fluid-filled equipment was appropriately stored within the King's Highway lay-down yard this week. 9/18/07	Continue to proactively store all fluid filled equipment in the designated contained locations. 9/18/07	Equipment was properly stored this week. Needs regular attention
	Fluid filled equipment was being stored on exposed soils in an unprotected location. 9/11 – 9/18/07	Designate a storage area that is contained or protected by the yard liner. 9/18/07	Needs attention
Additional Observations	None 9/18/07	None 9/18/07	NA

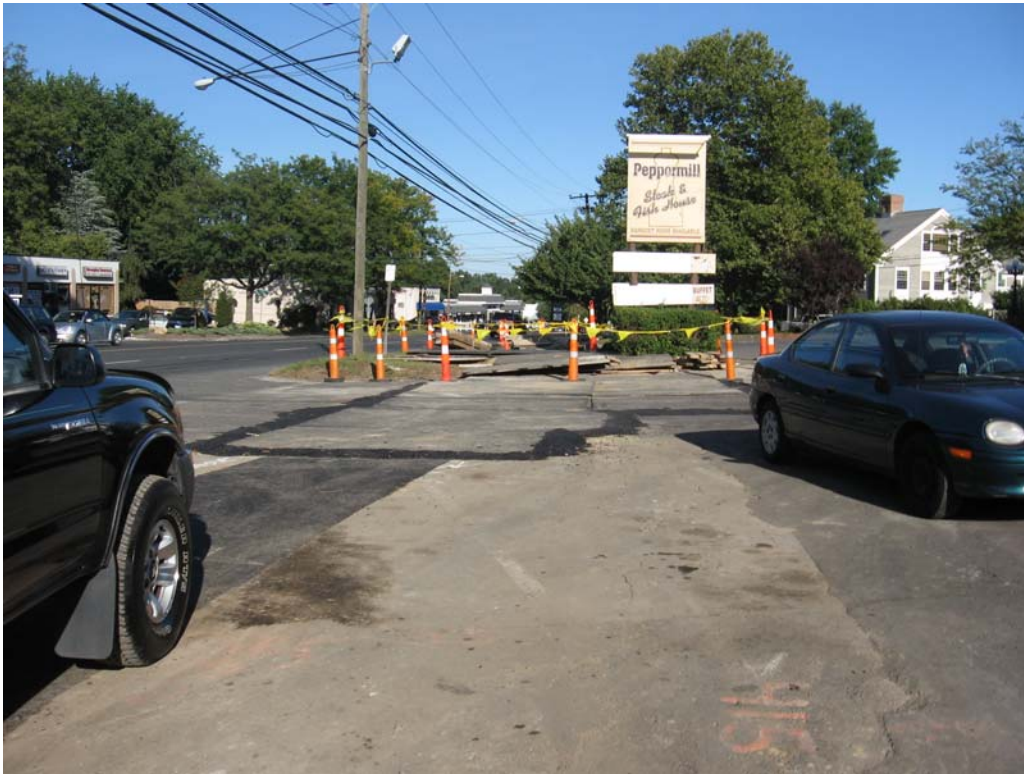
Photograph of trenching activities at and adjacent to vault #25.

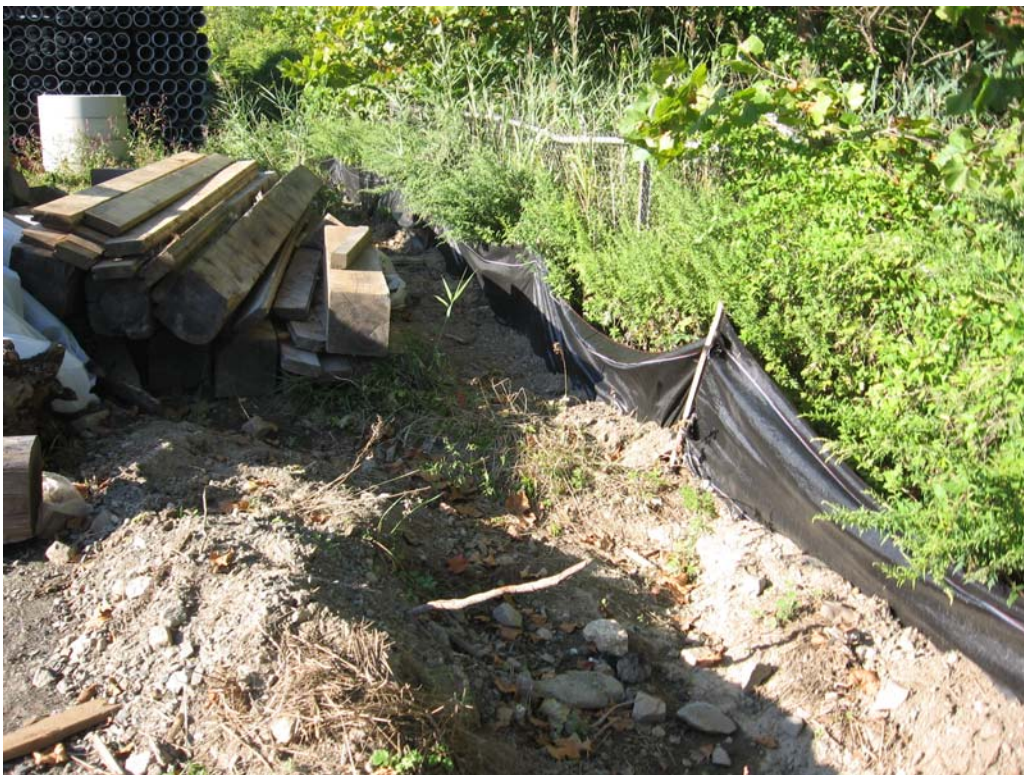
Photograph of erosion controls located adjacent to the watercourse within the King's Highway lay-down yard. Controls were formerly overwhelmed by materials, but have been re-established.
