B.1. Review of National Register Status for Property Proposed for Demolition, 31-35 South Main Street, Norwalk, South Main and Washington Streets Historic District Boundary Increase (NR# 85003505)

**Historic Property Evaluation Report
31-35 South Main Street, Norwalk, CT**

20 December, 2022

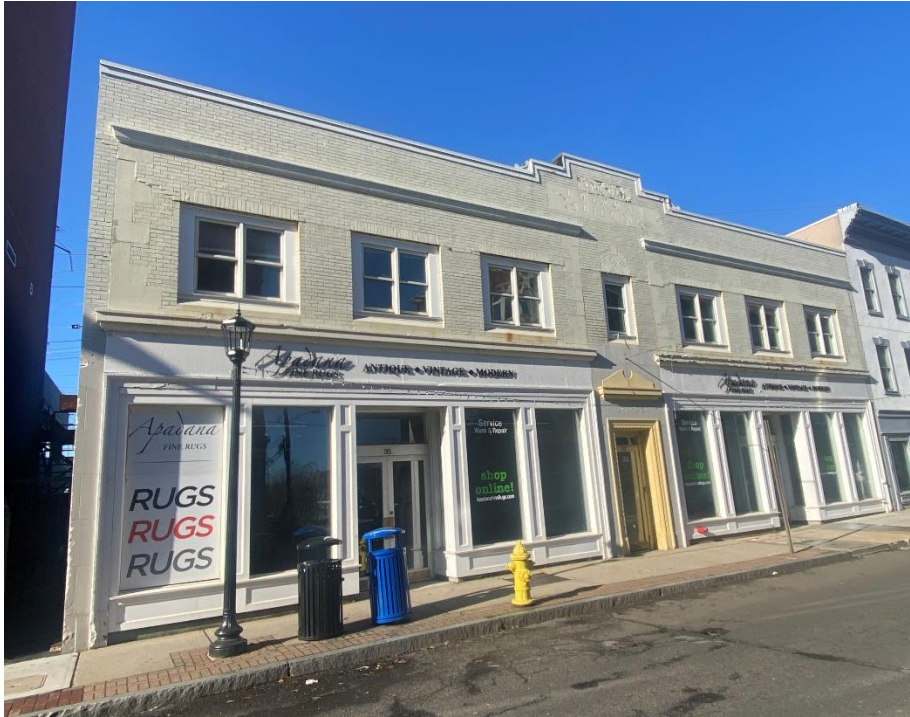
The building appears to have undergone a renovation within the last 20-25 years. The renovation (or a later intervention) included: removal of the original storefronts and replacement with new wood and glass elements that are much less articulated than the originals, replacement of the central main entry door, replacement of second floor windows. The work also has included complete painting of the building facade, which appears to have concealed a number of building deficiencies and deterioration as noted in the following conditions (Photo 1).

In order for the building to return to its original appearance, removal of the extant paint will be necessary. Paint removal will reveal a great number of deficiencies, both structural and cosmetic, that will impact the historical integrity of the building.

Photo 1 Paint obscures much of the damage and deterioration on the building façade

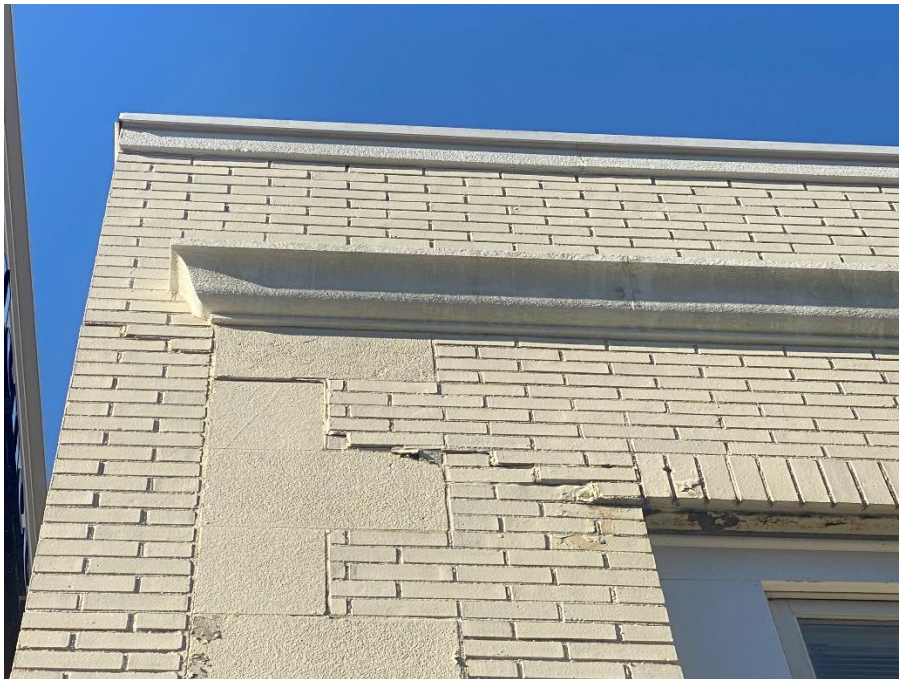
Paint has failed on the façade bricks at some locations. Serious displacement of the brick masonry above the second floor level window level has occurred, which appears to be a result of corrosion and oxide jacking of the steel lintels at the window heads. The masonry displacement is severe at some locations and may present a hazard to public safety (Photo 2).

Photo 2 Oxide jacking of steel has resulted in serious damage to brick and stone masonry.

It is likely that repair of the brick masonry will be problematic and not result in a successful “restoration”. Removal for salvage of the bricks above the lintel level without damage will be difficult, as they are laid in Portland cement mortar, a tenacious, rigid material that will not be able to be removed without damage to the bricks, thus a considerable amount of original masonry will be lost.

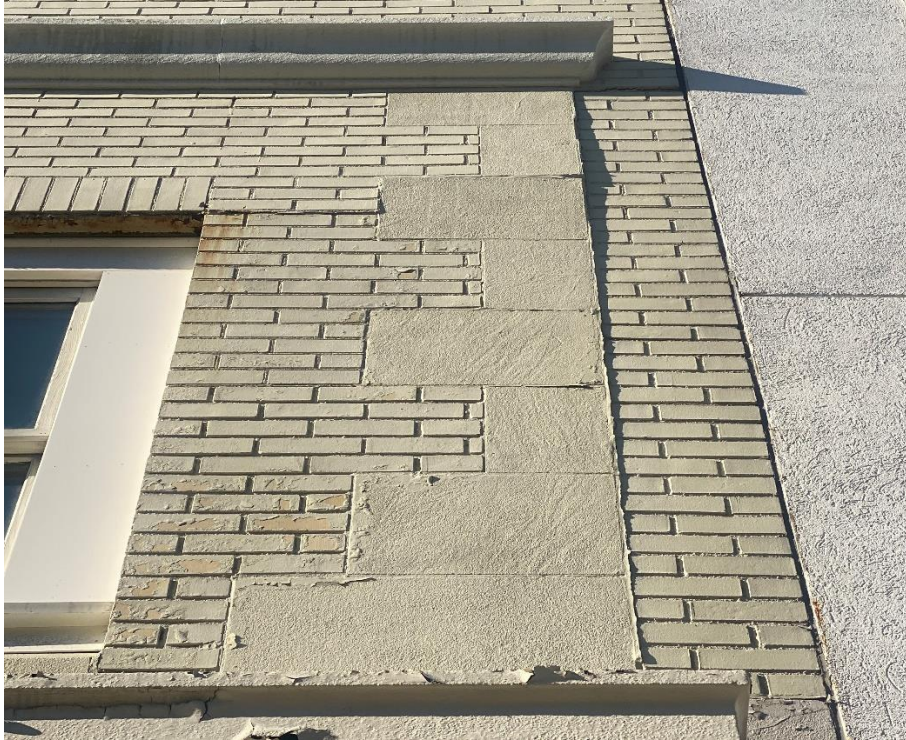
As with the brick masonry above the second floor level window level, limestone quoins are severely displaced and will be difficult to salvage and reuse without damage – resulting in a considerable amount of replacement (Photo 3).

Photo 3 Stone masonry has been seriously displaced and presents a hazardous condition

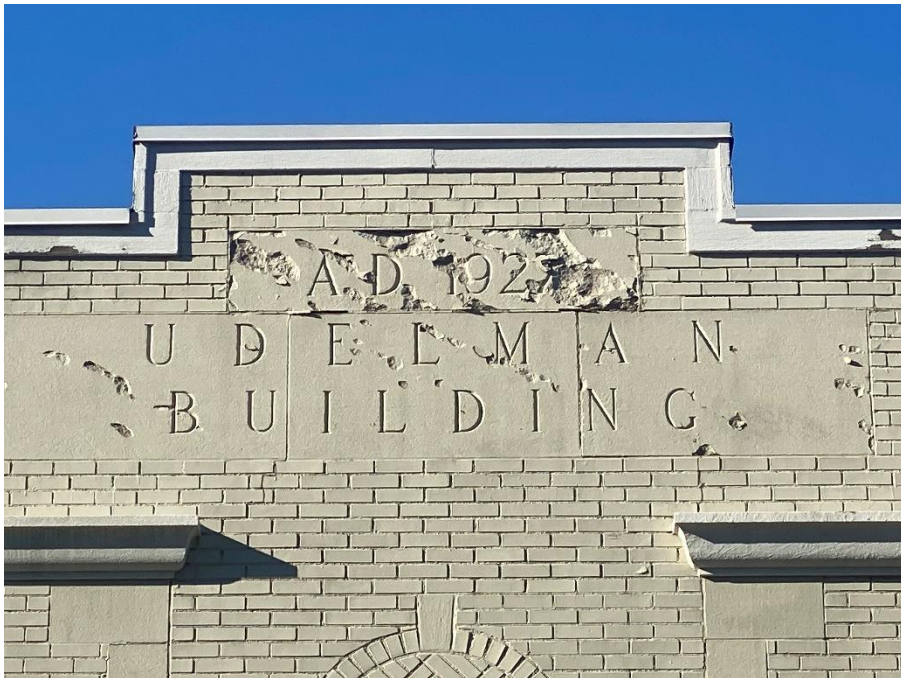
At the central pediment inset name and date panel limestone, there is a significant amount of stone spalling (Photo 4). The disfigured stone obscures the date of construction, and is visually obtrusive. At the parapet coping level, the copings have been covered with sheet metal that may be concealing damage, and the two stone scrolls that flank the stepped pediment have been covered with asphaltic material. At the limestone string course above the storefront sign band the original limestone cornice above the 31 Main St storefront appears to have been replaced with a ferrous replacement, which has

Photo 4 Limestone spalling will require significant intervention affecting building integrity

Considering the above conditions and the loss of authenticity that would be the result of any restoration effort, including an effort to salvage the existing façade and incorporate into a new building on the site, it is recommended that the building be permitted to be demolished, and several unique elements that might be able to be salvaged without damage (ex. The central entry door surround and pediment, name and date panel) be incorporated into or displayed within any new building constructed on the site.

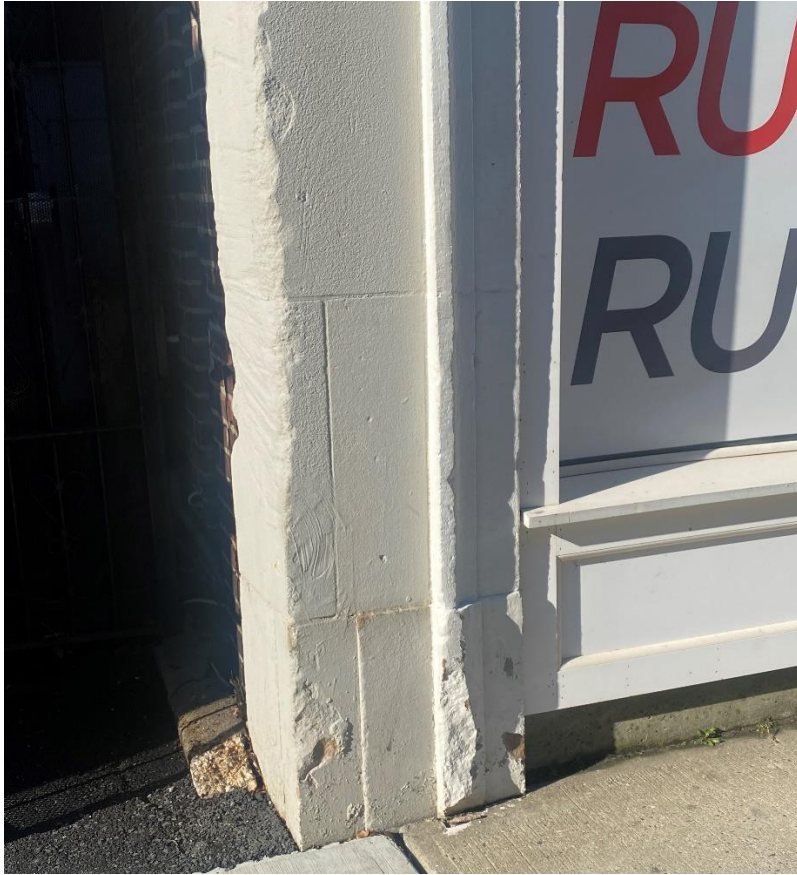
lost paint and is corroding. The course above the #35 storefront is delaminating and spalling at several locations. The sign band limestone at both storefronts appears to have been patched; awkwardly applied repairs are visible through the paint film. Portions of the limestone at the street level window surrounds are also damaged. At the central entry door surround, there are visible poorly applied patch repairs at the ashlar stone, and the rope detailing and base stones at the door surround are eroded, exhibiting mechanical damage. Early photographs of the façade reveal a cornice and entablature above the central door that appears much more robust and elaborate than the extant broken pediment and ovolo base element. The extant pediment shows a considerable amount of mechanical stone damage. The ashlar quoins at the two ends of the façade also exhibit considerable mechanical damage (Photo 5).

Photo 5 Ashlar quoins at the building ends are damaged and unsightly

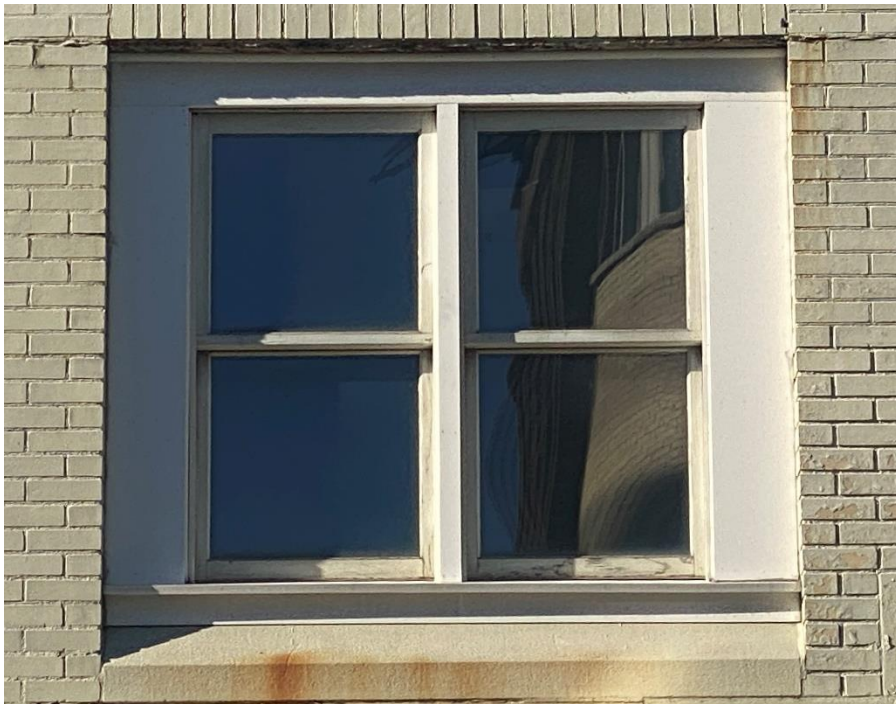
Early photographs reveal that the original windows featured one-over-one hung sash in frames that fully filled the punched openings. The extant windows are one-over-one wood sash, inappropriately smaller than the originals openings, and placed awkwardly off center within the masonry openings - with sheet metal infill panning at the perimeters (Photo 6).

Photo 6 Windows on the building are inappropriate and will require appropriate replacement.
