RE: HAZARDOUS MATERIALS SURVEY REPORT, NORTHERN PORTION OF
THE ADMINISTRATION BUILDING, SOUTH MEADOWS STATION, GATE
20 RESERVE ROAD, HARTFORD, CONNECTICUT (HRP# CRR0155.BA)

ASBESTOS AND HAZARDOUS MATERIALS ESTIMATED REMOVAL COSTS
MARCH 2012
NORTH PORTION OF ADMINISTRATION BUILDING
SOUTH MEADOWS STATION – GATE 20 RESERVE ROAD
HARTFORD, CONNECTICUT
HRP #CRR0155.BA

HAZARDOUS MATERIALS SURVEY REPORT

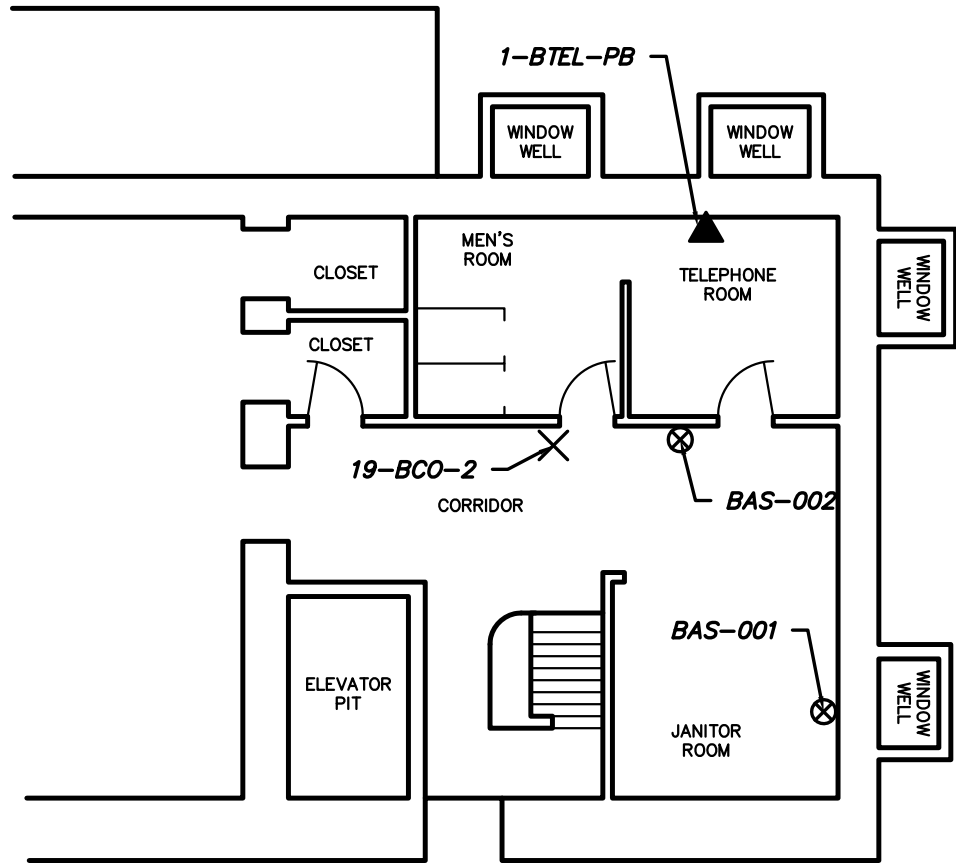
FIGURE 2
BASEMENT SAMPLING LOCATIONS
NORTH PORTION ADMIN. BUILDING
CRRA SOUTH MEADOWS STATION
GATE 20 RESERVE ROAD
HARTFORD, CONNECTICUT
HRP # CRR0155.BA
SCALE 1" = 10'±

No VSMG was noted on any accessible building materials in the inspected areas with the exception of the janitor's room located in the basement (and the adjacent corridor near the basement stairwell) and the 4th floor stairwell. VSMG was noted on

the painted concrete walls and ceiling of the basement. VSMG was also noted on the interior walls of the 4th floor stairwell leading to the roof.

The two (2) swab samples collected from the Janitor's Room were found to contain high levels of Cladosporium. The sample collected of the 4th floor wall stairwell was found to have high levels of Aspergillus/Penicillium and low levels of Cladosporium spores. A copy of the complete laboratory results is included as Appendix F.

Suspect mold growth was observed throughout the Janitor's room in the basement and on the staircase walls of the 4th floor. As mentioned above, the VSMG in the areas sampled were found to have low to high levels of mold spores (*Aspergillus/Penicillium and Cladosporium*). These mold spores are known allergens.

- Prior to any mold abatement work, the roof leak from the penthouse area of the stairwell will need to be repaired so that there is no further water intrusion into the building.
- Replace the stained ceiling tiles on the 3rd floor, Office Area #1.
- The walls in the basement of the Janitor's Room (and the adjacent corridor near the basement stairwell) and 4th Floor staircase should also be microbial cleaned. Proper personal protective equipment should be used during this work including an N-95 respirator, gloves and goggles. HRP recommends consulting with a mold remediation contractor for the affected area in order to develop a plan for proper removal and disposal of damaged materials. The contractor will also need to coordinate mold abatement with abatement of lead-containing and lead-based painted walls/ceilings.

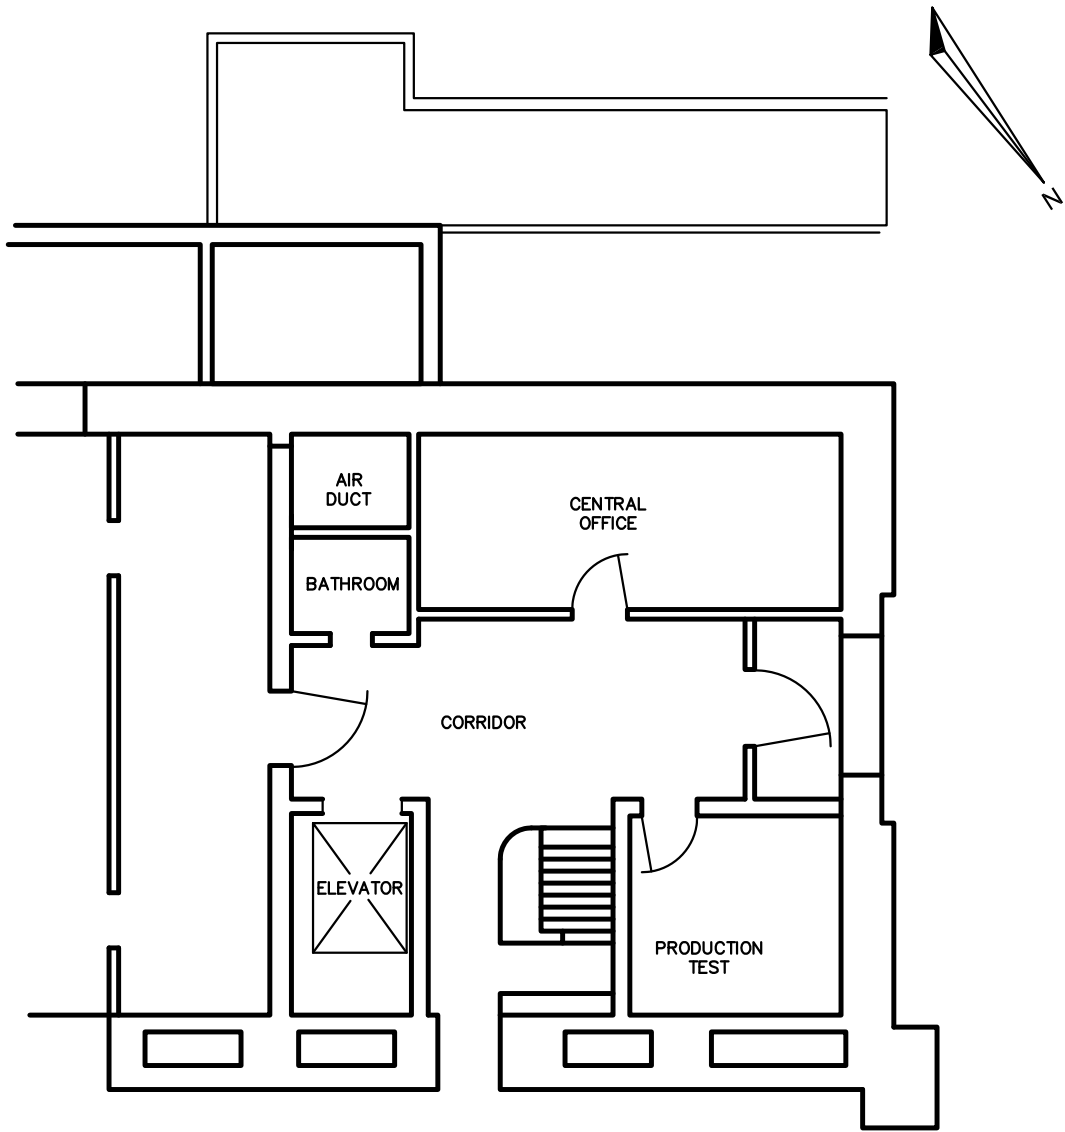
FIGURE 3
FIRST FLOOR SAMPLING LOCATIONS
NORTH PORTION ADMIN. BUILDING
CRRA SOUTH MEADOWS STATION
GATE 20 RESERVE ROAD
HARTFORD, CONNECTICUT
HRP # CRR0155.BA
SCALE 1" = 10'±

Both ACMs, which were found by HRP to be in intact, non-friable condition, were identified within the first floor "staff room" (Central Office, see Figure 3). HRP measured approximately 200 square feet for each of these materials.

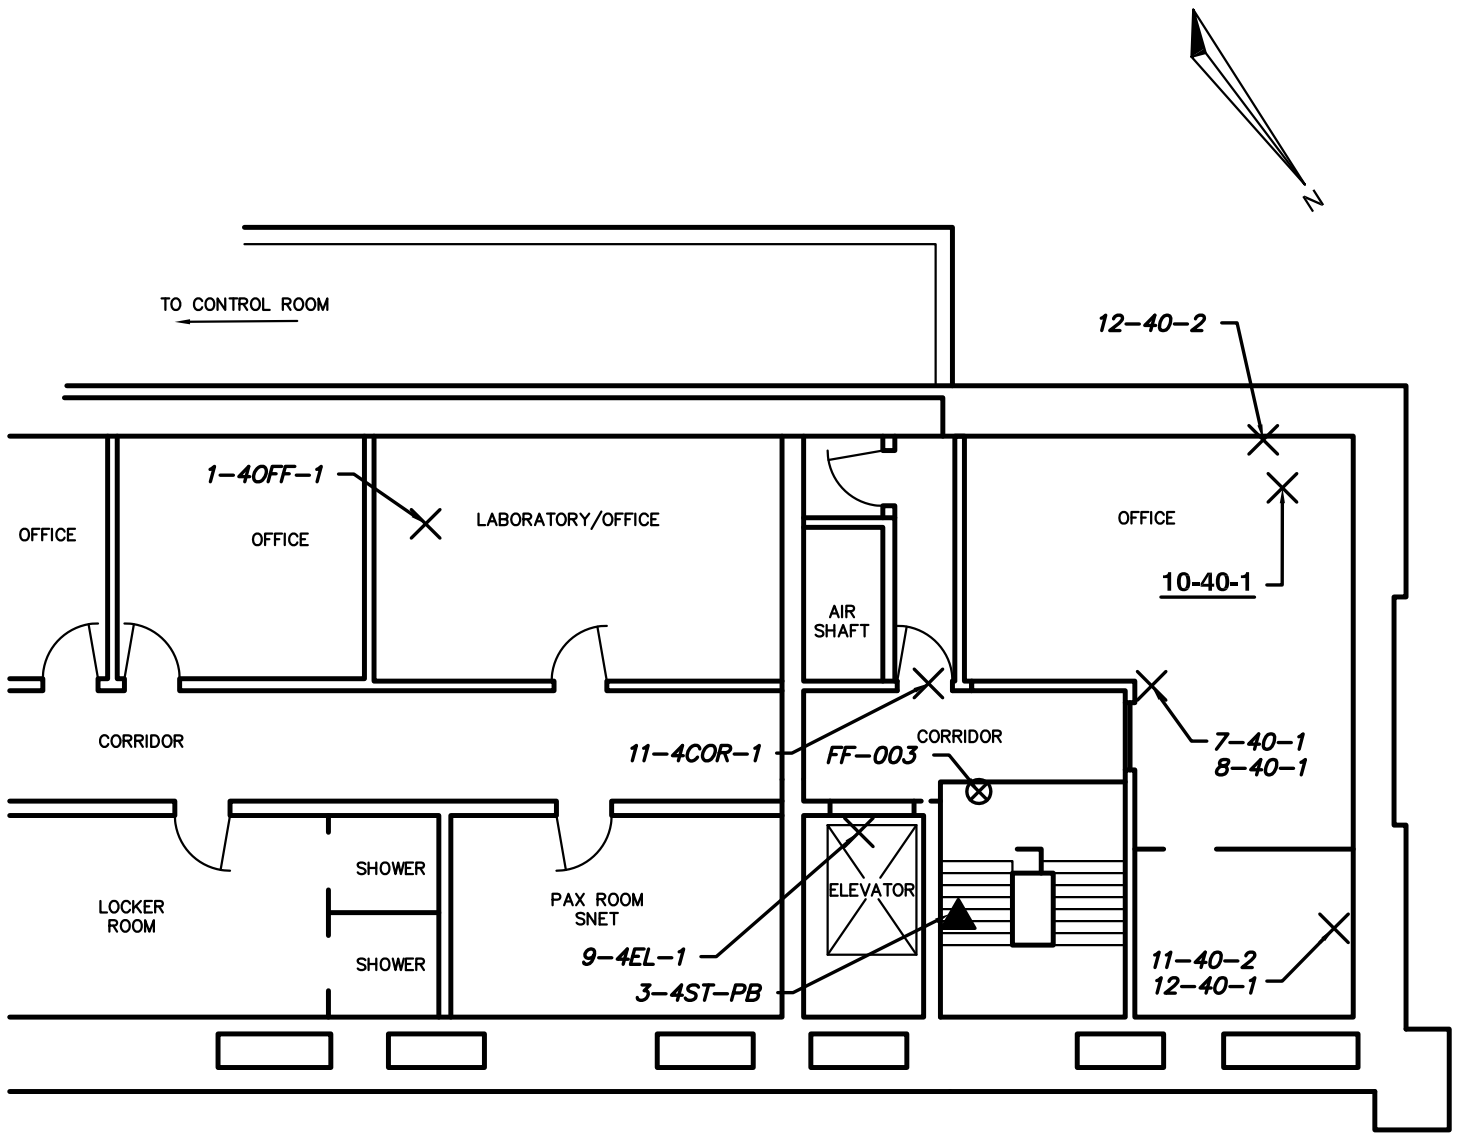
FIGURE 7
FOURTH FLOOR SAMPLING LOCATIONS
NORTH PORTION ADMIN. BUILDING
CRRA SOUTH MEADOWS STATION
GATE 20 RESERVE ROAD
HARTFORD, CONNECTICUT
HRP # CRR0155.BA
SCALE 1" = 10'±

All of the ACMs identified are non-friable materials and with the exception of the damaged red/brown 9"x9" vinyl floor tiles on the fourth floor, all were in good condition at the time of the HRP survey and risk for building occupant exposure is very low provided the materials do not become disturbed or further damaged.
