Health Assessment for

HAMILTON STANDARD

WINDSOR LOCKS, CONNECTICUT

HEALTH ASSESSMENT
FOR THE
HAMILTON STANDARD RCRA FACILITY CTD001145341
WINDSOR LOCKS, CT

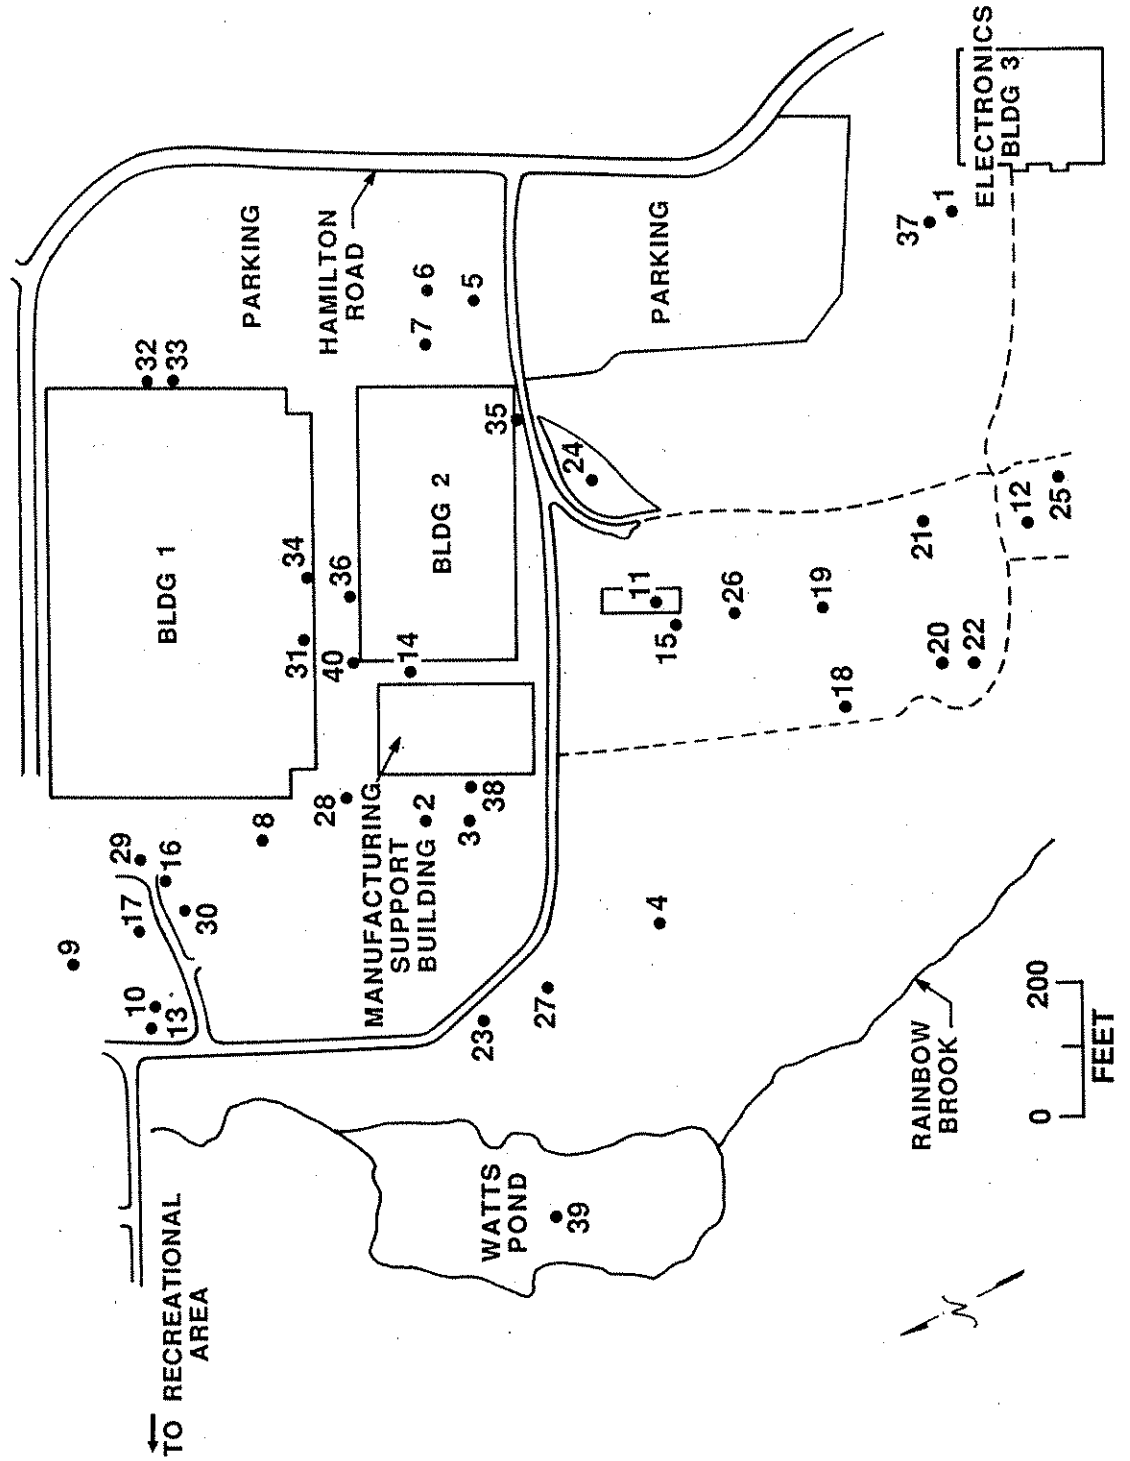
Figure A.1

HAMILTON STANDARD SITE MAP WITH SOLID WASTE MANAGEMENT UNITS INDICATED BY NUMBER

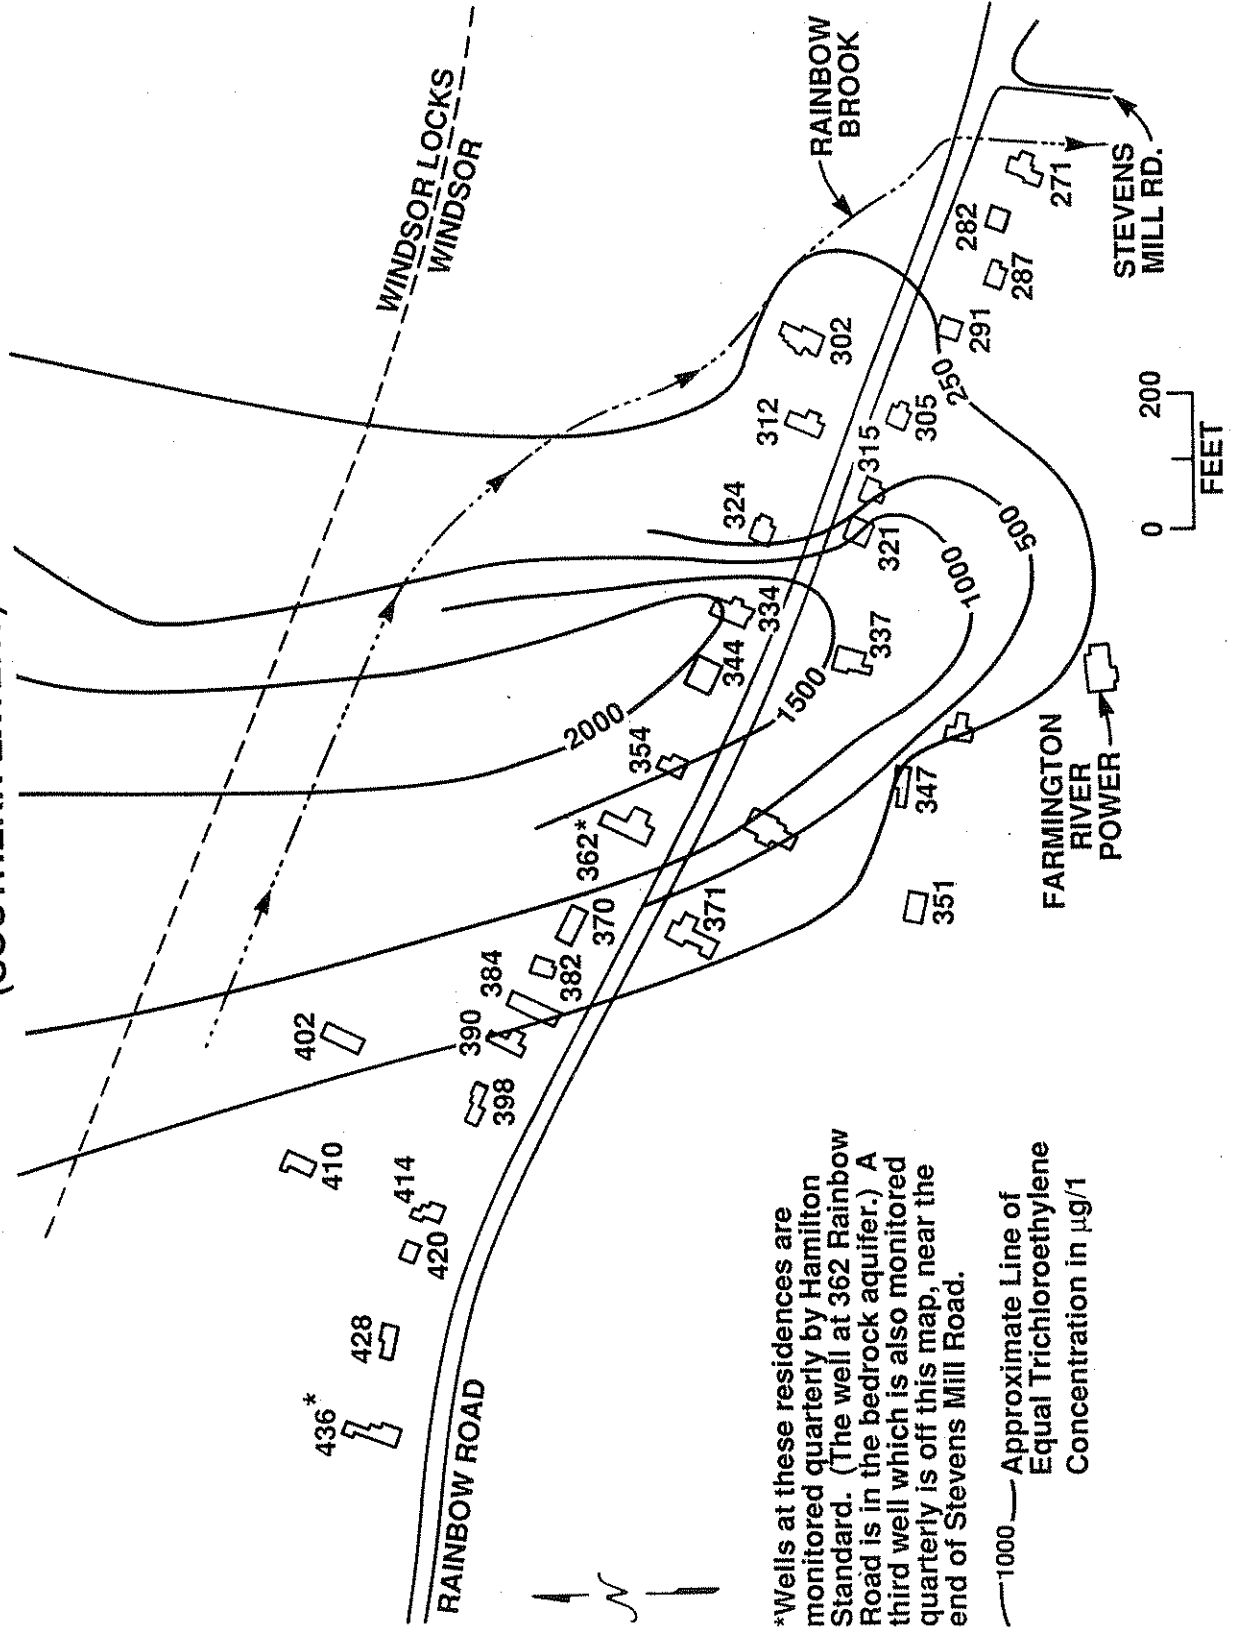
Figure A.2

The most recent quarterly monitoring data (1987-1988) of three private wells south of the Hamilton Standard facility reveal trace amounts of VOCs and chromium in the water table aquifer. However, these wells are on the fringe of a VOC plume which was identified in 1980, and the 1987-1988 data alone may not be representative of the full extent of off-site groundwater contamination. Thus, to provide a more realistic off-site contamination assessment, data from the 1980 sampling event at the residences along Rainbow Road are included in Appendix E; Figure 2 in Appendix A depicts the extent of the trichloroethylene plume in 1980.

HAMILTON STANDARD FACILITY (SOUTHERN EXTENT)

*Wells at these residences are monitored quarterly by Hamilton Standard. (The well at 362 Rainbow Road is in the bedrock aquifer.) A third well which is also monitored quarterly is off this map, near the end of Stevens Mill Road.

—1000— Approximate Line of Equal Trichloroethylene Concentration in $\mu\text{g}/\text{l}$
