**State of Connecticut
Department of Public Works
165 Capitol Avenue, Room 265
Hartford, Connecticut 06106
Mr. George P. Nakos**

**Property Condition Evaluation
Physical Condition Evaluation Report
of
18-20 Trinity Street
Hartford, Connecticut 06106**

**EMG Project No.: 91954
Date of Report: July 16, 2002
On-site Dates: April 24, 2002**

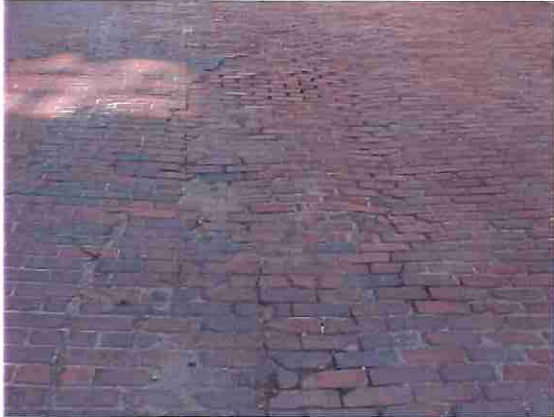
- The brick paver pavement has areas of failure that require alignment, and damaged areas that require replacement. Removal and replacement of these areas is recommended.

Photo #7: Damaged brick pavers

3.1	Pavement, brick paver replacement	Repair brick paver drive at the north side of the building.	400	SF	\$6.00	\$2,400
3.3	Retaining walls, unit masonry / concrete	Repair damaged concrete retaining walls.	1	LS	\$10,000.00	\$10,000

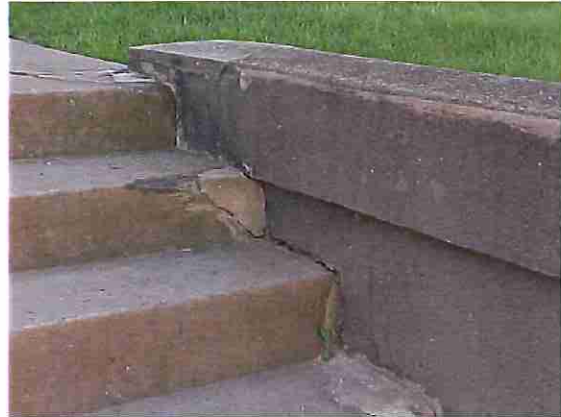
Photo #8: Damaged concrete steps

Sec	Component or System	Comments	Quantity	Unit	Cost	ST-Totals\$
3.1	Steps, concrete repair	Repair damaged and misaligned concrete steps.	500	SF	\$6.00	\$3,000

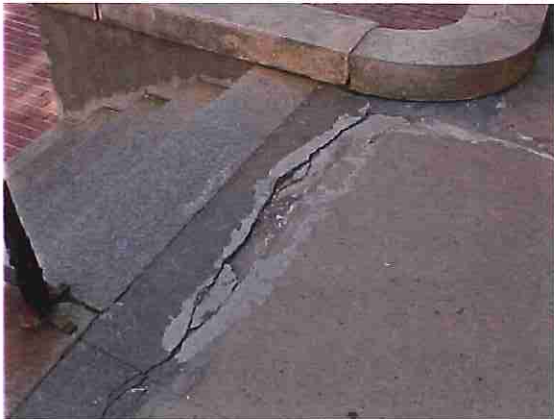
Photo #9: Cracking concrete at exterior steps

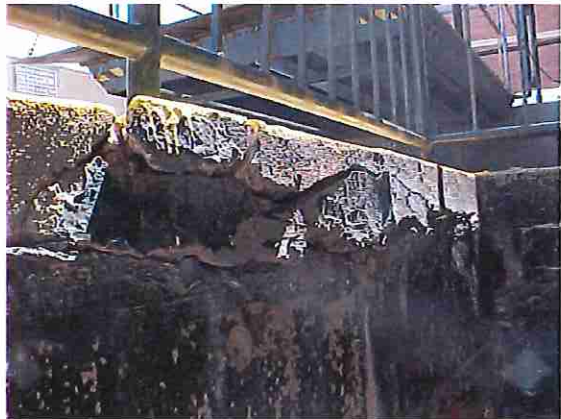
Photo #10: Damaged concrete at exterior concrete stair

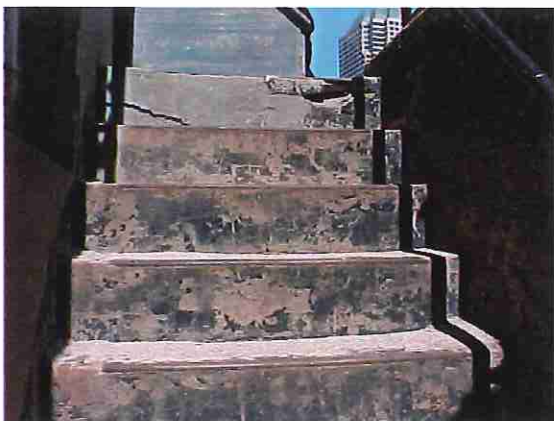
Photo #11: Exterior stair and spalling concrete

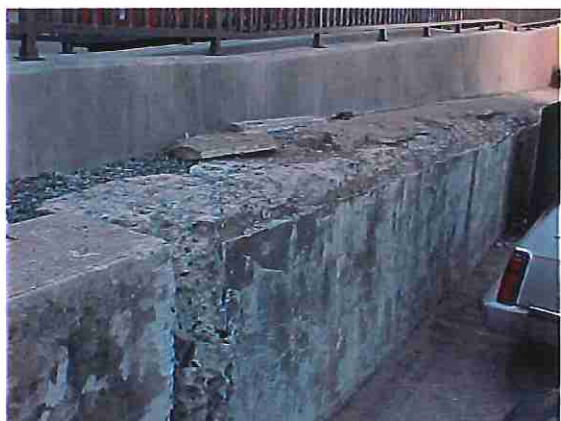
Photo #12: Damaged concrete retaining wall along southern property line

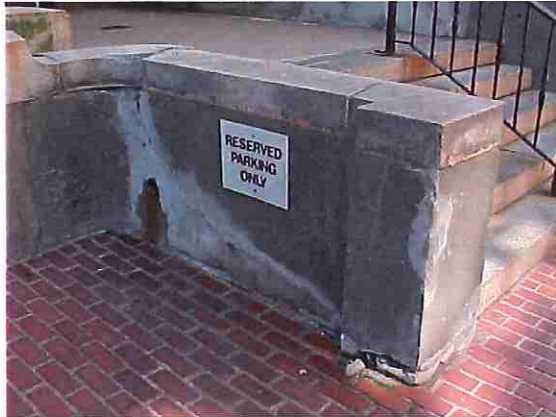
Photo #13: Damaged concrete retaining wall

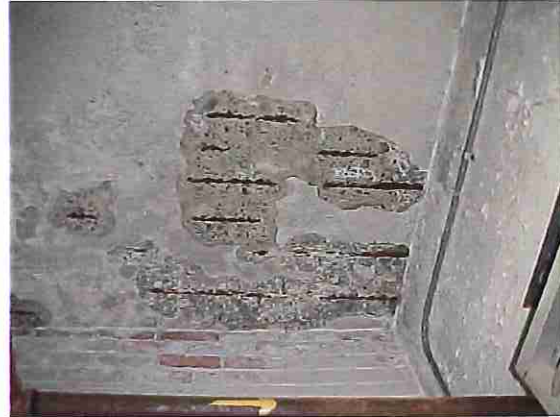
- Significant water damage and surface spalling of the concrete ceiling basement slab below the rear parking area was observed. Repairs are required within the year. As part of this repair, waterproofing and sealing of the lower rear wall at foundation/asphalt pavement transition. The cost of this work is included in the Short Term Repairs Cost Estimate (Table 2).

Photo #14: Spalling concrete basement ceiling

4.2	Concrete floor slab	Repair concrete basement slab and waterproof.	1	LS	\$7,500.00	\$7,500
4.4	Exterior walls, masonry cleaning / repointing	Repair remaining building facades as required.	1	LS	\$500,000.00	\$500,000

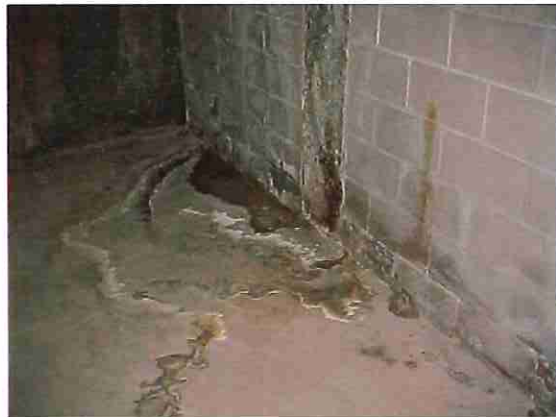
Photo #15: Water staining in basement at rear wall

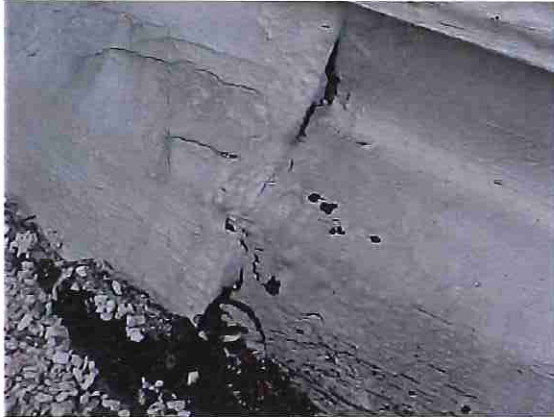
Photo #19: Damaged built-up roof flashing

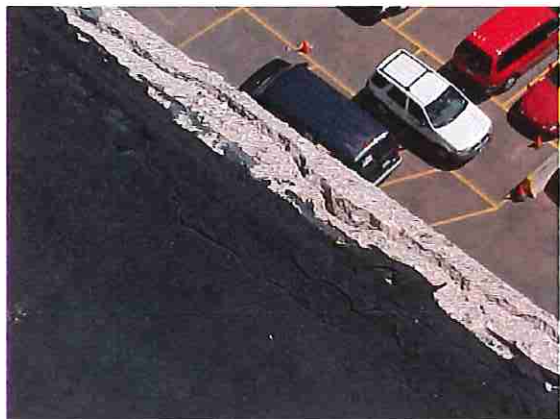
Photo #22: Spalling stone veneer at parapet wall

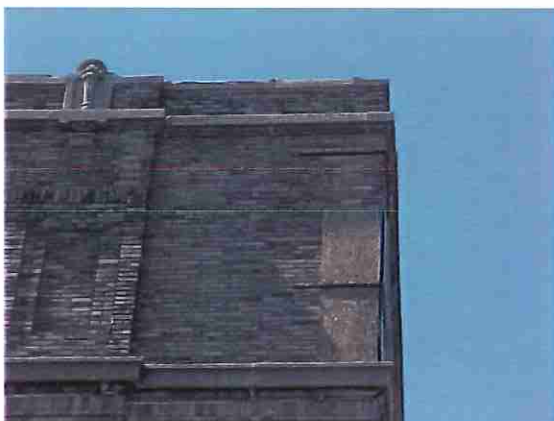
- The brick and stone are in fair to poor condition. A general deterioration of the brick and mortar joints has occurred along the corners of the 6-story portion of the building. Corrosion of the steel lintels was also observed. Temporary repairs and bracing was observed. A detailed *Exterior Wall Investigation Report*, prepared by DuBose Associates Inc. Architects, (included in the appendices of the report), outlines the existing conditions, causes, potential consequences and recommendations for repairs. The recommended repairs should be completed immediately based on the severity of the situations.

Photo #23: Exterior masonry wall damage and temporary wood bracing

Sec	Component or System	Comments	Quantity	Unit	Cost	I-Totals\$
4.4	Exterior walls, masonry cleaning / repointing	Repair building corners of 6-story portion of the bldg.	1	LS	\$1,650,000.00	\$1,650,000
4.5	Interior stair walls	Re-finish plaster walls that were damaged by water infiltration.	1	LS	\$1,500.00	\$1,500

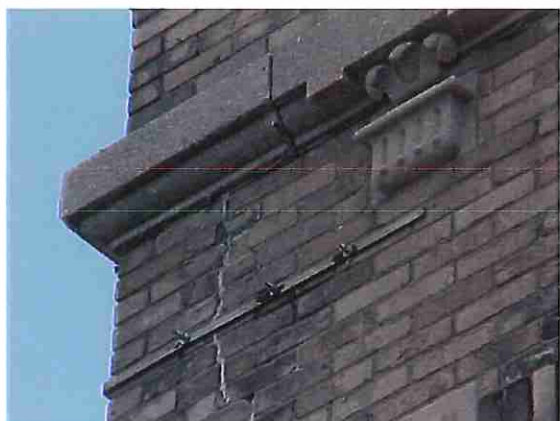
Photo #24: Masonry wall cracking

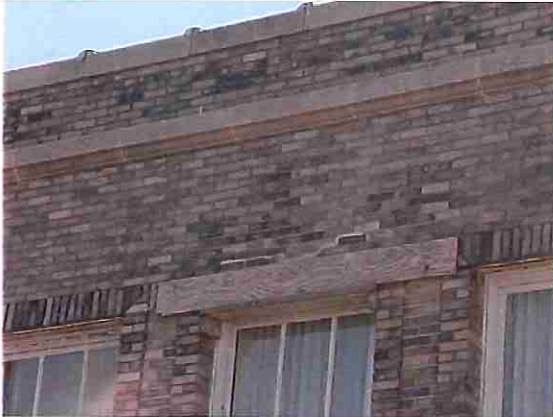
Photo #25: Damaged masonry wall over window

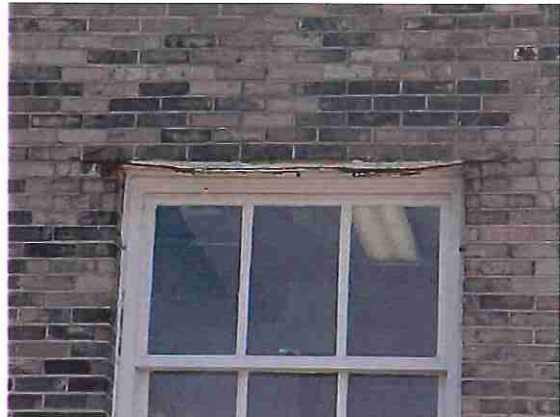
Photo #26: Deteriorating steel lintel at window opening

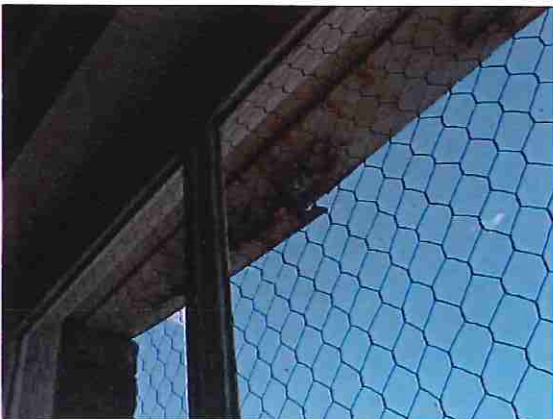
Photo #27: Deteriorating steel lintel

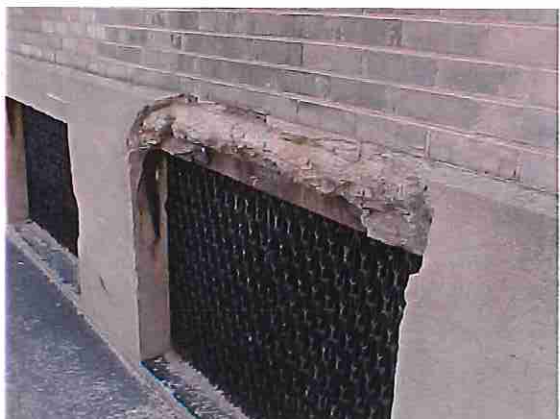
Photo #28: Damaged stone veneer

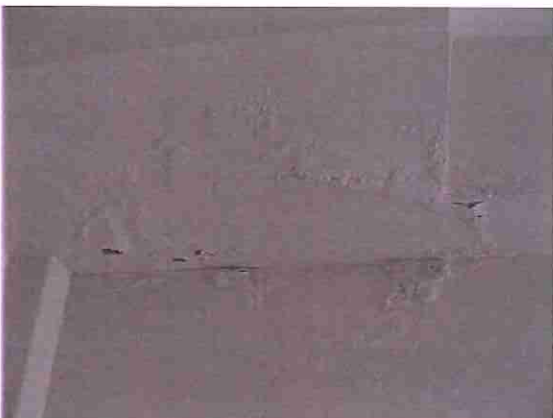
Photo #29: Water infiltration at interior wall

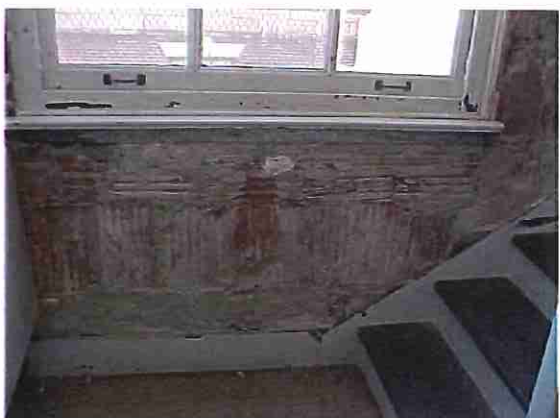
- The interior stairways and handrails are in good to poor condition. The plaster wall finish was removed from the north stair tower, floors 3 through 5. Damaged was caused by recently repaired water infiltration through the exterior wall. Repair and refinish interior plaster walls at the north stair tower, floors 3 through 5 immediately.

Photo #30: Removed plaster wall finish for north stairwell

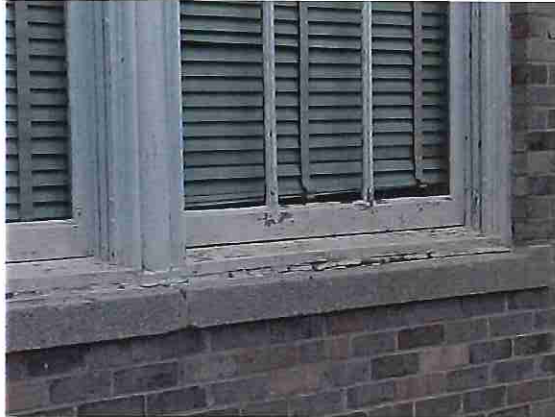
Photo #31: Deteriorating window finish and sealant

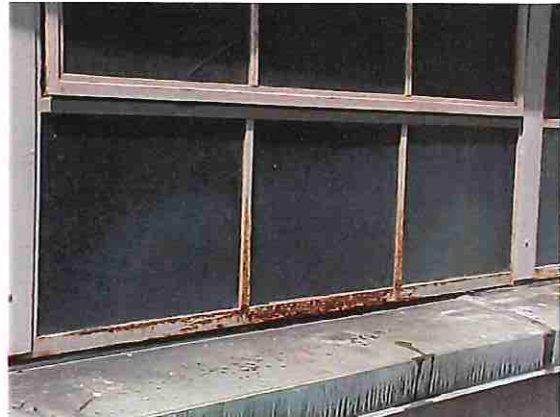
- The windows are in fair condition. Rusting and peeling paint were observed at a majority of the exterior wood and metal windows. Rotting wood sashes were also observed. Repairs, scraping, priming and painting will be required.

Photo #32: Rusting window frame

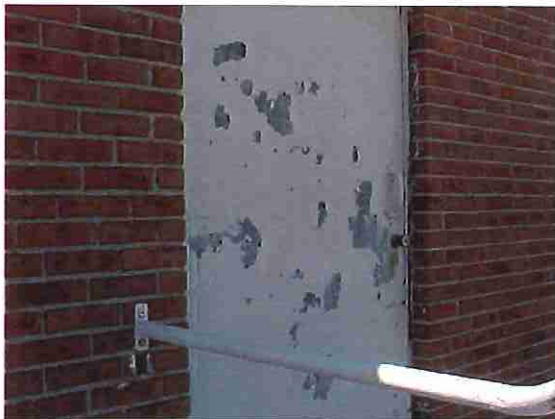
Photo #33: Peeling paint at rooftop door

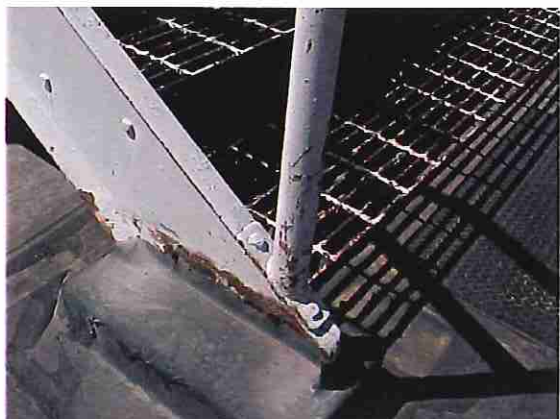
Photo #34: Rusted rooftop stair

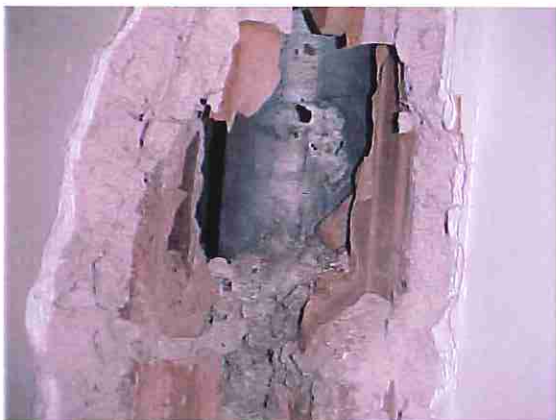
Photo #53: Rusted through galvanized drain lines

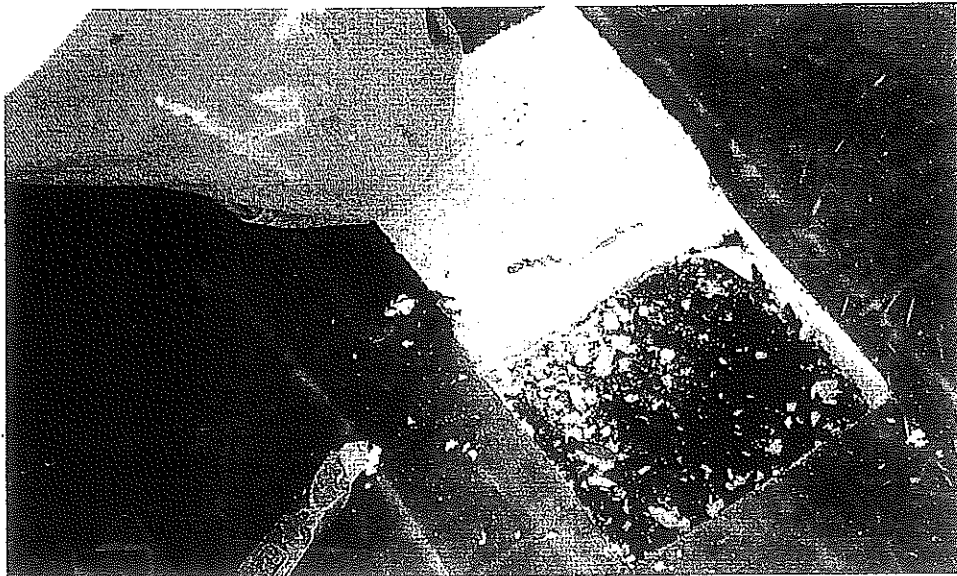
PHOTO -D ROOF TEST CUT AT NORTHWEST CORNER OF THE ROOF IS DRY.

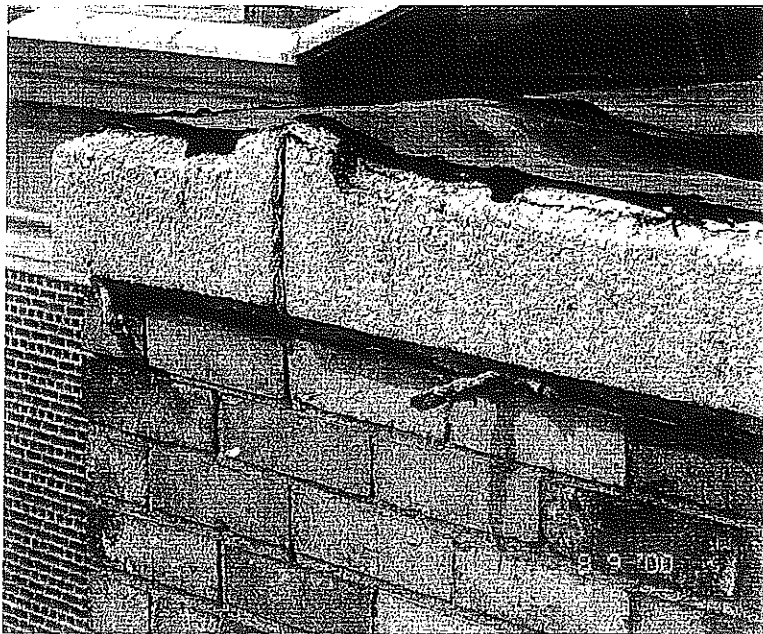
PHOTO -F CRACK SAMPLE ABOVE THE PRECAST CONCRETE COPING.

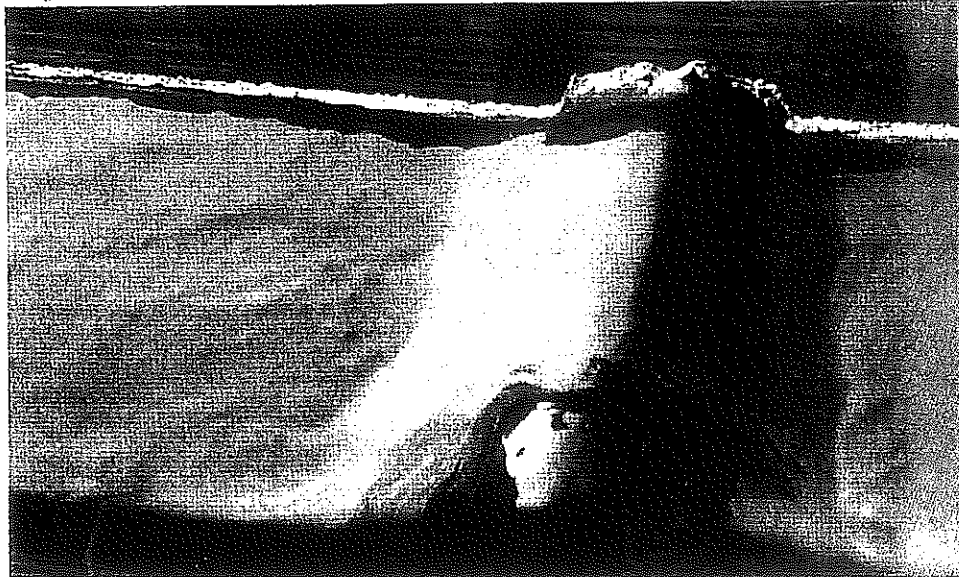
PHOTO -G TYPICAL MEMBRANE COVERING ABOUT 75% OF THE PRECAST CONCRETE COPING. CRACKS ARE VERY PROMINENT AT THE RIDGE OF THE COPING.

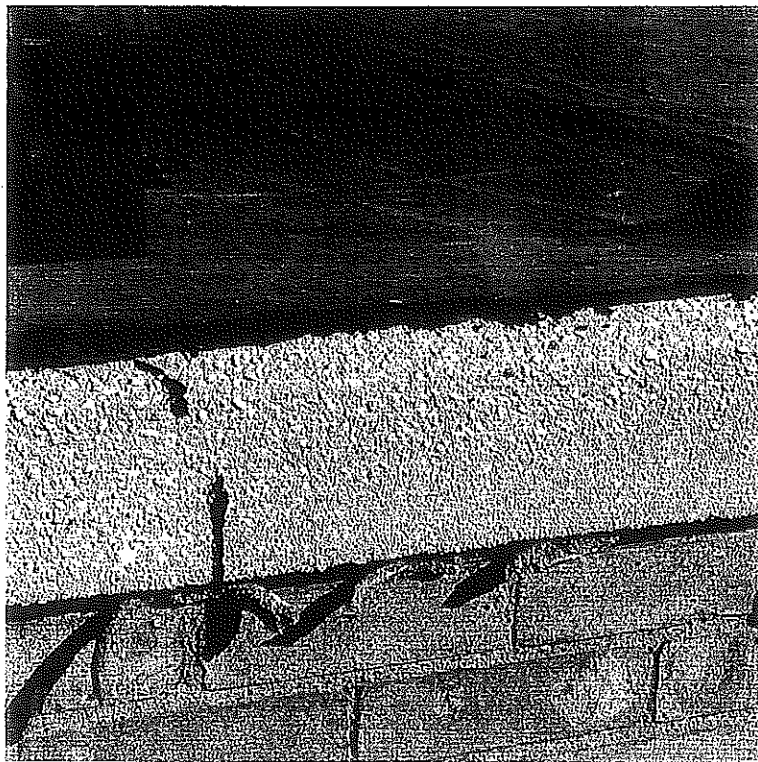
PHOTO -H PRECAST CONCRETE COPING. NOTE: CAULKING IS MISSING

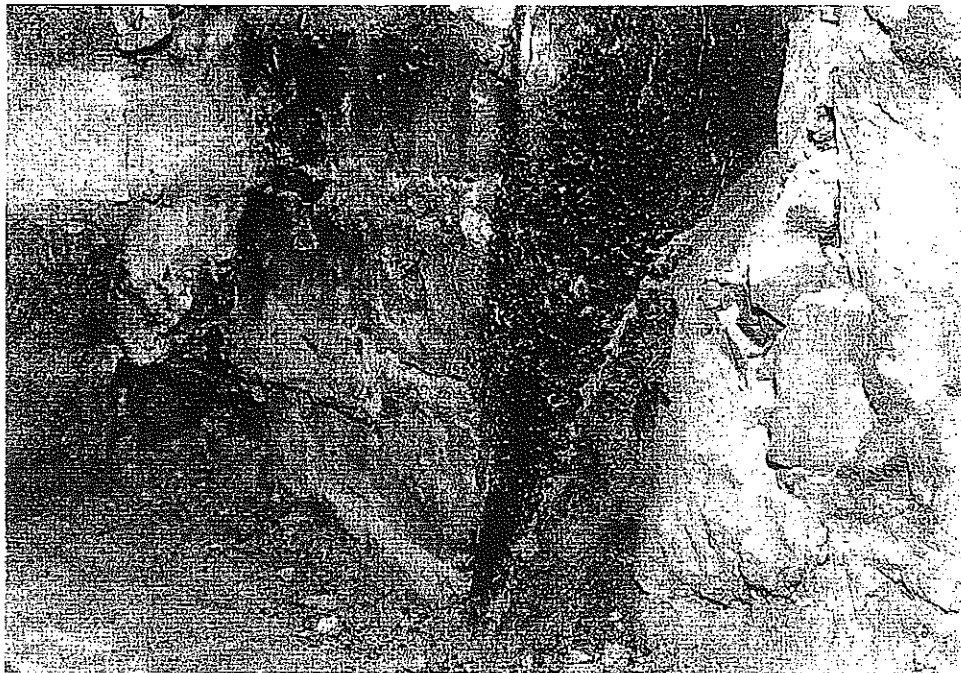
PHOTO#8 PHOTO #7 CLOSE UP SHOWING CORRODED FLANGE

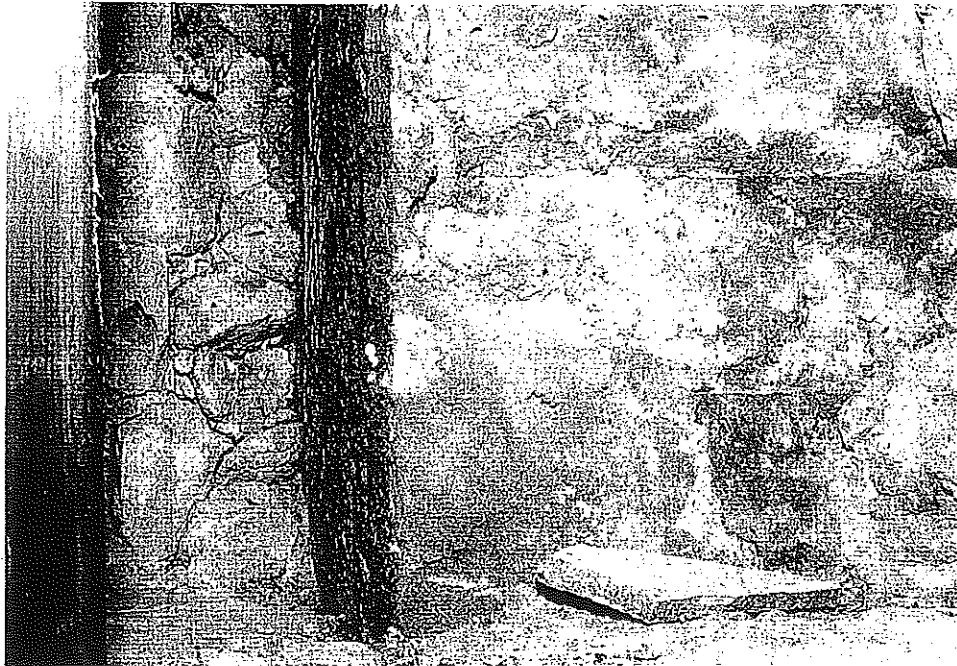
PHOTO# 10 PHOTO#9 CLOSE UP SHOWING CORRODED FLANGE

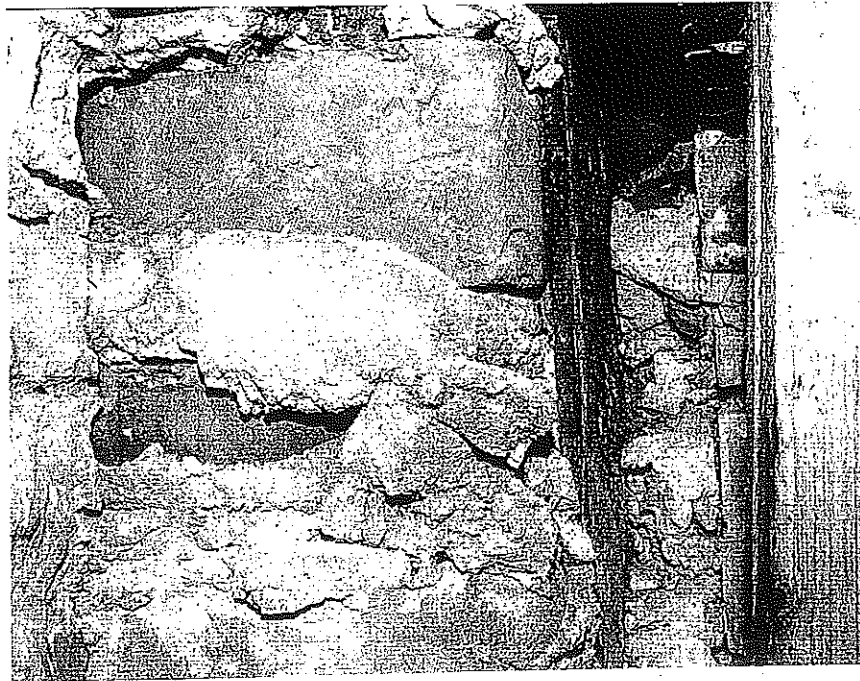
PHOTO# 12 PHOTO # 11 CLOSE UP- MILD CORROSION OF FLANGE

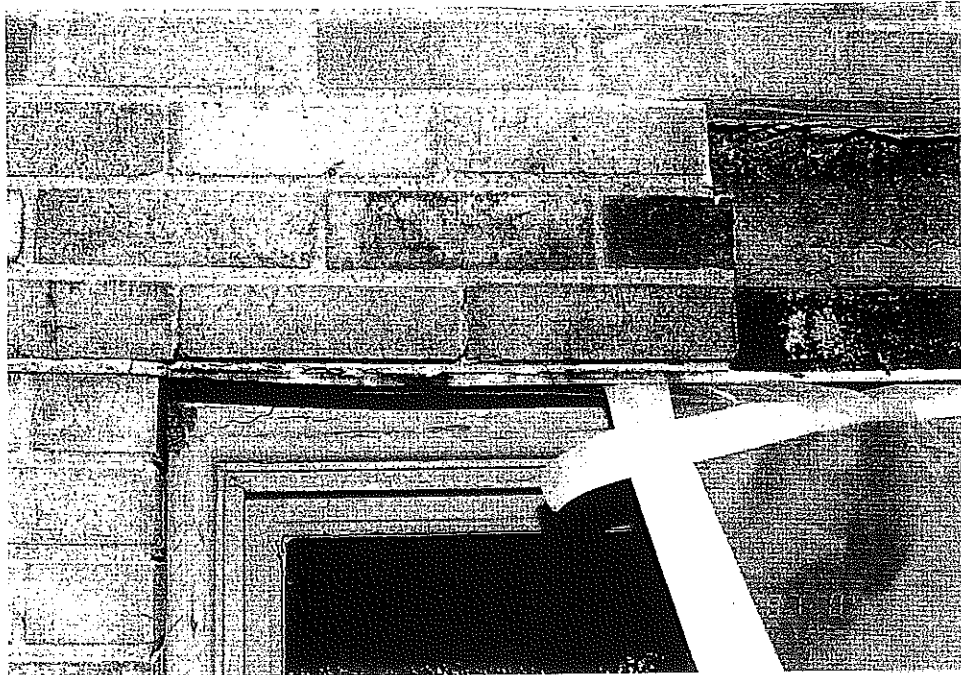
PHOTO# 18 NORTH WALL - CORRODED WINDOW LINTEL.

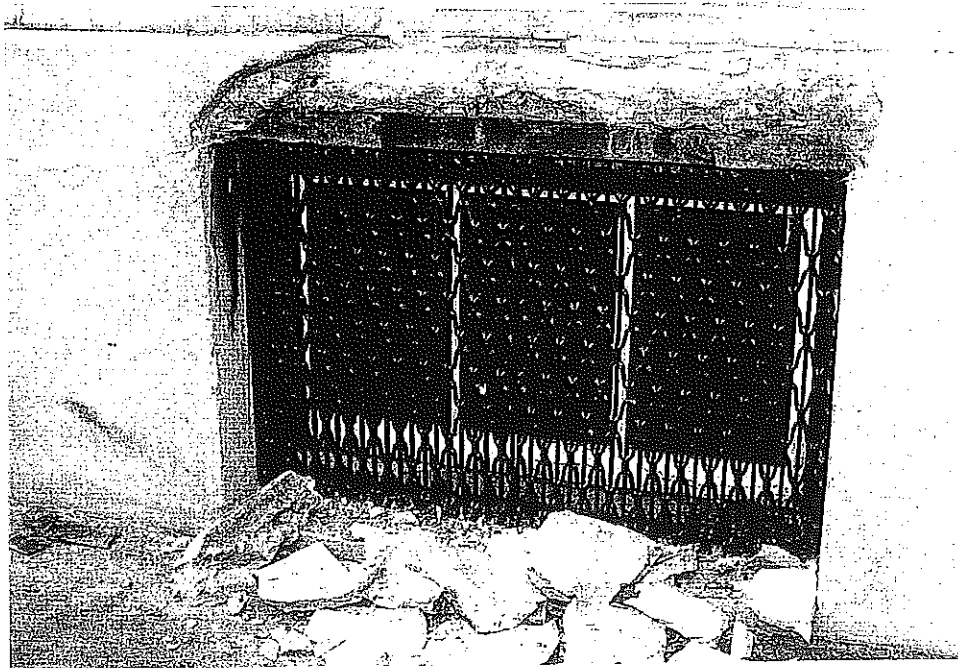
PHOTO#19 NORTH WALL - CORRODED BASEMENT WINDOW LINTEL

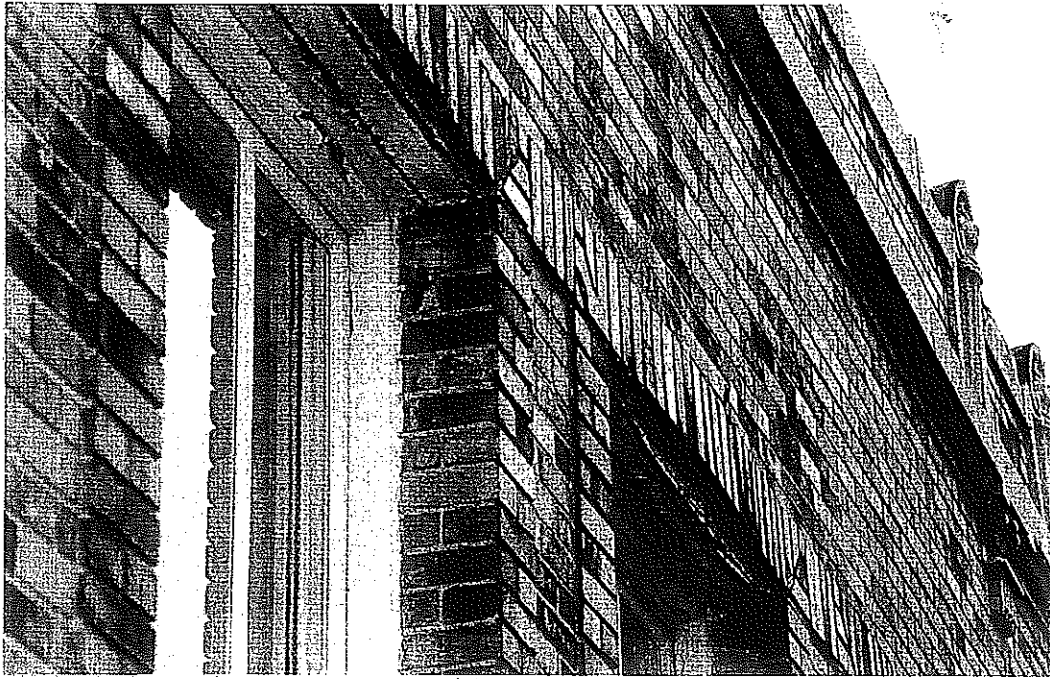
PHOTO# 20 NORTH WALL - LINTEL CORROSION

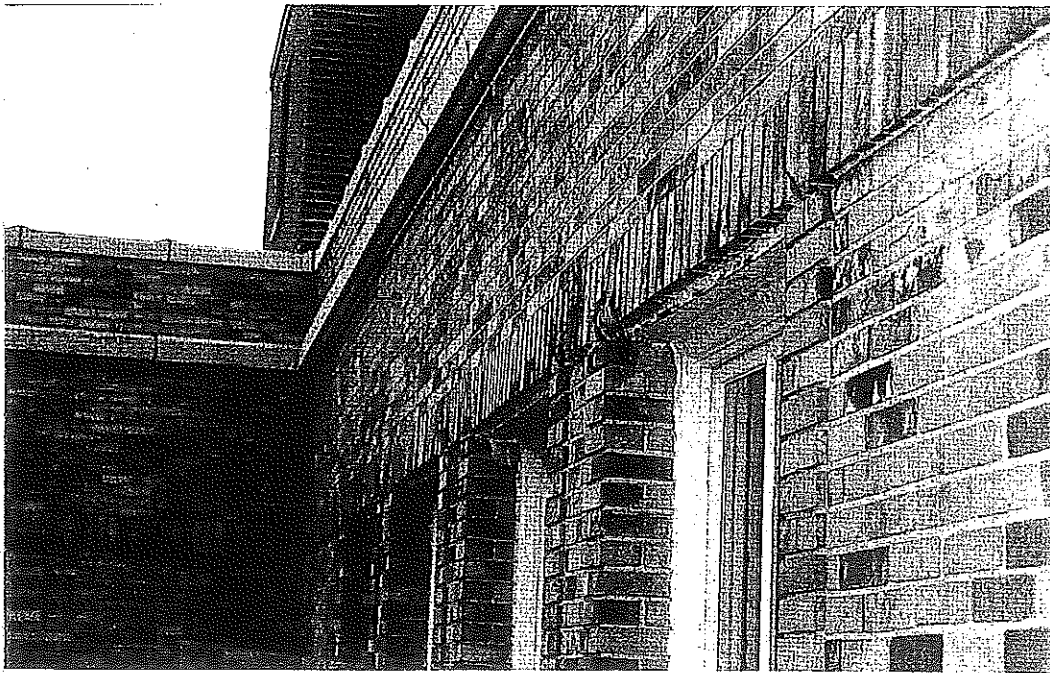
PHOTO# 21 SOUTH WALL- LINTEL CORROSION

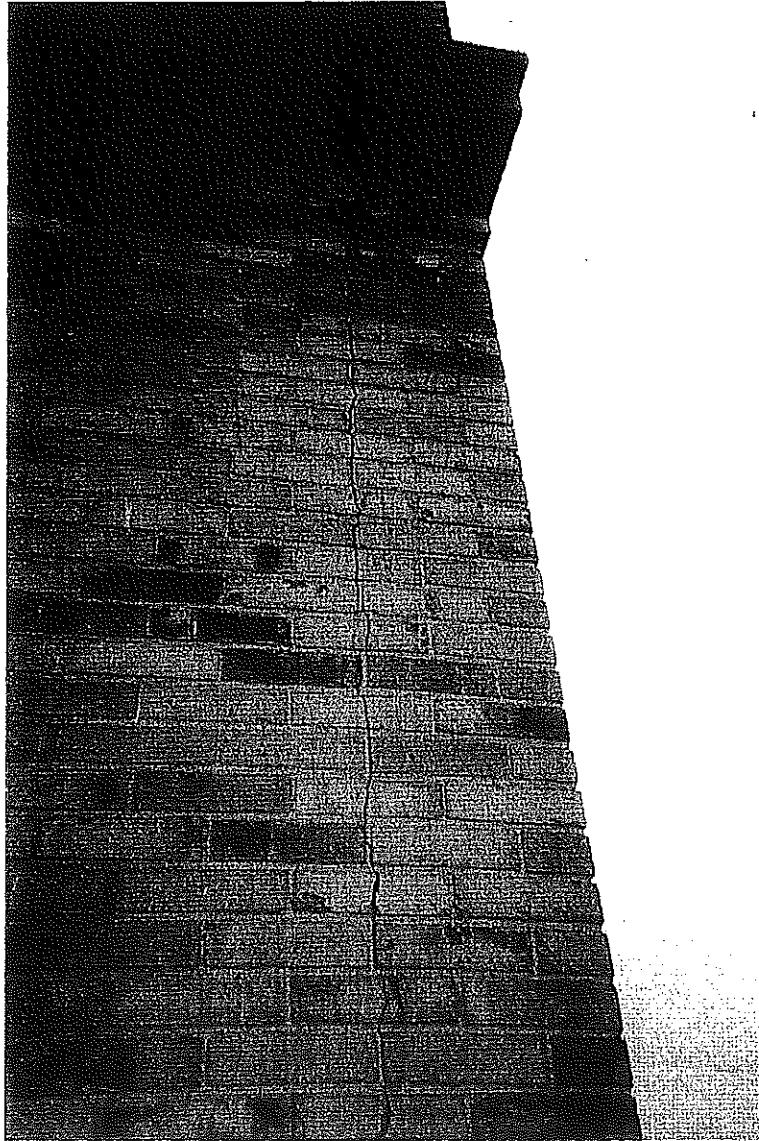
PHOTO #24 CONTINUOUS VERTICAL CRACK FROM THE TOP OF THE PARAPET DOWN TO THE FOURHT FLOOR OF SOUTHEAST CORNER. NOTE, BOTTOM SECTION OF THE PRECAST CONCRETE CORNICE FELL OFF.

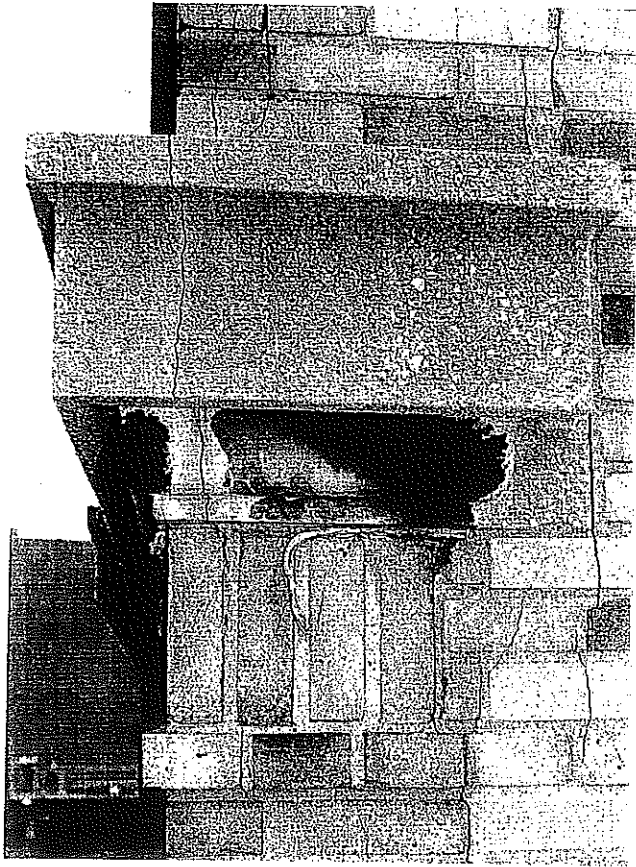
PHOTO #25 CONTINUOUS VERTICAL CRACKS ARE VISIBLE AND VERY PROMINENT AT THE TOP OF THE NORTHEAST CORNER OF THE BUILDING. NOTE, PRECAST CONCRETE CORNICE CRACKED AND BOTTOM PART FELL OFF.

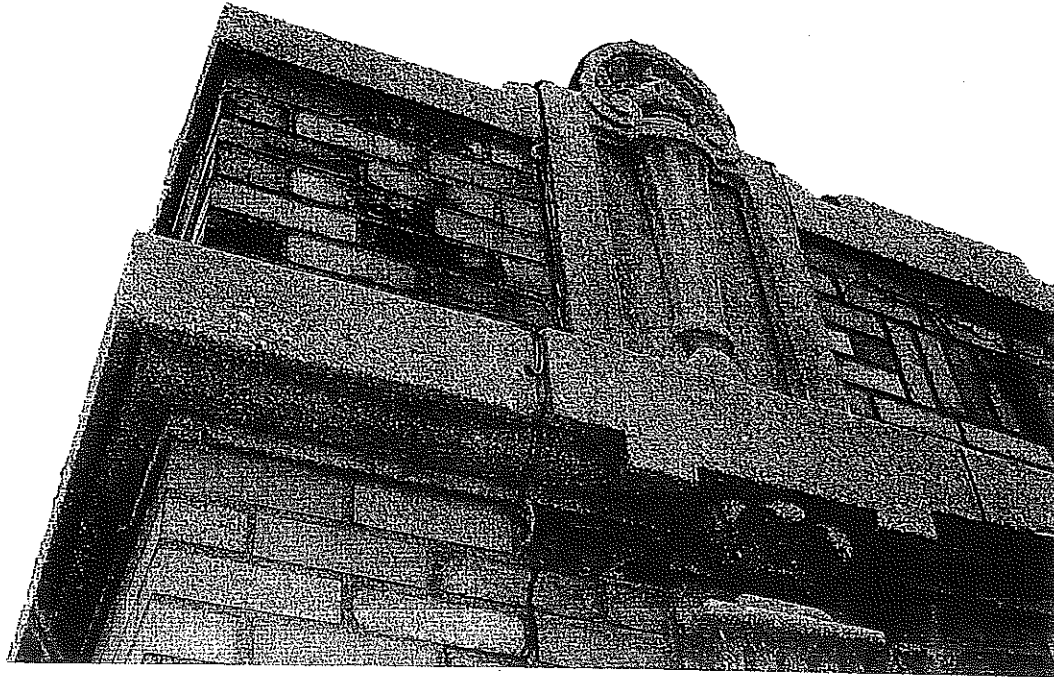
PHOTO #26 PRECAST CONCRETE COPING, DECORATIVE ORNAMENTS AND CORNICES. CAULKING IS MISSING. NOTE VERTICAL CRACK FROM PARAPET AT NORTHEAST CORNER.

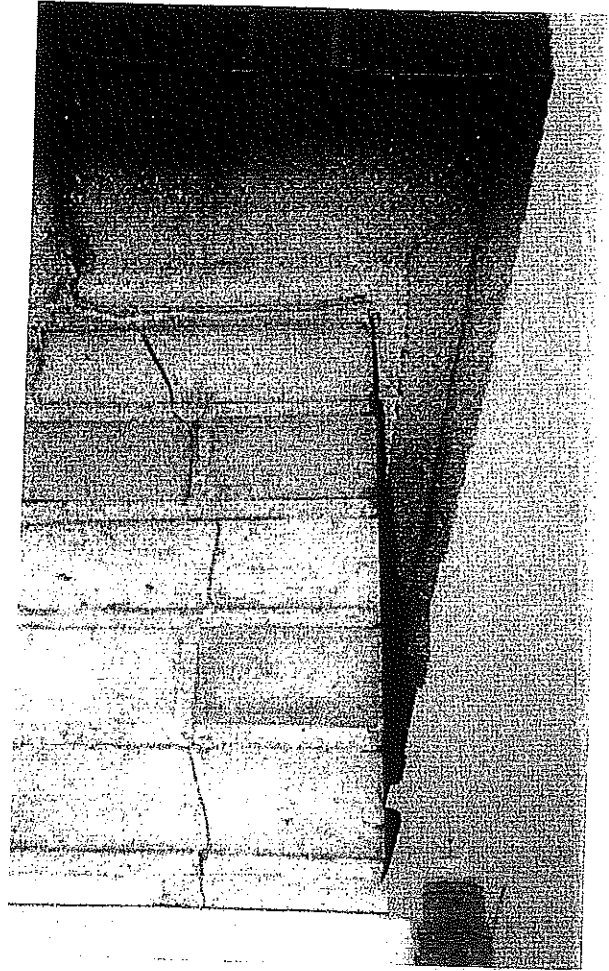
PHOTO #28 NORTHWEST TOP CORNER PRECAST CONCRETE CORNICE JOINT AND BRICK WALL CRACK.
