PRE-RENOVATION INVESTIGATIVE SURVEY FOR ASBESTOS- CONTAINING MATERIALS AND LEAD BASED PAINT 18-20 TRINITY STREET HARTFORD, CONNECTICUT

Project No. 19-2B-HAZ-12
DCS No. 19028

July 2, 2019

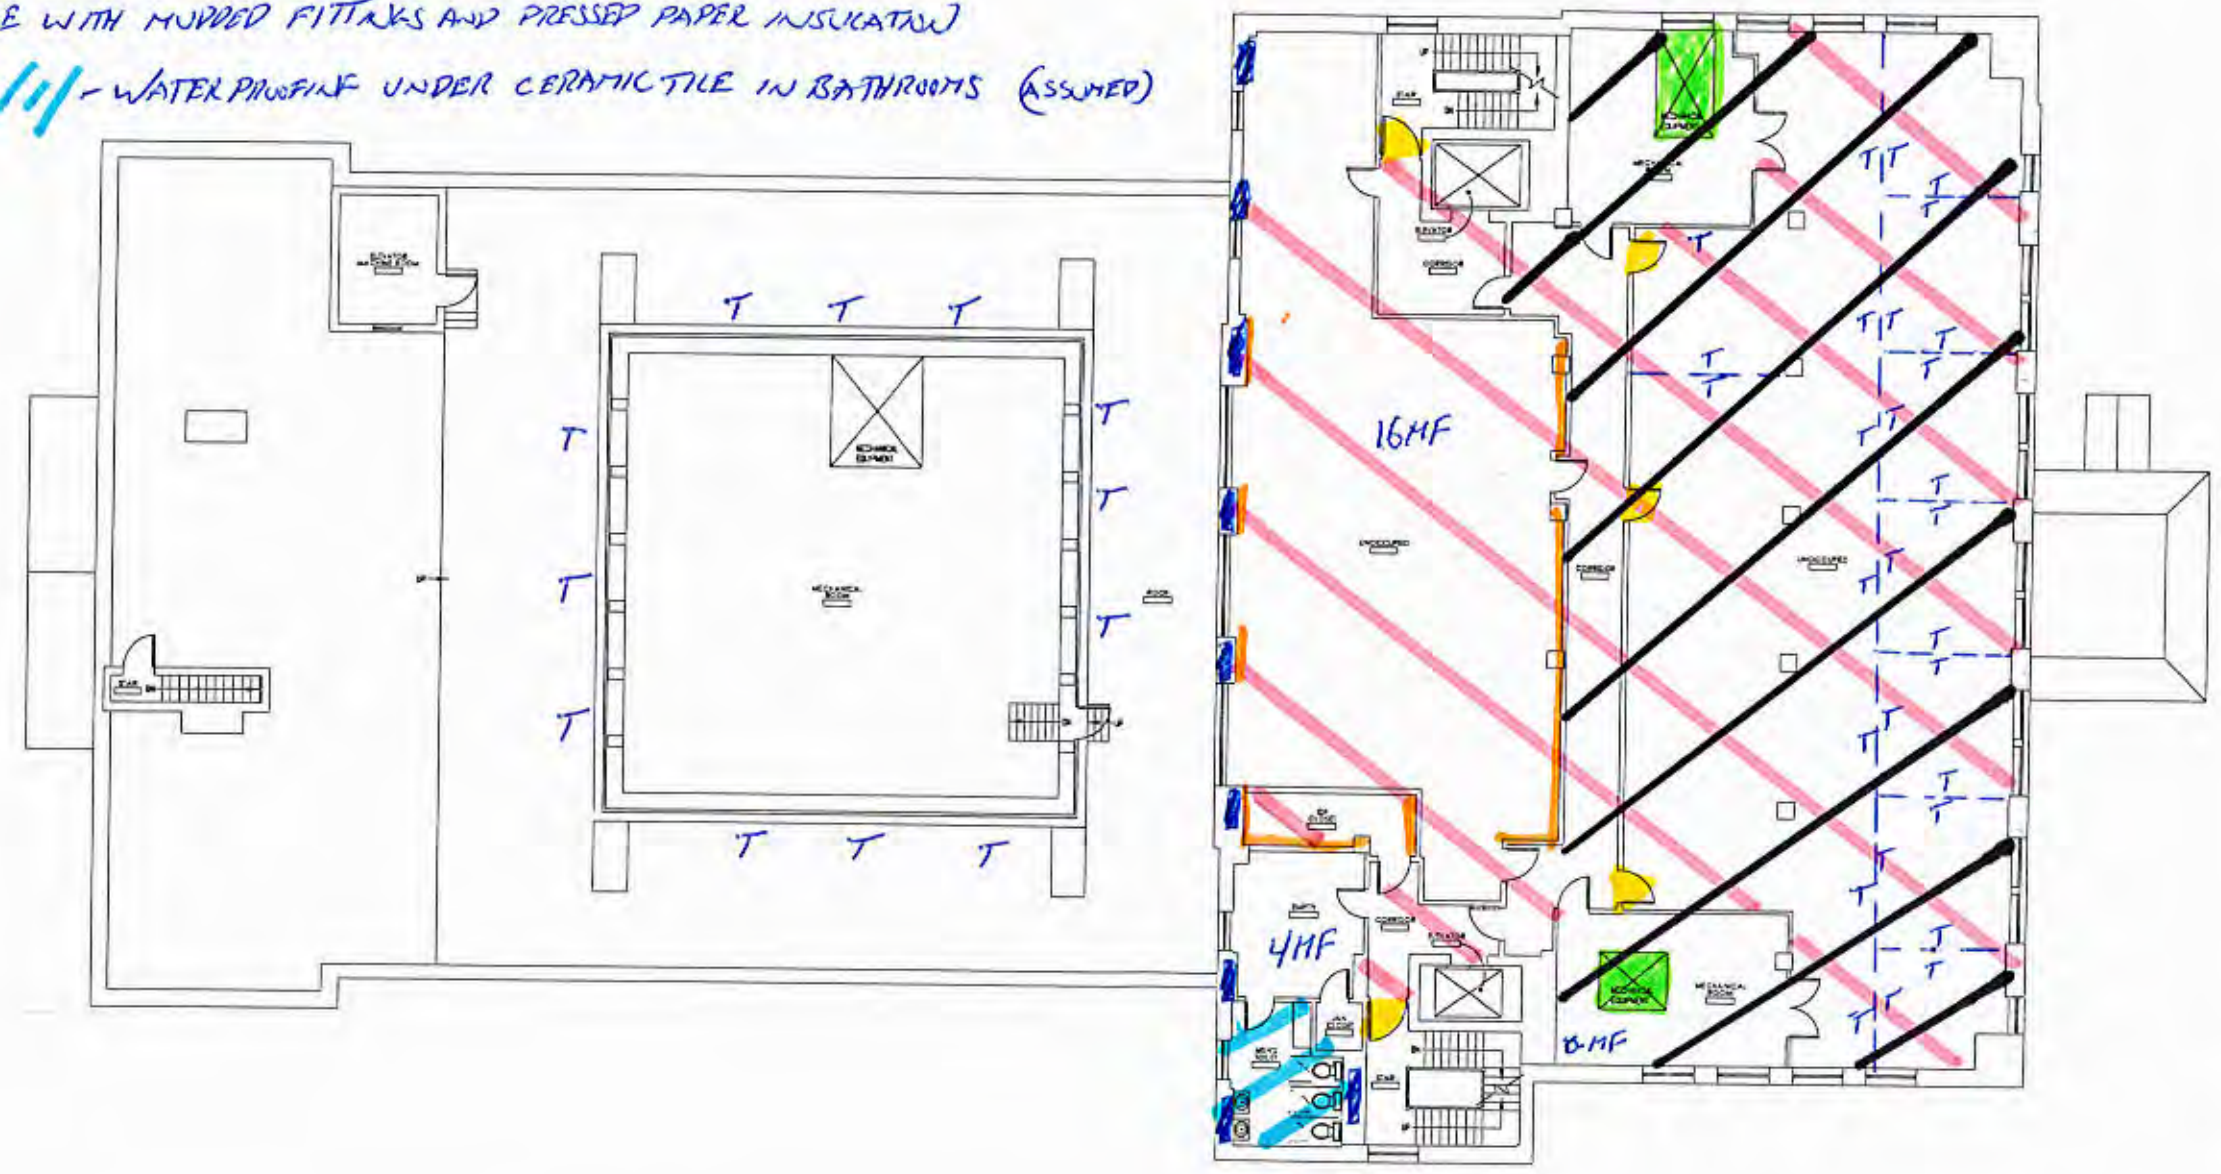
Fourth Floor Plan
1" = 8'-0"

- ASSUME ACM FLOOR TILE AND MASTIC UNDER WALL PARTITIONS, RAMPS, AND RAISED FLOORS
- ASSUME MIRROR GLUE PANELS IN BATHROOMS
- ASSUME WATER PROOFING UNDER CERAMIC TILE IN BATHROOMS

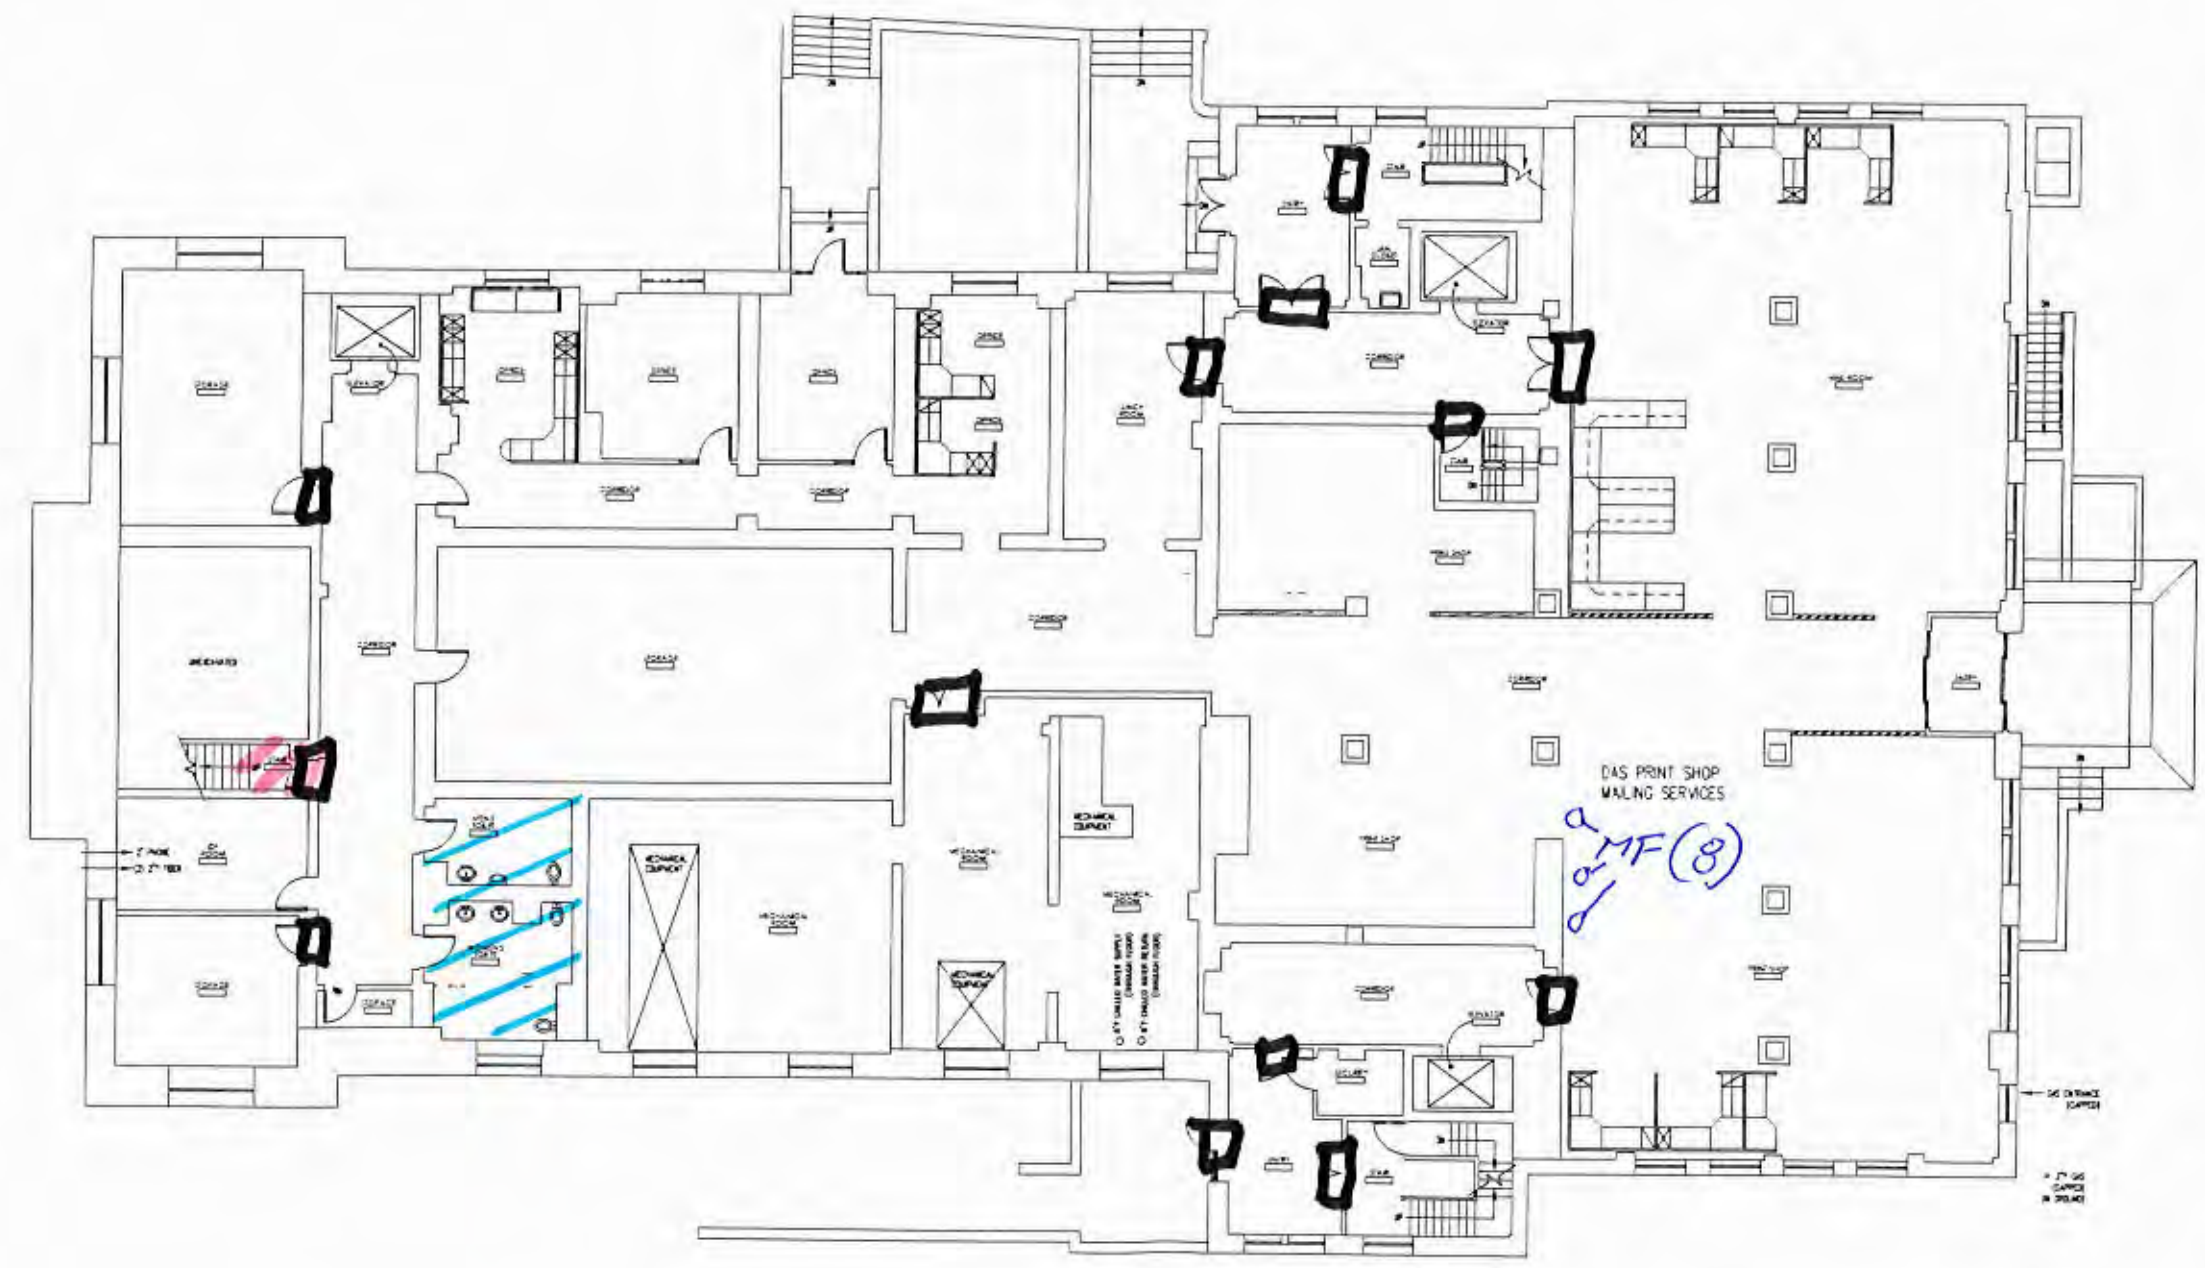
Ground Floor Plan
1" = 8'-0"

- ASSUME MIRROR GLUE PAUBS IN BATHROOM

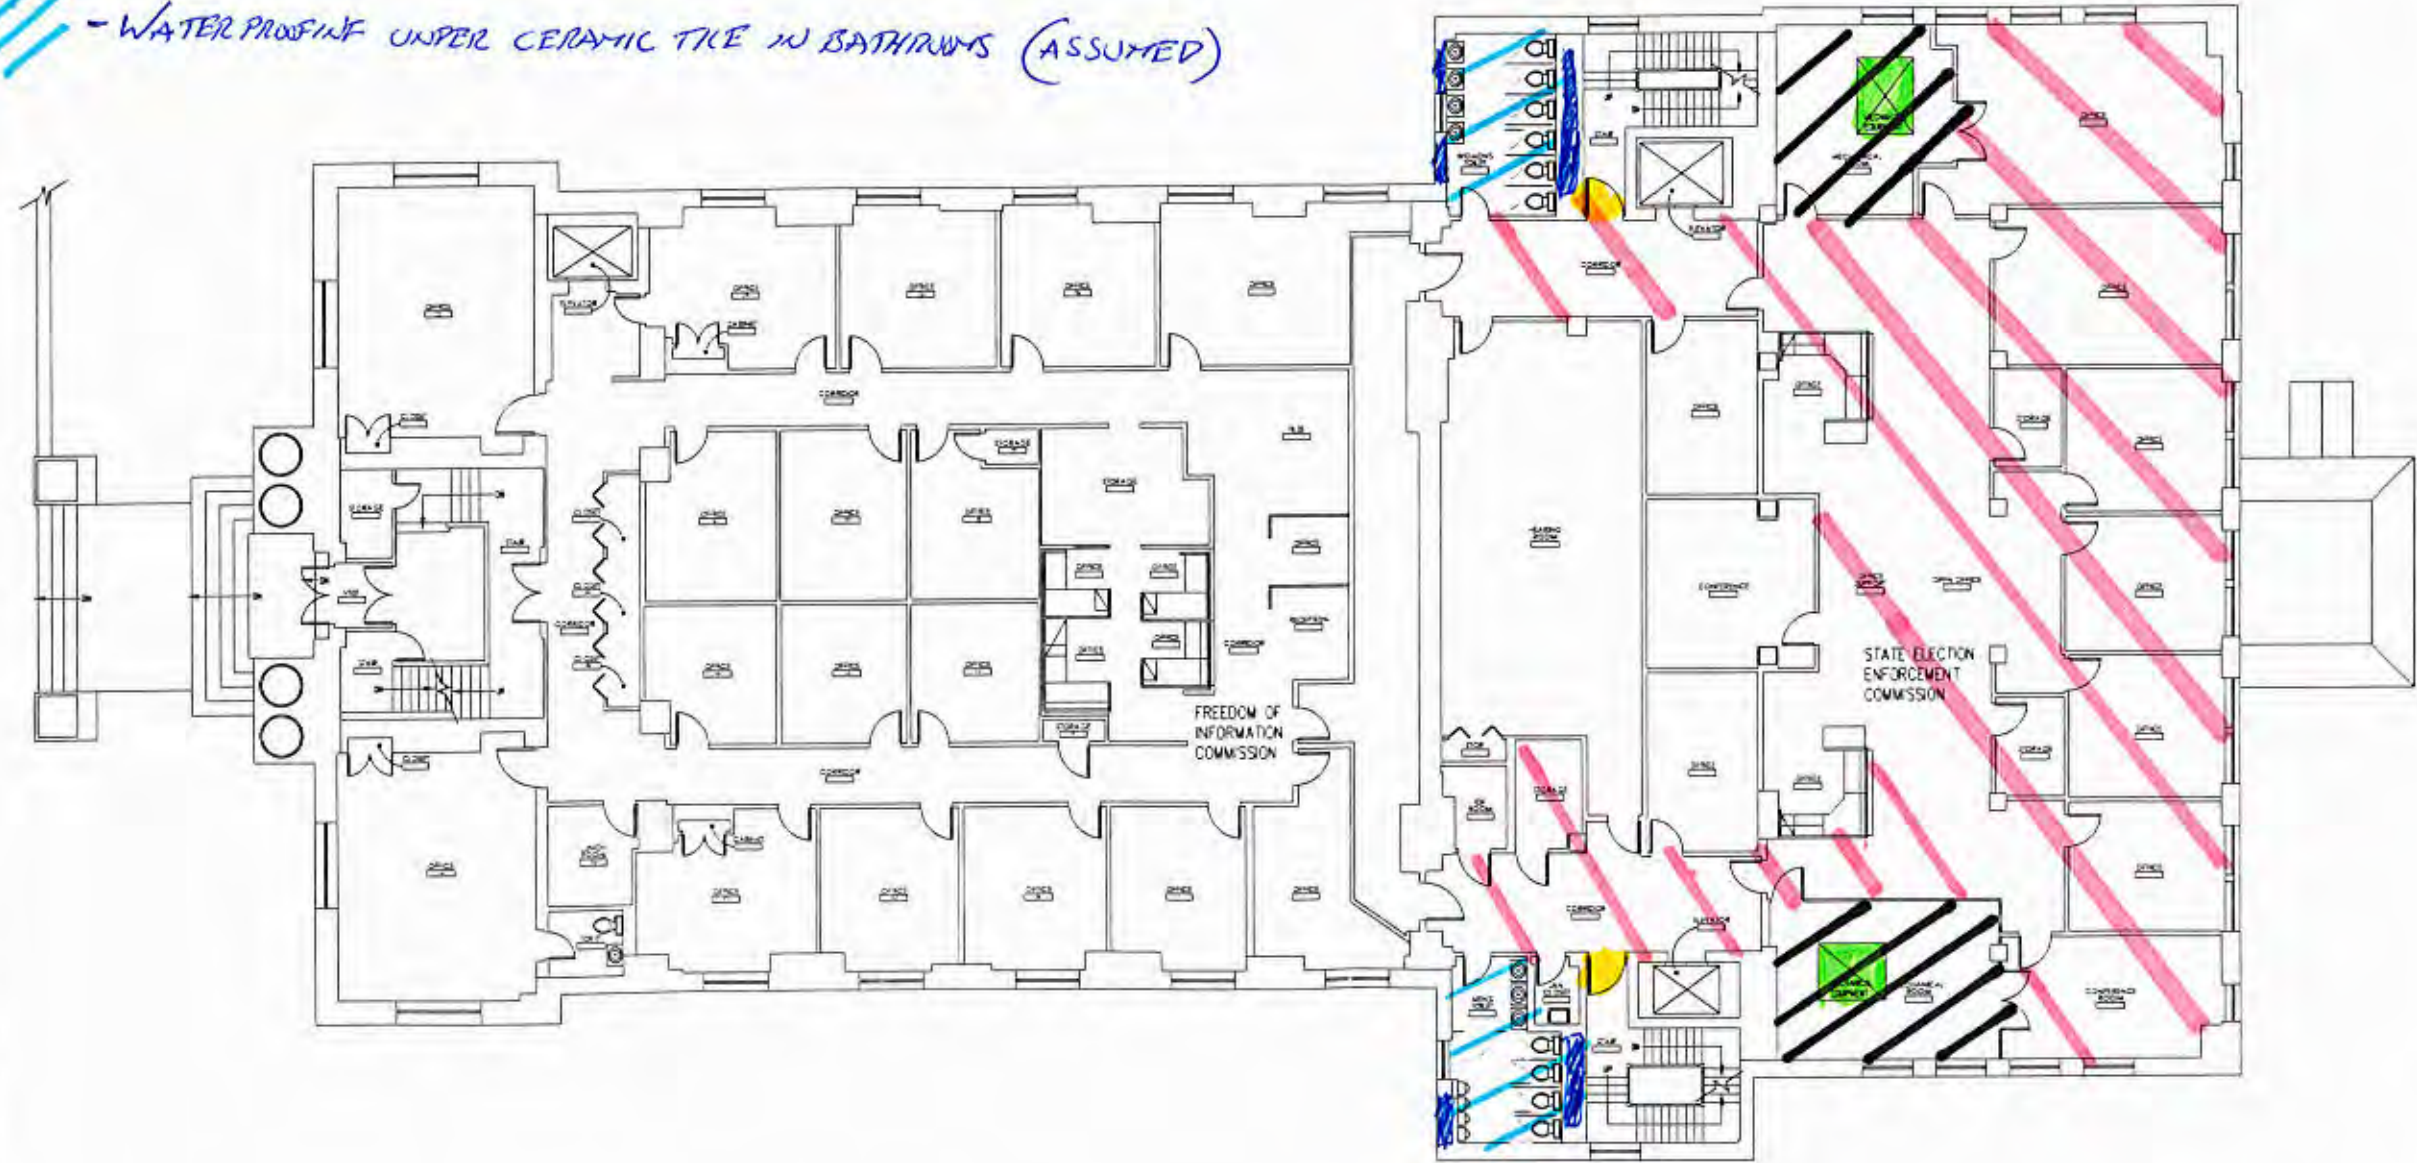
First Floor Plan
1" = 6'-0"

- ASSUME MIRROR GLUE PAUBS IN BATHROOMS

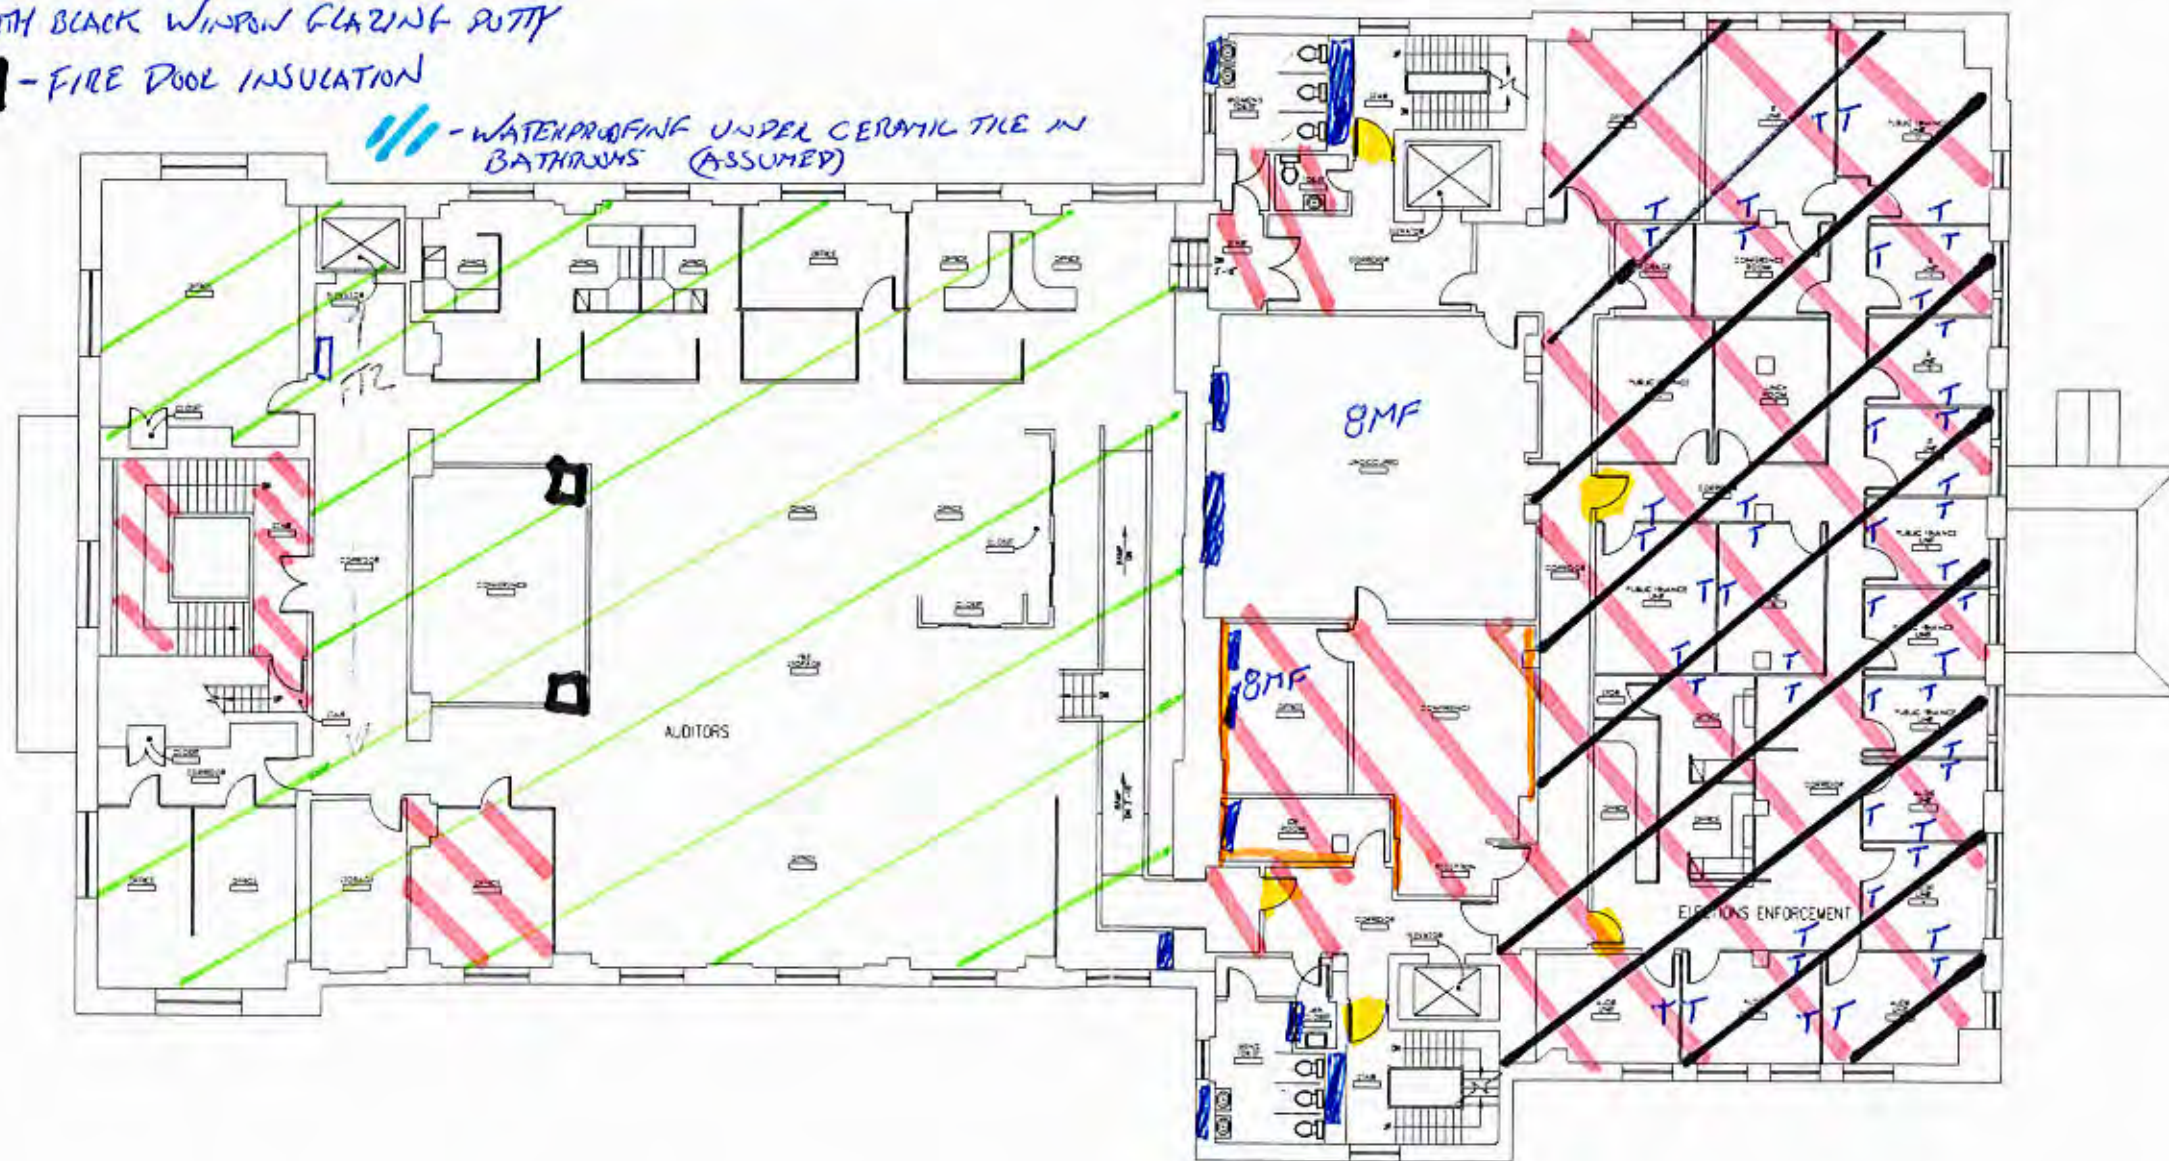
Third Floor Plan
1" = 8'-0"

- ASSUME ACM FLOOR TILE AND MASTIC UNDER WALLS, PARTITIONS, RAMPS, RAISED FLOORS
- ASSUME MIRROR GLUE DAUBS IN BATHROOMS
- ASSUME WATER PROOFING UNDER CERAMIC TILE IN BATHROOMS

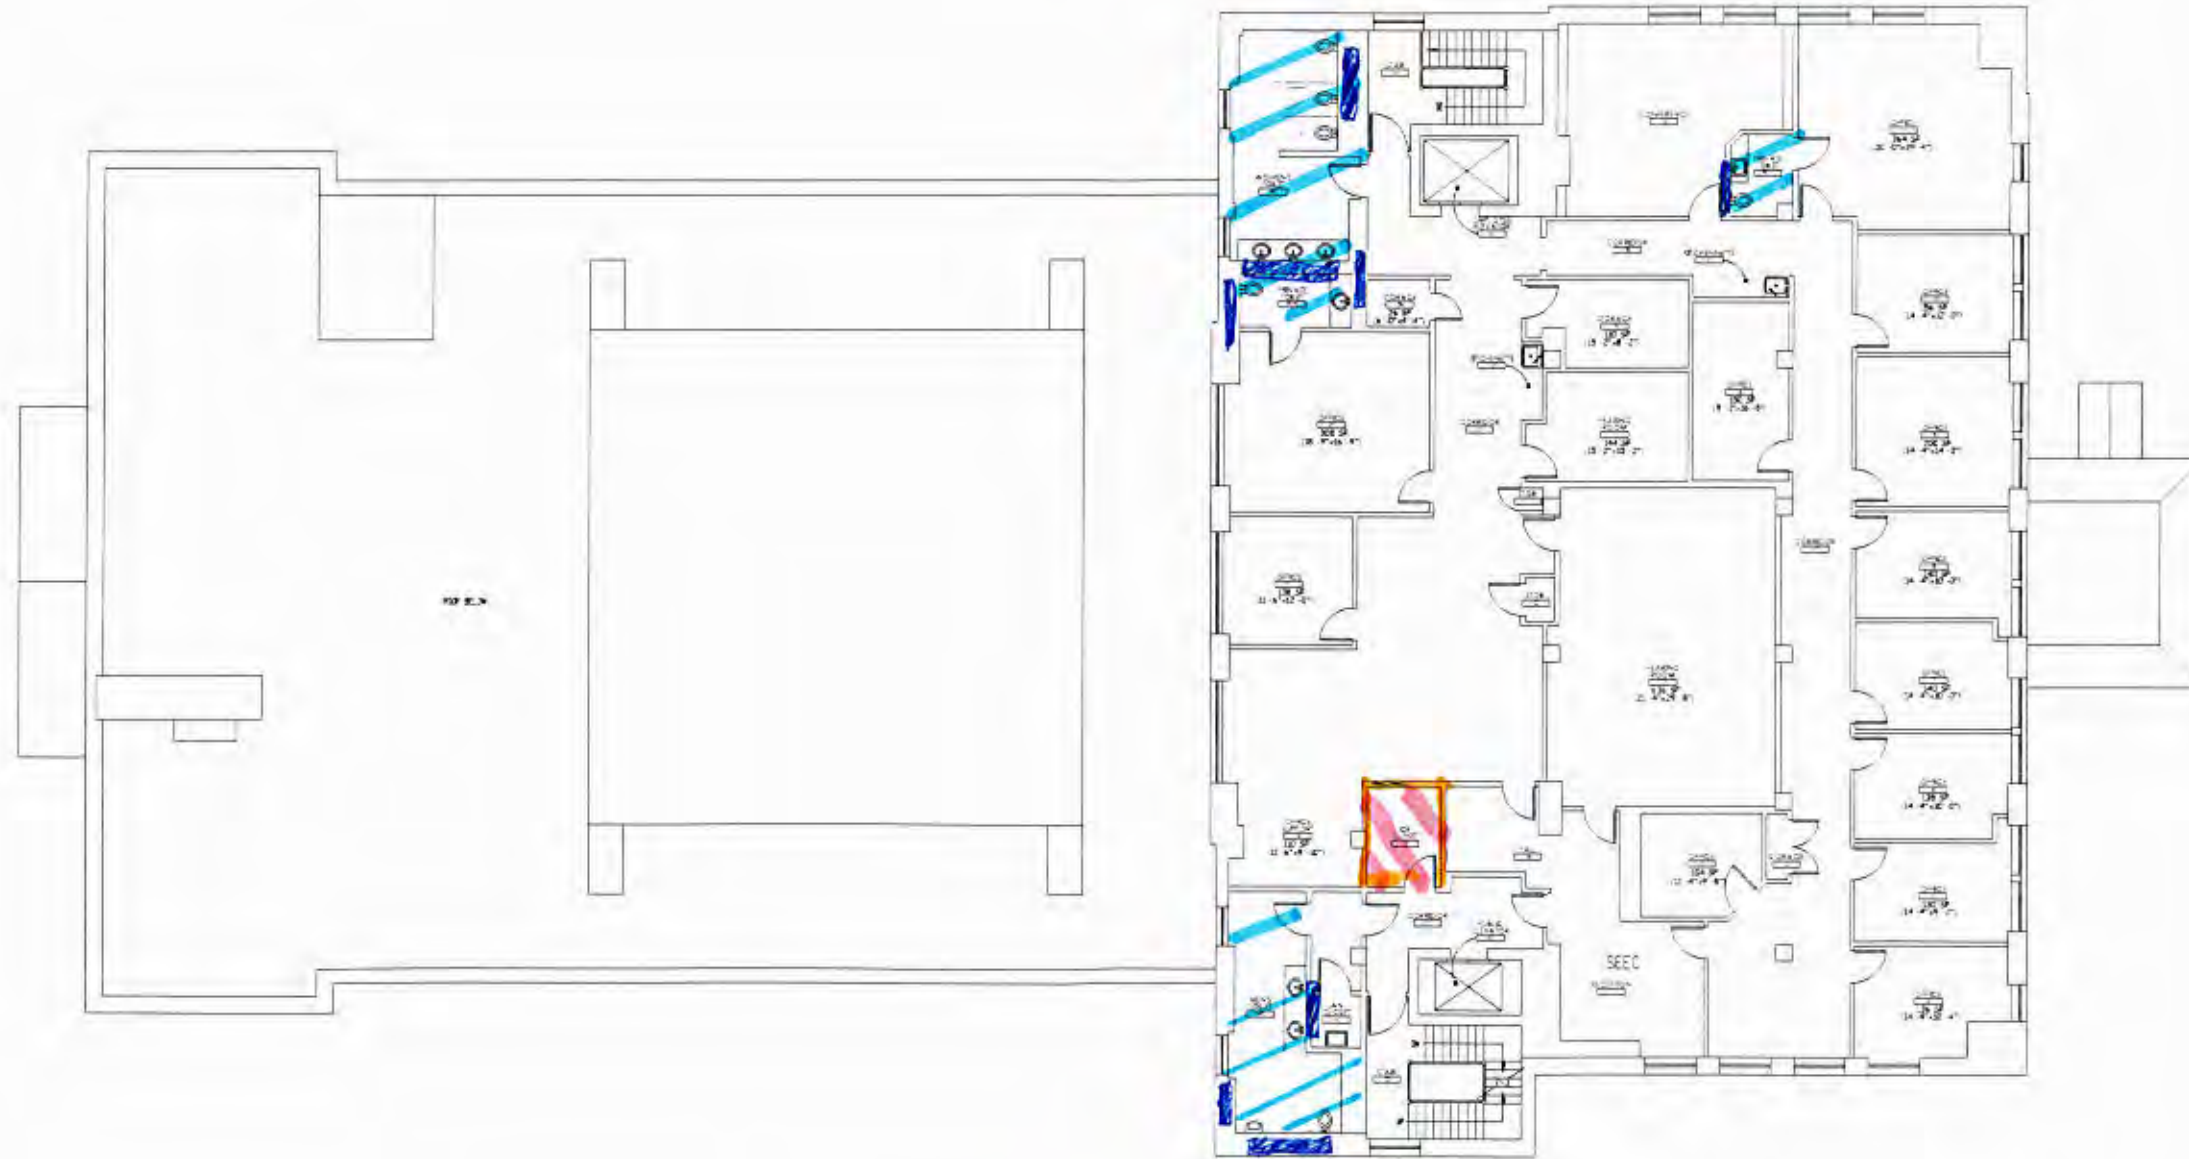
Fifth Floor Plan
1" = 8'-0"

- ASSUME ACM FLOOR TILE AND MASTIC UNDER WALL PARTITIONS, RAMPS AND RAISED FLOORS
- ASSUME MIRROR GLUE DAUBS IN BATHROOMS
- ASSUME WATER PROOFING UNDER CERAMIC TILE IN BATHROOMS
