# **Balcony Flood Testing Investigation Report**

For  
25 Sigourney Street  
Hartford, CT 06106  
DPW Project Number B1-2B-033L

Prepared For  
STATE OF CONNECTICUT  
Department of Public Works

April 13, 2009

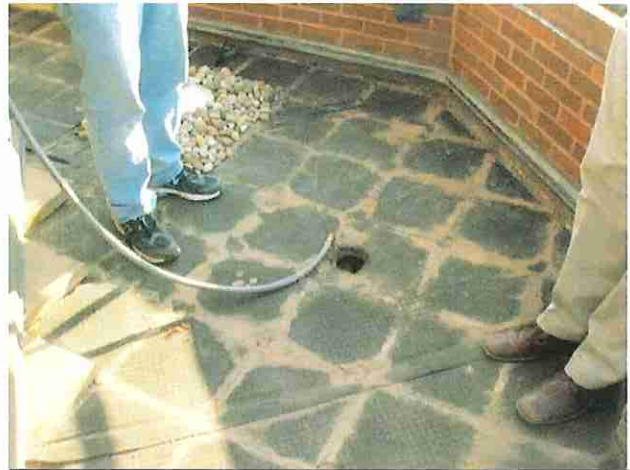
Condition of Roof Membrane

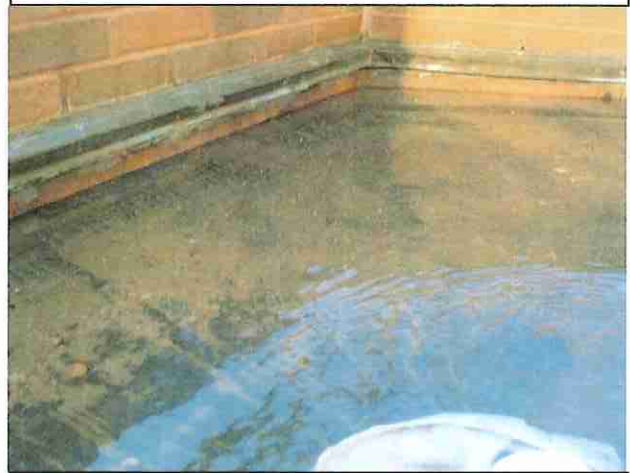
Flooding the Roof Membrane

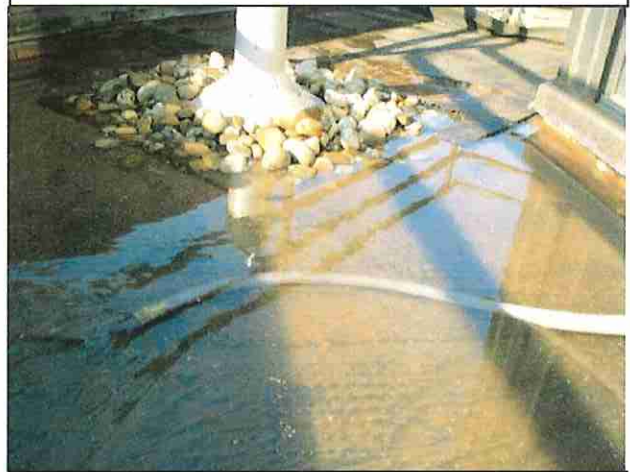
Flooding the Roof Membrane

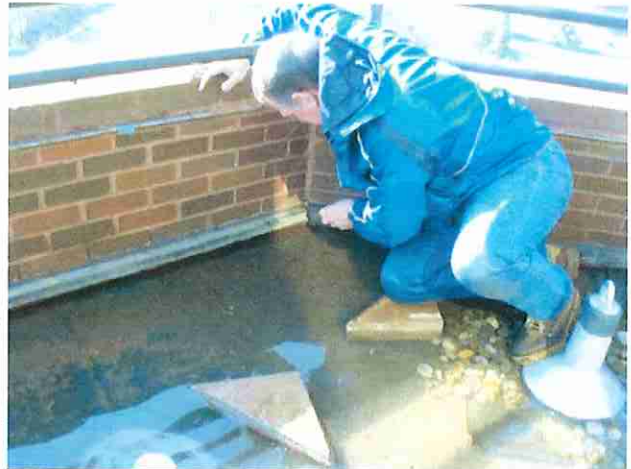
Searching for Leaks above Reglet

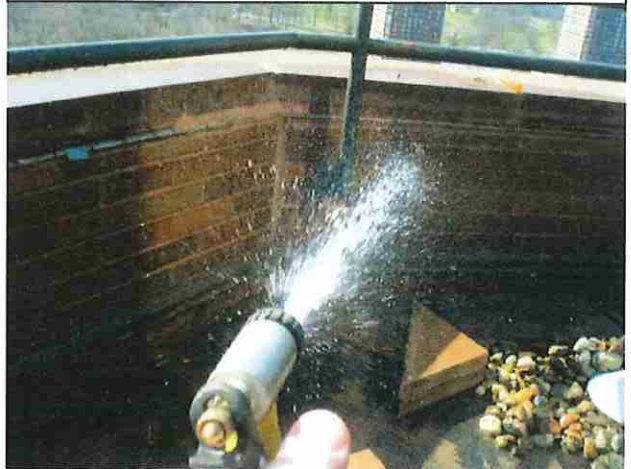
Soaking the Interior Parapet Wall

Until these proper steps can be taken to permanently fix the leaks there is a rather simple temporary solution that can be performed by the Servus Management to slow the amount of water infiltrating the building. A simple tarp can be taped to the interior wall of the parapet at least one foot on each side of the corner that is reported leaking spanning from the high point of the coping stones to the top of the roofing reglet. This should temporarily impede water from soaking through the wall.

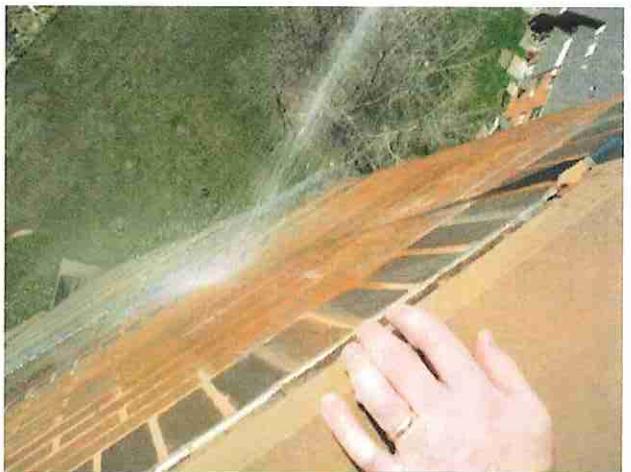
Soaking the Exterior Wall above Window

the office at its traditional drip. We believe that the water leaks at the corner because the steel and flashing at the corner is cut and not connected to each other. There is also no metal 'turn up' at the back of the flashing, which is the last line of defense for this type of water infiltration. However water should never make it this far into the cavity unless there are penetrations through the fabric flashing membrane located above the metal flashing and steel.

It is our recommendation that problems in the fabric flashing located at the corner of the window just above the window head in the office on the 18<sup>th</sup> floor be examined by the installing contractor and a professional. In order to do this the soldier course and a minimum of two brick courses above that should be removed around the corner where water is penetrating the building. Once the bricks have been removed the fabric flashing underneath can be examined thoroughly for tears or penetrations. The fabric flashing needs to either be patched and repaired or completely replaced. Once the fabric is replaced the bricks can be set back into place and after a few days the walls should be flood tested to see if the problem has been solved. The exterior wall leak should be solved with this solution but the separate leak on the interior will still persist.

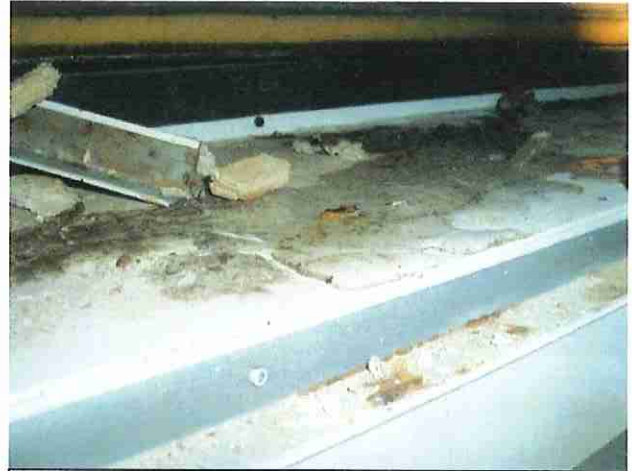
Water Soaking through Backer Rod and Pooling above Window

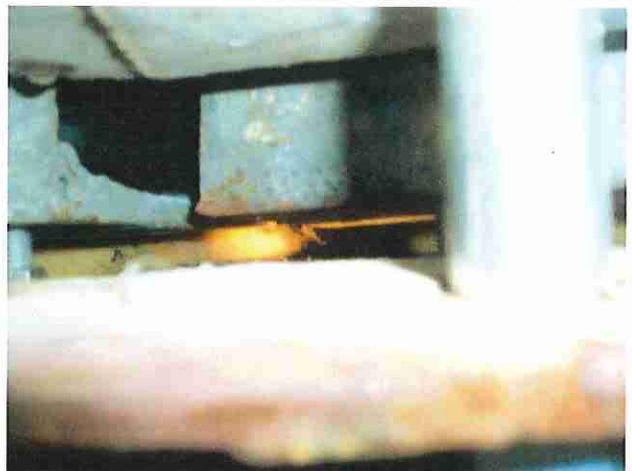
Discontinuous Steel Angle @ Corner  
(Area where the exterior water infiltrates)

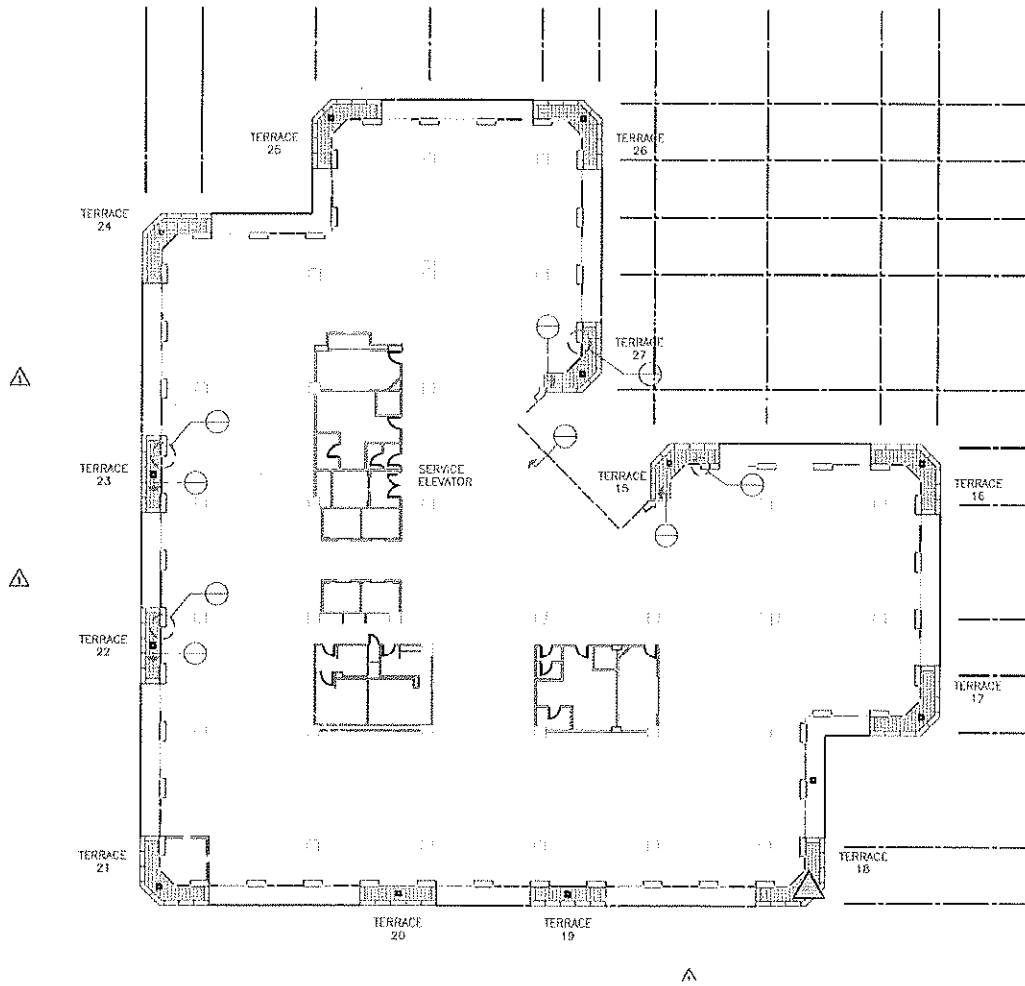
NINETEENTH FLOOR PLAN

△ - Flood Tested April 10th 2009
